Safety Alert 14-14

#### DESIGNED FOR A REASON – HULL MAGNETS

##### MODIFICATIONS MADE TO PILOT LADDER MAGNETIC SECURING DEVICES LEAD TO ACCIDENTS

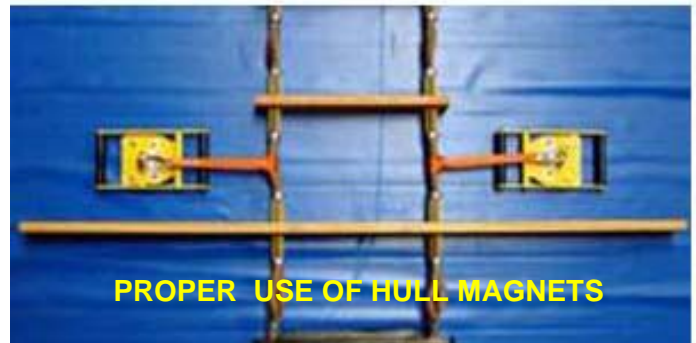
Hull magnets are easy to operate devices and when positioned correctly, provide substantial holding force. The handle of the magnet is also a lever and enables easy release from the hull of the vessel. The intended proper use of the magnets is shown in the above image. In the incidents where the magnets unexpectedly detached from the hull, only one securing magnet was used between the rails of the ladder along with equipment alterations that deviated from the manufacturer's design (see image below).

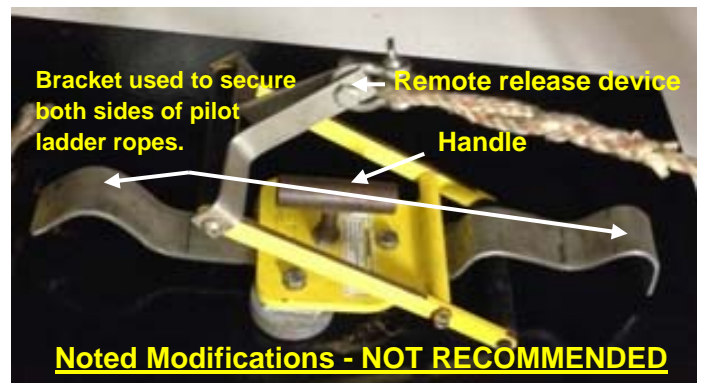
This alert raises awareness as to the importance of not modifying equipment or components from their intended design or operation. Recently, a State Pilot suffered a concussion as he was boarding a vessel via its pilot ladder. The primary cause of the accident was an improperly modified embarkation ladder hull magnet that disconnected from the ship's hull and struck the Pilot on the head.

The Coast Guard **strongly recommends** that vessel owners/operators refrain from modifying embarkation equipment. In addition, operators should regularly inspect existing vessel boarding equipment and return improper modifications back to the manufacturer's original design. Pilots are encouraged to consult with their appropriate associations to determine if any additional precautions should be taken as part of their normal boarding practices and this identified risk.
