PILOT BOARDING DEFICIENCY REPORT

DATE: JAN 13, 2020 TIME: 17:20

VESSEL: ANDIMILOS

PILOT: SALVADOR RIVAS

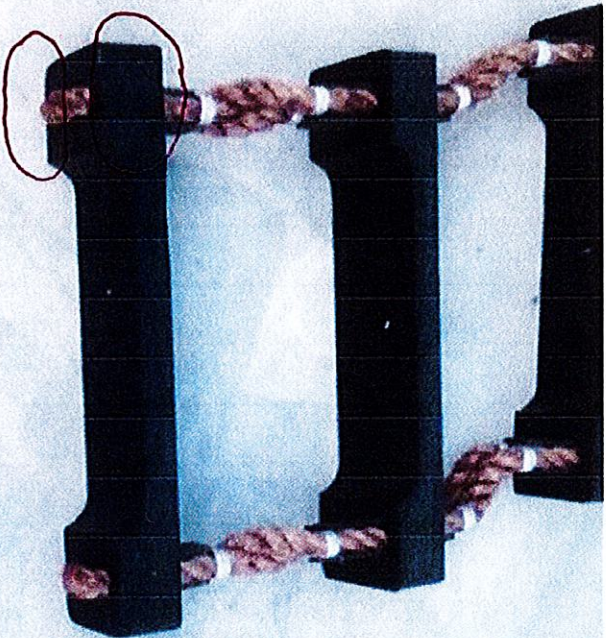
1) BOTTOM MOST STEP WAS BROKEN AND NOTHING PREVENTING ONE SIDE FROM FALLING OUT

BLACK CORNERS
ON RUNS ON
BOTTOM STEP
MISSING. NOTHING
PREVENTING STEP
FILM COMING OUT
OF SLICE

NOT ACTUAL CAMERA (PICTURE USED
TO DESCRIBE DEFICIENCY)

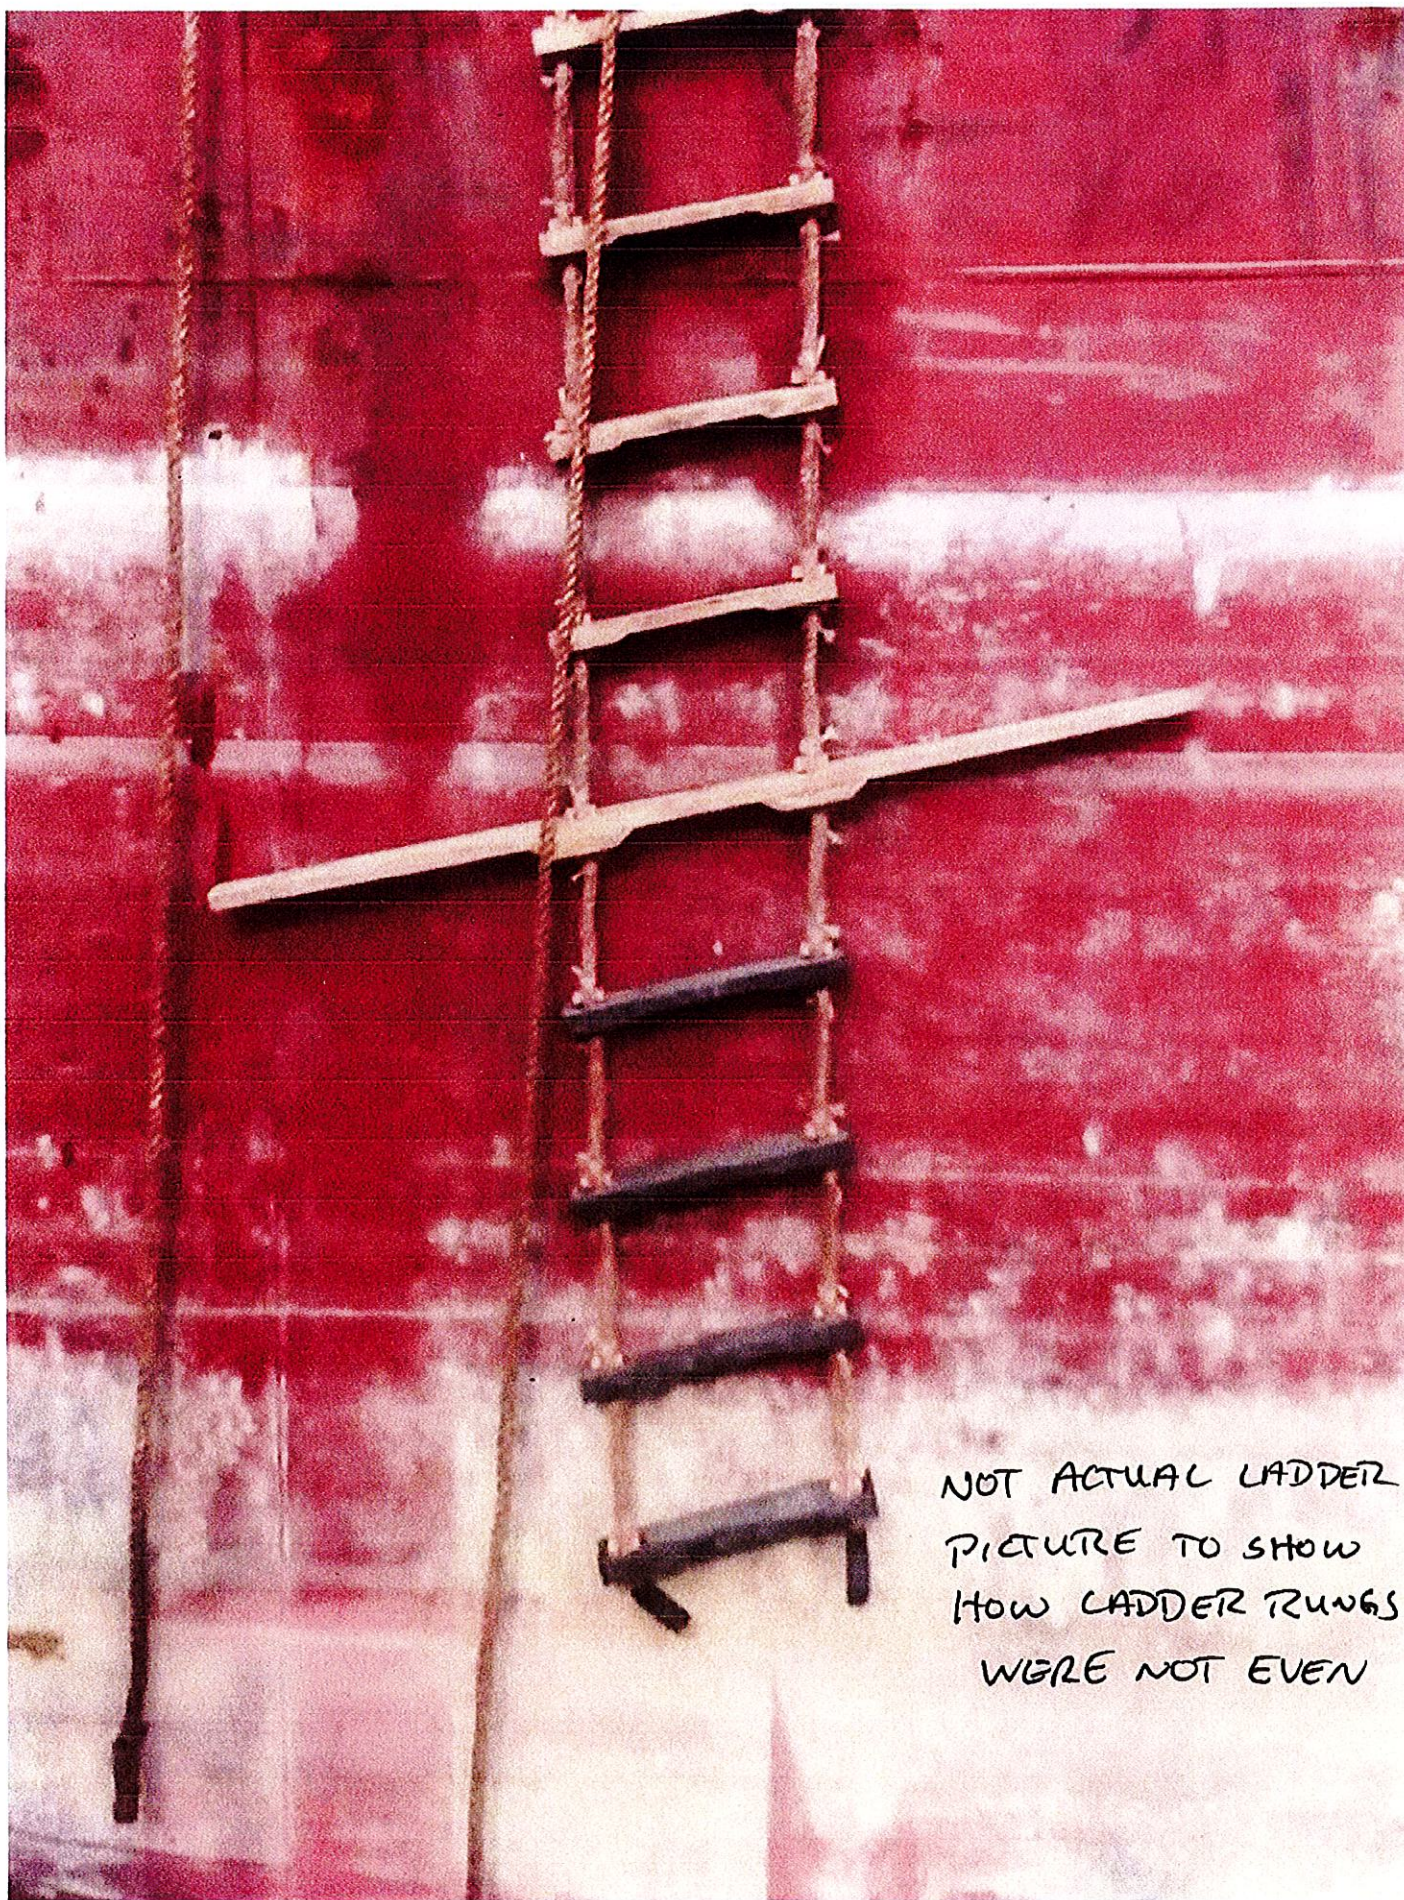
2) RIGHT SIDE OF LADDER LOWER THAN LEFT RUNGS WERE NOT EVEN

NOT ACTUAL LADDER
PICTURE TO SHOW
HOW LADDER RUNGS
WERE NOT EVEN
