PILOT BOARDING DEFICIENCY REPORT

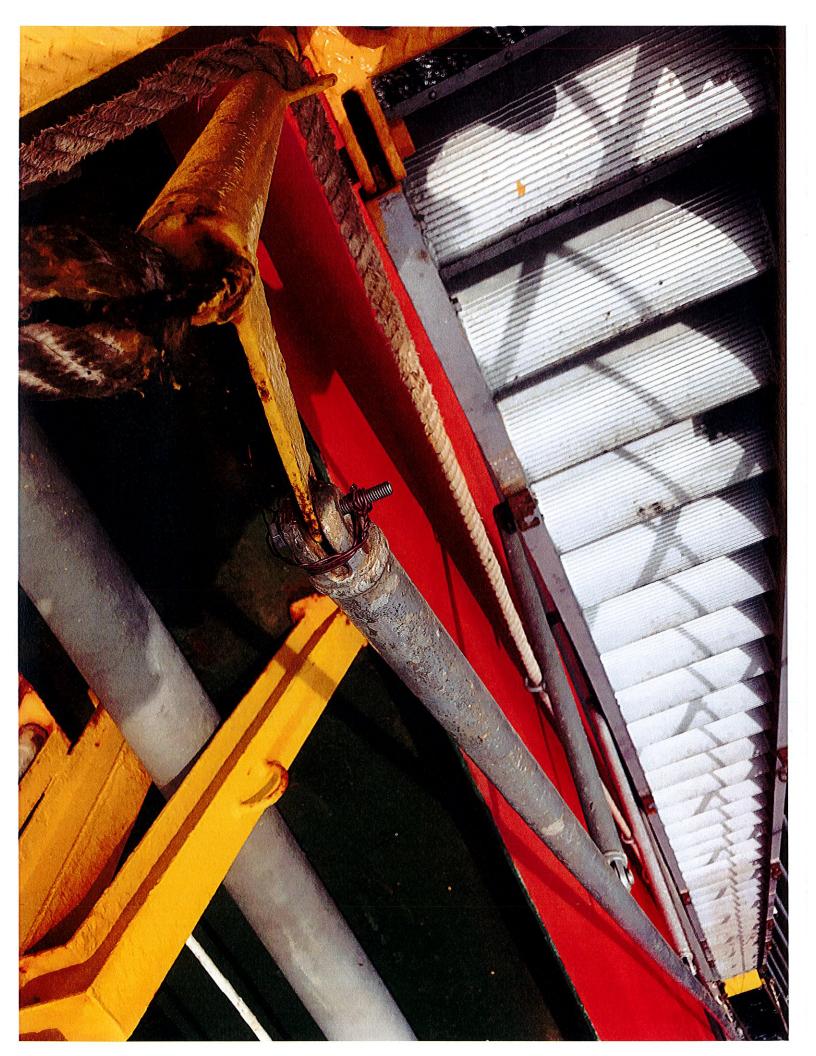
DATE:	9/2/18 TIME: 1300
VESSEL	: ATLANTIC CROWN
MASTE	R:
PILOT:	SALVADOR RIVAS
CONDI	FIONS: LIGHT EASTERLY WINDS + SEAS
APPLIC	ABLE LADDER ARRANGEMENTS (check all that apply):
	PILOT LADDER ONLY COMBINATION LADDER SIDE PORT OTHER
DEFICIE	NCIES (check all that apply and provide brief comment)
	GENERAL ARRANGEMENT (ie: Insufficient lighting, no officer, unsafe deck access, etc.)
	PILOT LADDER (ie: Poor condition/wear, not resting on hull, poor rigging, etc.)
	COMBINATION LADDER (ie: Poor condition/wear, not secured, platform too low, etc.)
	BOLTS HOLDING GANGWAY RAILS LECUTED BY WIRES NOT NUT
	MAN ROPES (ie: Poor condition/wear, incorrect diameter, poor rigging, etc.)
_	
П	DOCKSIDE (ie: Gangway condition/pitch, netting, poor rigging, etc.)
ADDITIO	DNAL REMARKS:
	TICED WHILE DISEMBARKING USED STARBOARD GANGWAY
NOT	COMBINATION (PILOT DECISION) BOLTS HOLDING TRAILS ON BOTH SIDE
MIS	SING LOT NUTS & BOTH WERE SECURED BY WIRE (SEE PICTURE).
