M.V. Atlantic Ensenada

**Investigation Report on:
Unsafe Access in Port and Incorrect Rigging Pilot Ladder on
departure from port of New York, USA on 07th January 2020.**

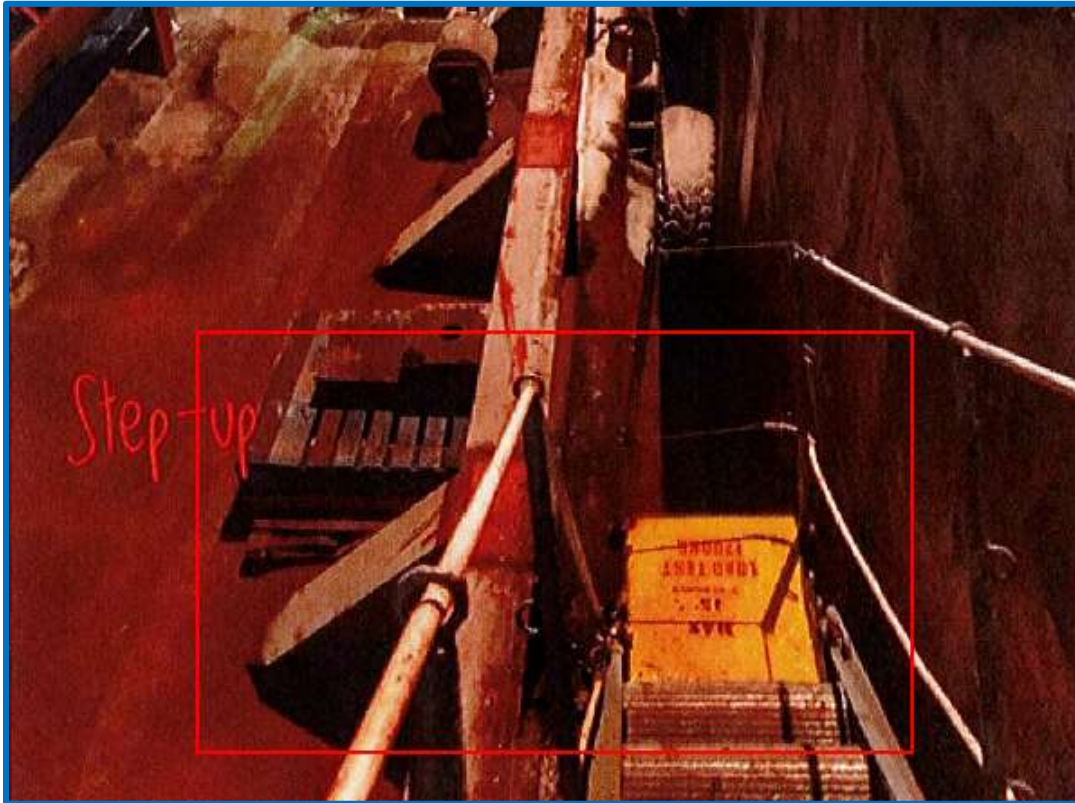
With reference to the picture below attached to the 'Pilot boarding deficiency report' – it is readily noticeable from the picture that the "wooden pallet - step arrangement" not in proper position due to slight ahead movement of the vessel, reason as stated above.

Crewmember overlooked the misalignment of the step-up arrangement as they failed to notice that own vessel had moved ahead and “wooden palette – steps arrangement” need to be readjusted for midship gangway to be readily accessible.

- Ship's crew failed to monitor the safe access to the vessel. The "wooden pallet - step arrangement" located on the barge was misaligned due to surging of the vessel, crewmembers failed to notice same and hence did not inform the barge personnel to correct the misaligned step-up arrangement. Thus, when Sea Pilot boarded the vessel – the midship gangway was not readily accessible via "wooden pallet - step arrangement".
- Ship's crew busy with departure preparation failed to notice the boarding of Sea pilot via misaligned "wooden pallet - step arrangement", thus unable to rectify the error prior pilot's boarding and failed to provide safe access.

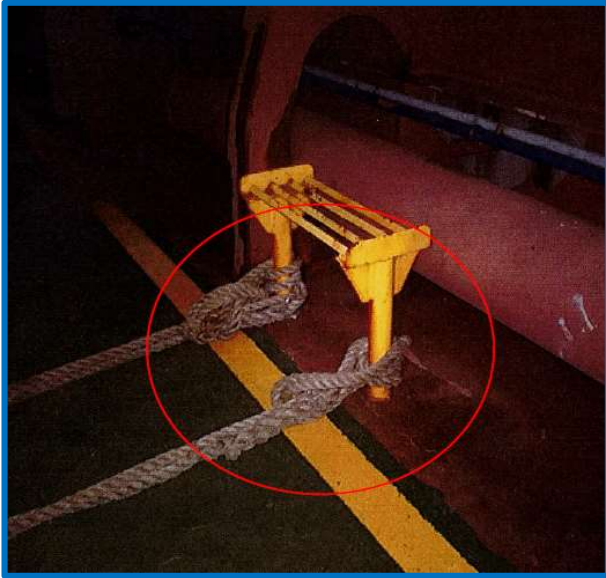
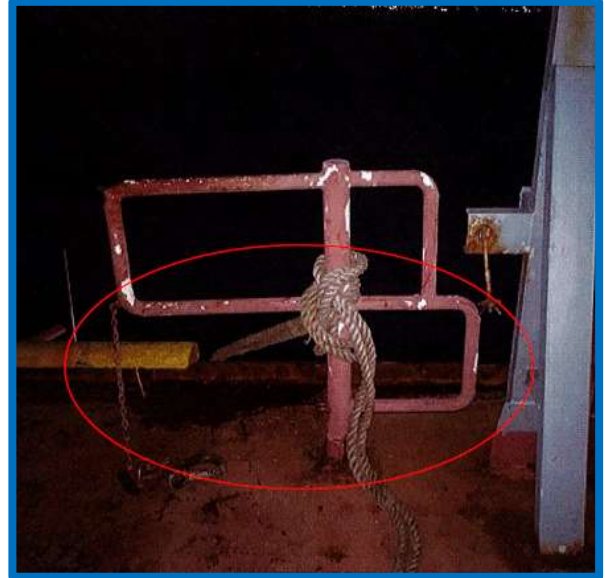
Ship’s crew lowered last two steps of the short Pilot ladder in order to reach tugboat’s deck and as a result there were no more steps left to make fast the short Pilot ladder with shackles on deck D-rings.

Ship’s crew made fast the short Pilot ladder’s end ropes to deck fittings / fixed rails as shown in the pictures below.

Dock Pilot refused to use the short Pilot ladder secured in manner as per picture below as he deemed same to be unsafe.

- Ship's departure free board was 13.12 metres based on the midship draft of 5.08 metres.
- Vessel crew failed to prepare the Combination Pilot ladders in compliance with the:

(1) SOLAS requirements as stated in Chapter V Regulation 23: *"All arrangements used for pilot transfer shall efficiently fulfil their purpose of enabling pilots to embark and disembark safely. The appliances shall be kept clean, properly maintained and stowed and shall be regularly inspected to ensure that they are safe to use."*

(2) IMO Resolution A.1045(27) Pilot Transfer Arrangements, Section 5 states: *"Access to Deck states that "Means should be provided to ensure safe, convenient and unobstructed passage for any person embarking on, or disembarking from, the ship between the head of the pilot ladder, or of any accommodation ladder, and the ship's deck; such access should be gained directly by a platform securely guarded by handrails."*

Ship's crew quickly change the short Pilot ladder with a longer Pilot ladder which was kept on the starboard side of main deck and took about 15 minutes to rig same.

Then Port side midship gangway angle was adjusted as required, the Combination ladder rigging was completed to the satisfaction of the pilot.
