PILOT BOARDING DEFICIENCY REPORT

DATE: 7 Jan 2019 TIME: 0330

VESSEL: ATLANTIC EENSENADA

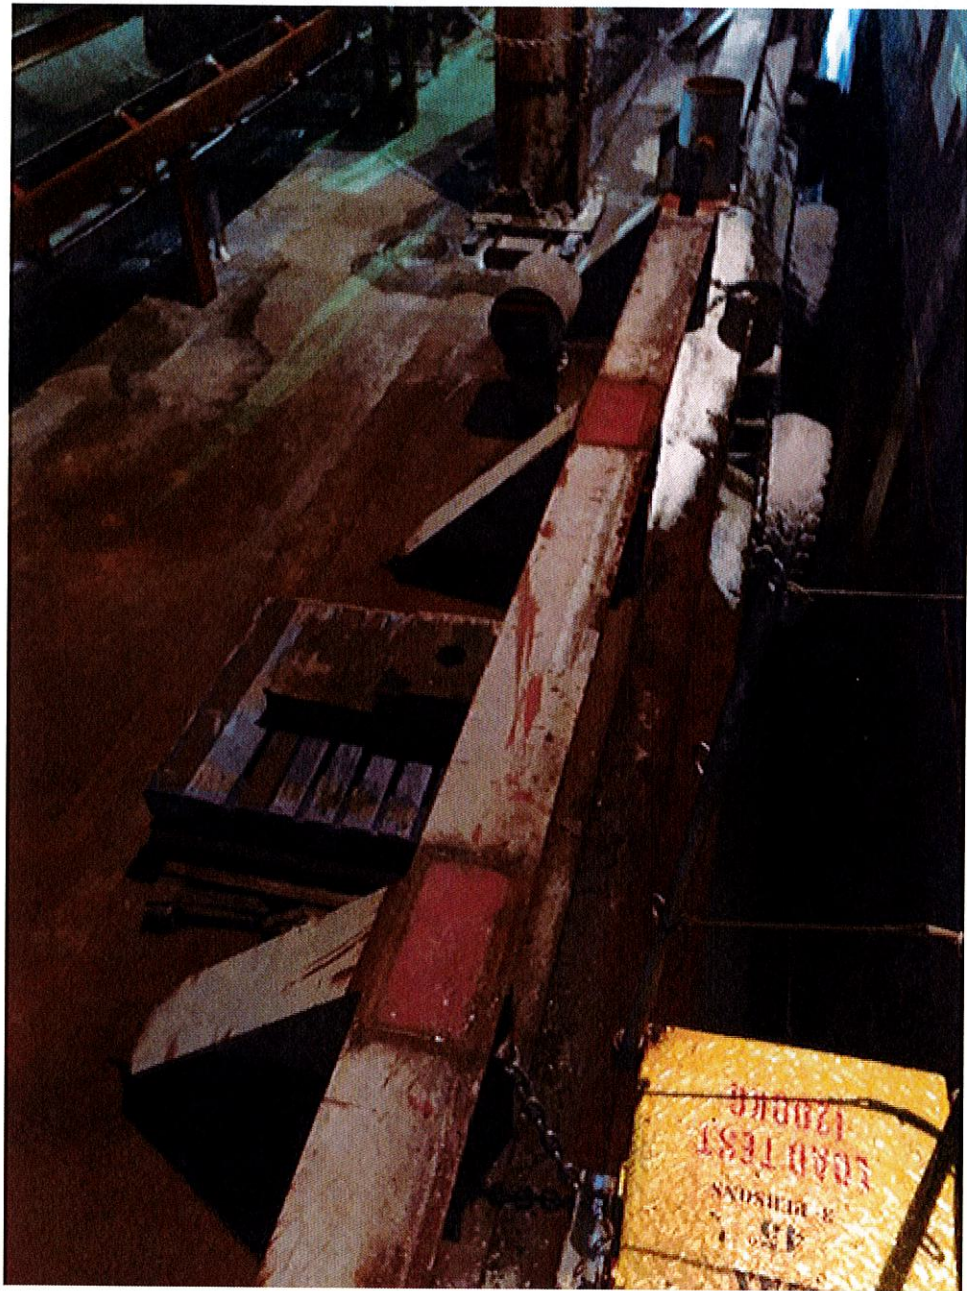
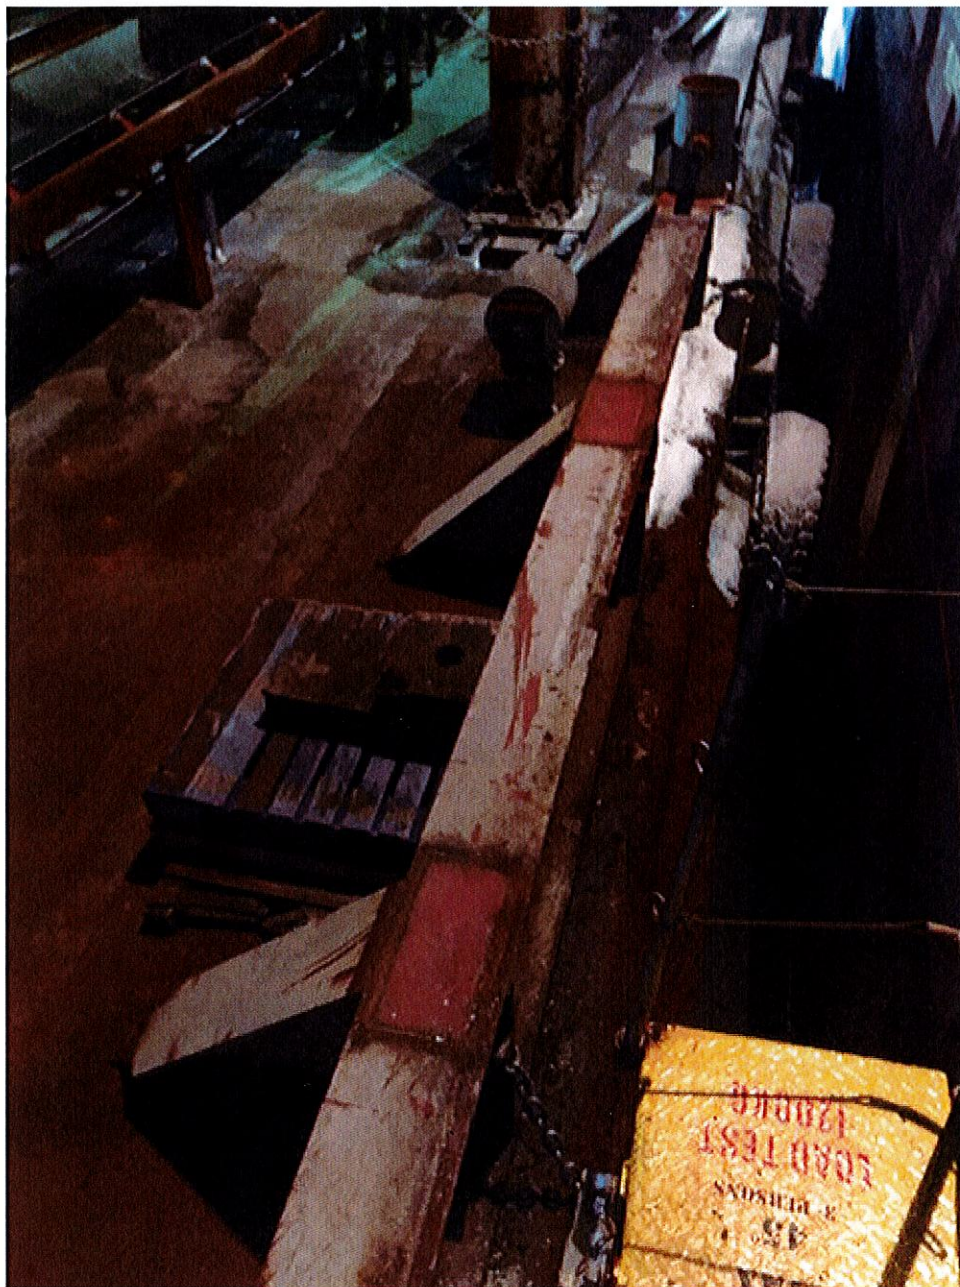
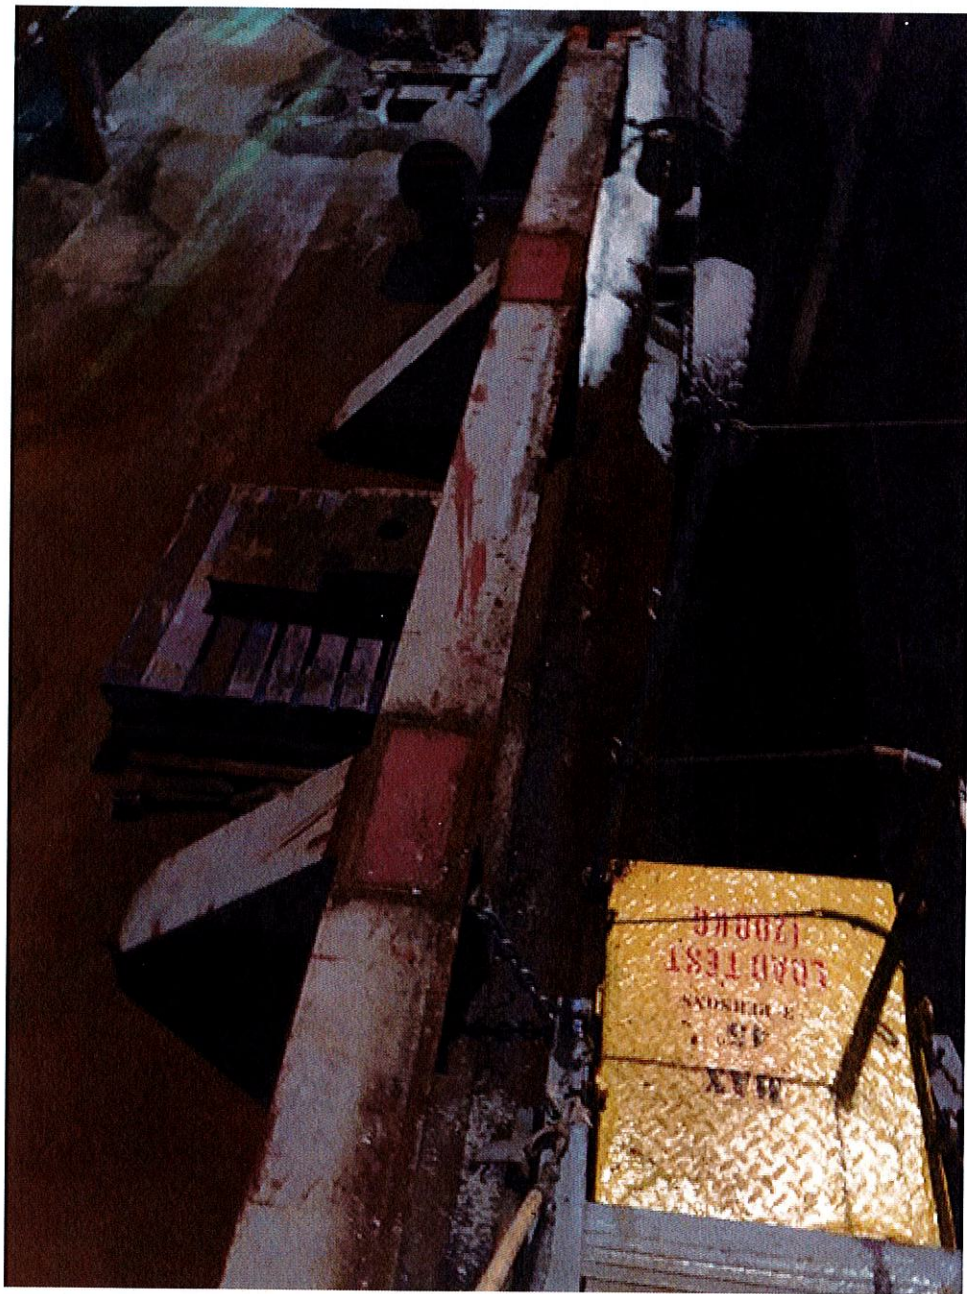
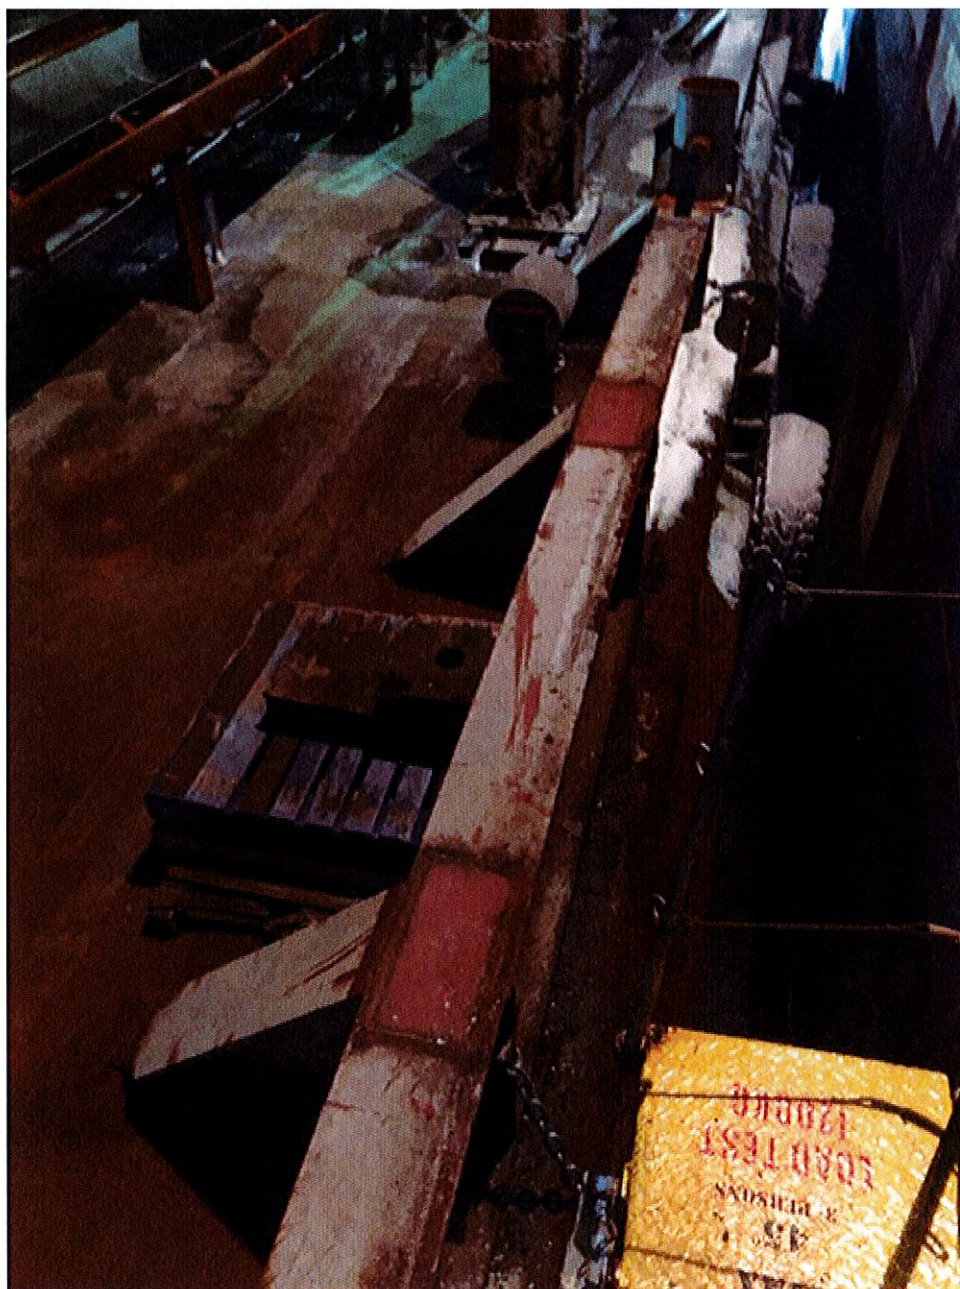
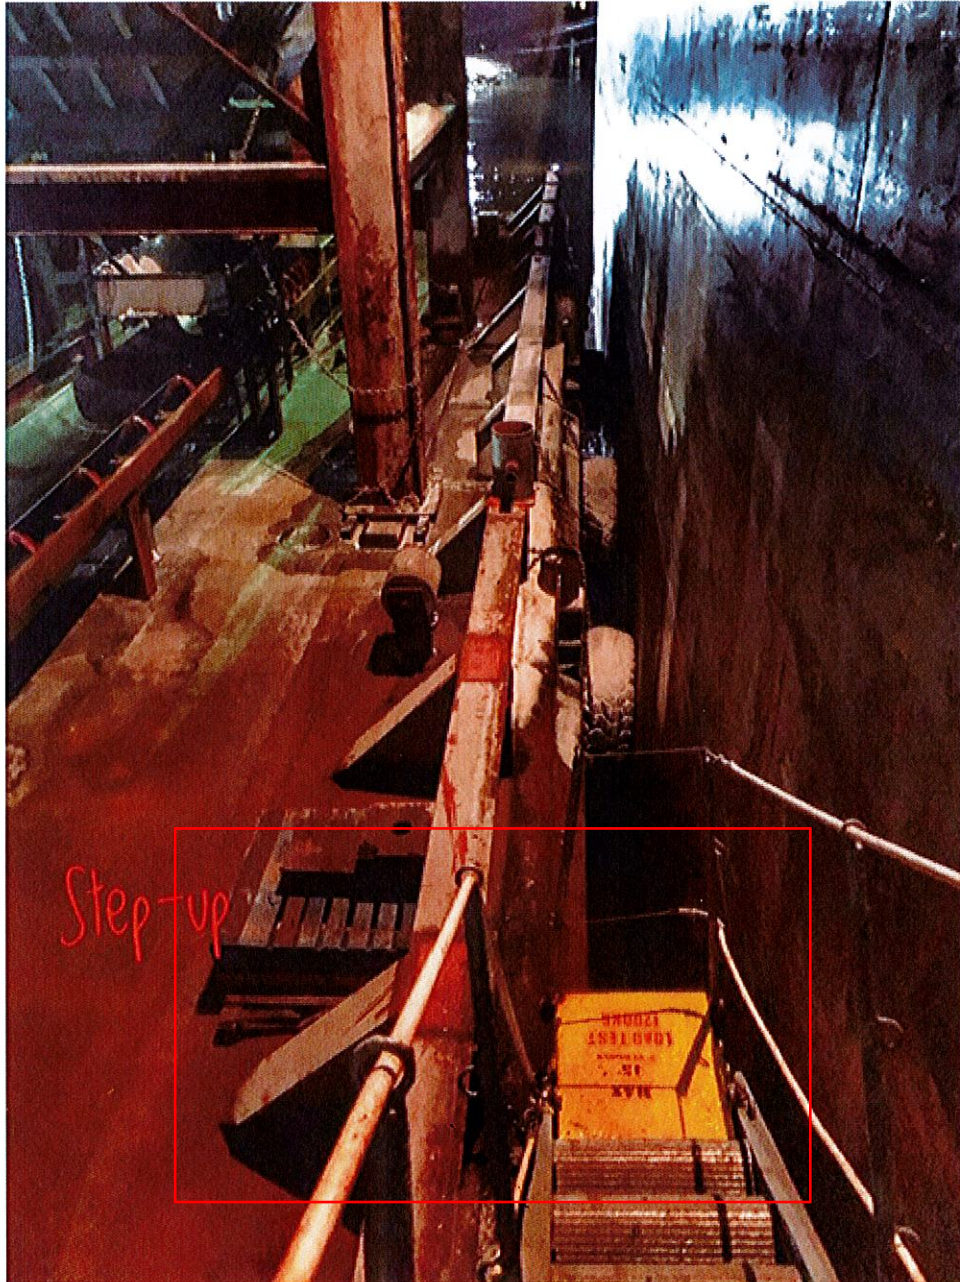
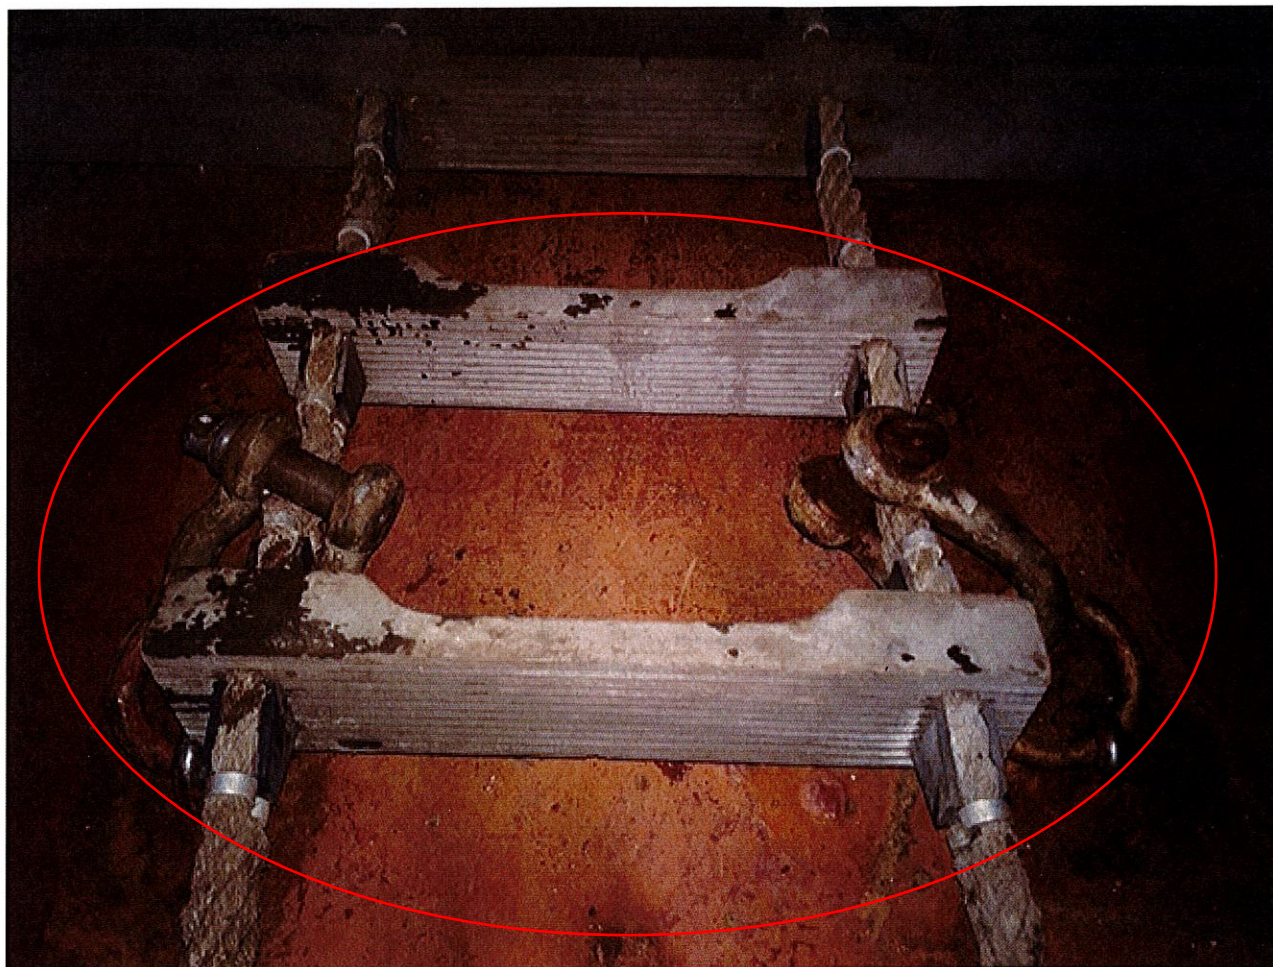
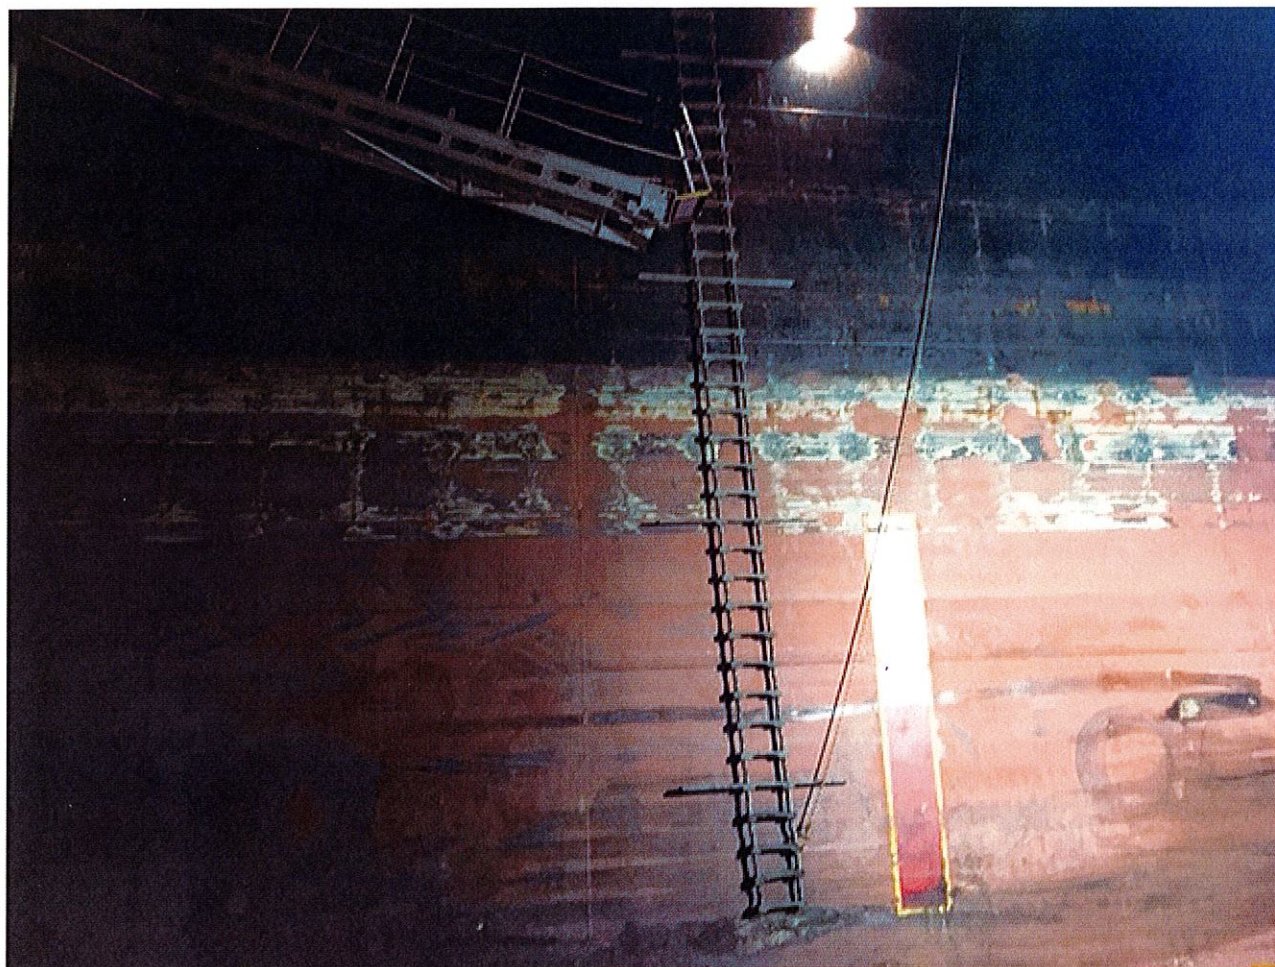
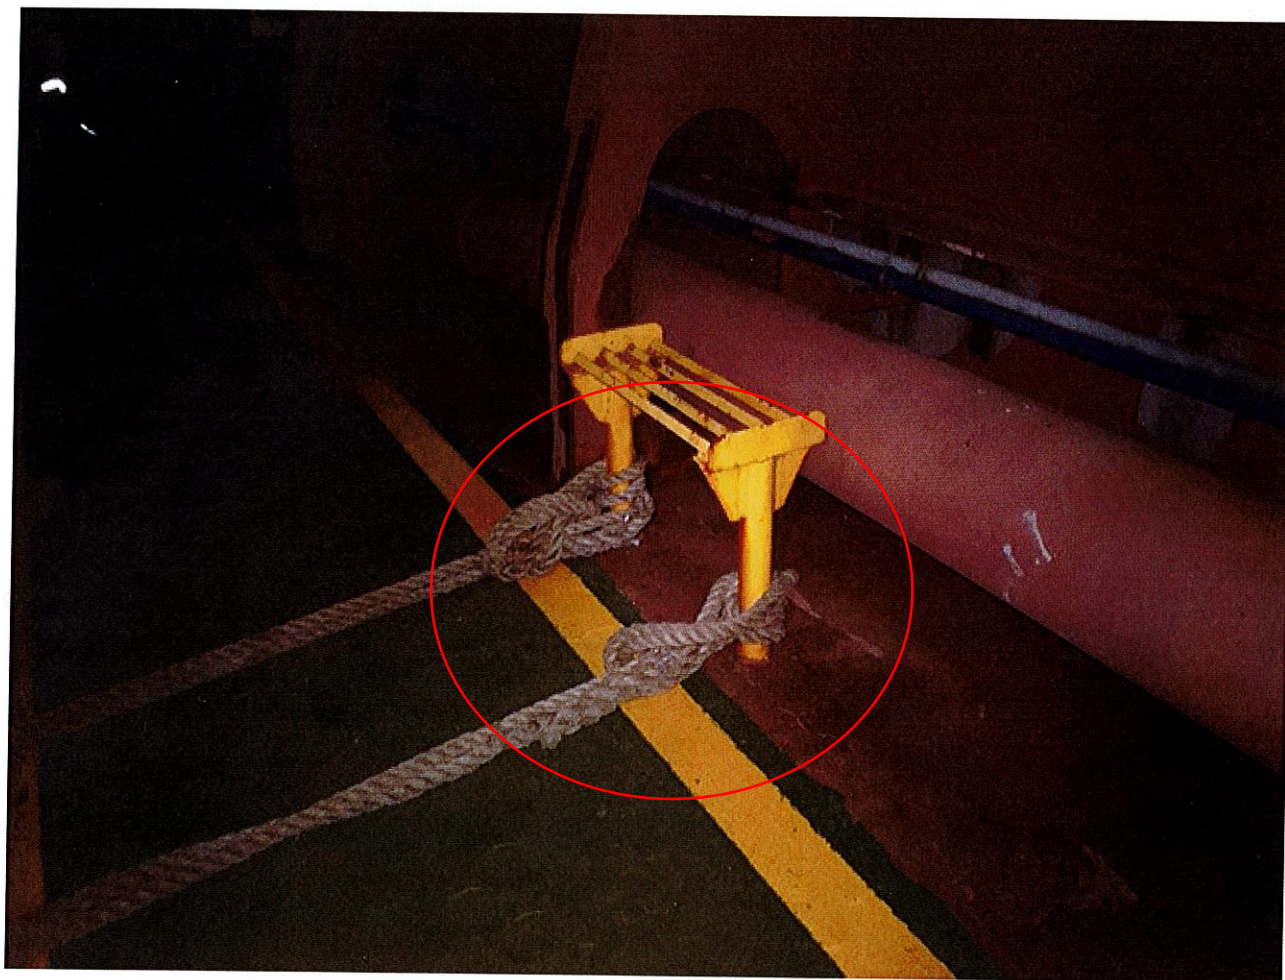
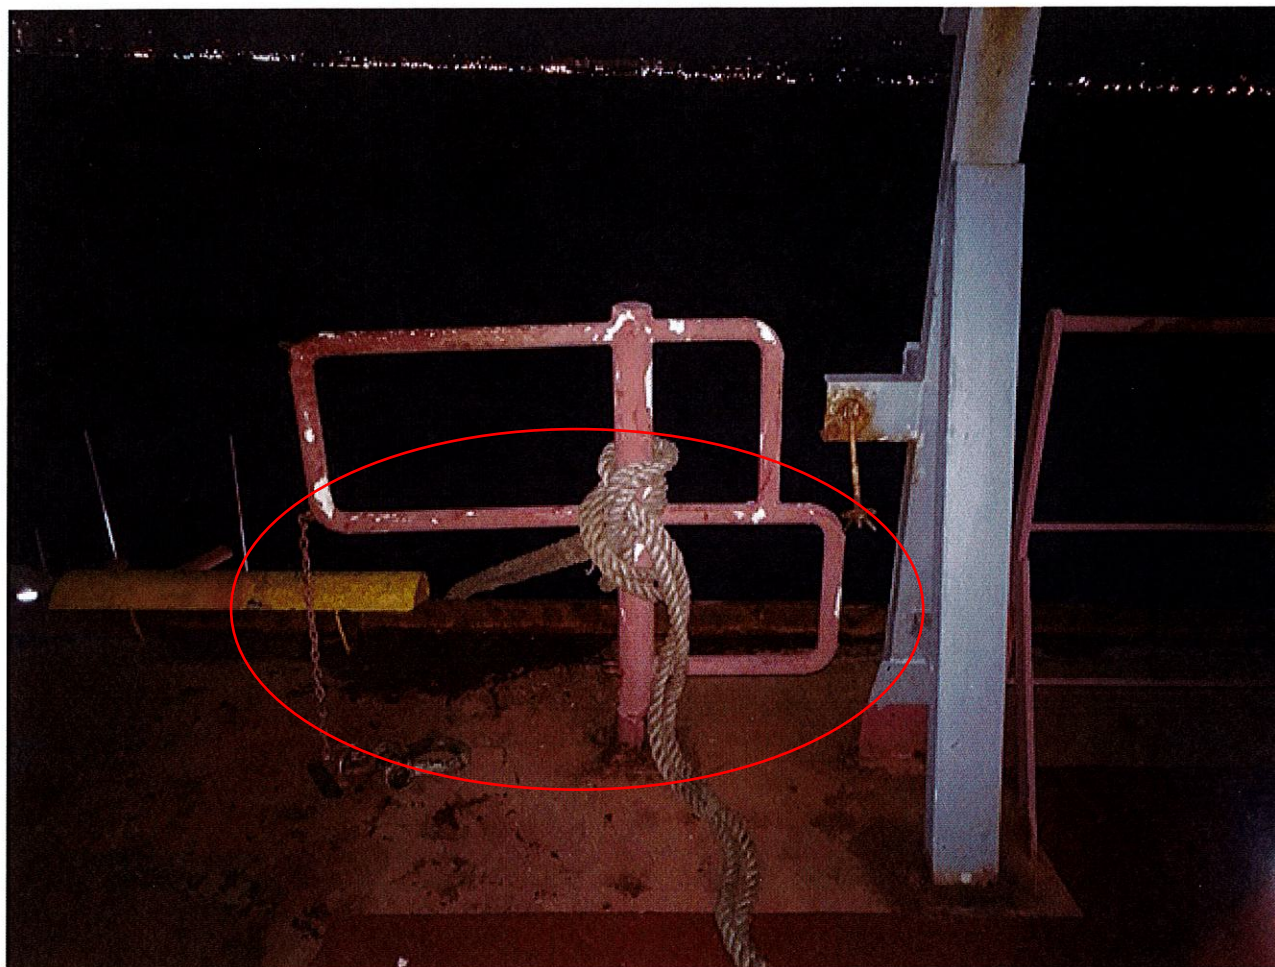
- ☐ MAN ROPES (ie: Poor condition/wear, incorrect diameter, poor rigging, etc.)
- LADDER 1: POOR CONDITION, NOT SECURED PROPERLY, LADDER TOO HIGH LADDER 2: WRONG ANGLE; NOT SECURED

NO RAILING/PROTECTION FROM FALL BETWEEN BARGE & SHIP

Also, DOCKING PILOT WAS MADE TO BOARD VIA PILOT LADDER. THIS WAS AFTER A GANGWAY OR COMBO LADDER WAS ASKED FOR. AS SEEN IN PHOTOS, FREEBOARD IS WELL OVER 9M.
