MARINE CIRCULAR	Reference Number	MAR/2020/007
		Prepared By	Arindam Sen
		Approved By	Yi Wenhao
		Date	22 January 2020

Re: Unsafe Access and Improper Rigging Pilot Ladder

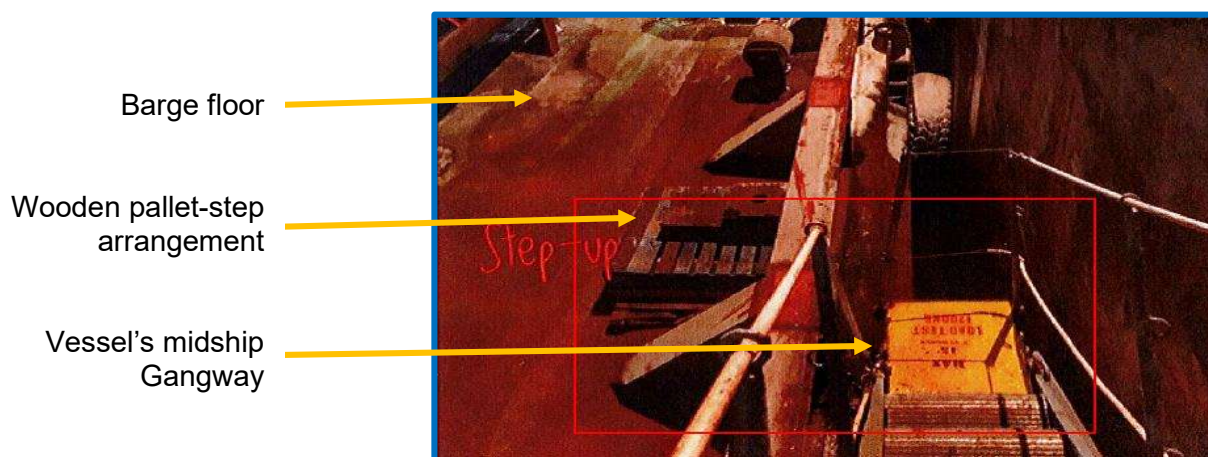
The "wooden pallet - step arrangement" positioned on the barge floor to access the midship starboard gangway of the vessel misaligned due to slight ahead movement of the vessel, reason as stated above.

Sea pilot boarding via same midship gangway at 0312LT and complained about the misalignment of the "step-up" arrangement and unsafe access to the vessel.

- ❑ Resultant deficiency as stated in the report – "No railing / protection from fall between barge and ship".

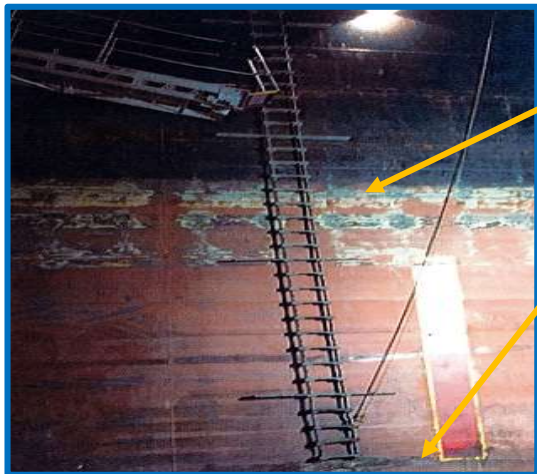
Ship side (port) - High freeboard

Short Pilot ladder not of sufficient length to reach down.

- Resultant deficiency as stated in report – “Ladder 1 Poor condition, not secured properly, ladder too high”.

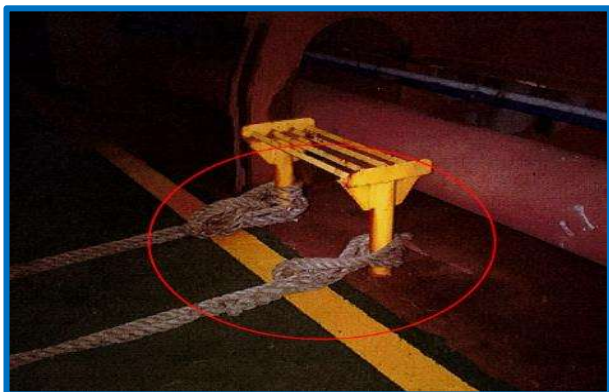
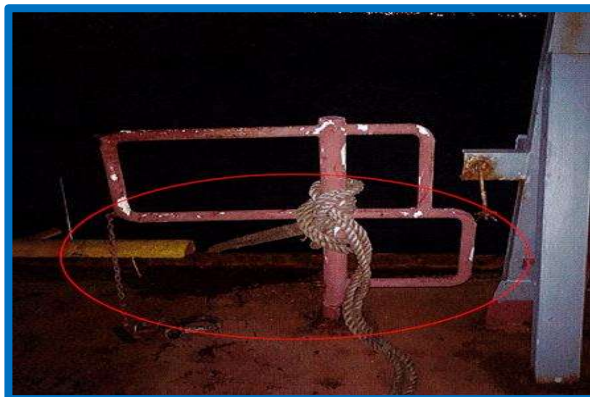
Ship’s crew made fast the short Pilot ladder’s end ropes to deck fittings / fixed rails as shown in the pictures below so that the short Pilot ladder can reach the tugboat’s deck.

Dock Pilot refused to use the short Pilot ladder secured in above manner as he deemed same to be unsafe.

- Resultant deficiency as stated in the report – “Ladder 2 Wrong angle, not secured”.

Ship’s crew change the short Pilot ladder with a long Pilot ladder reaching the tugboat deck and completed the Combination ladder rigging.
