PILOT BOARDING DEFICIENCY REPORT

DATE: 10 MARCH 2020 TIME: 1310

VESSEL: MSC CARMEN

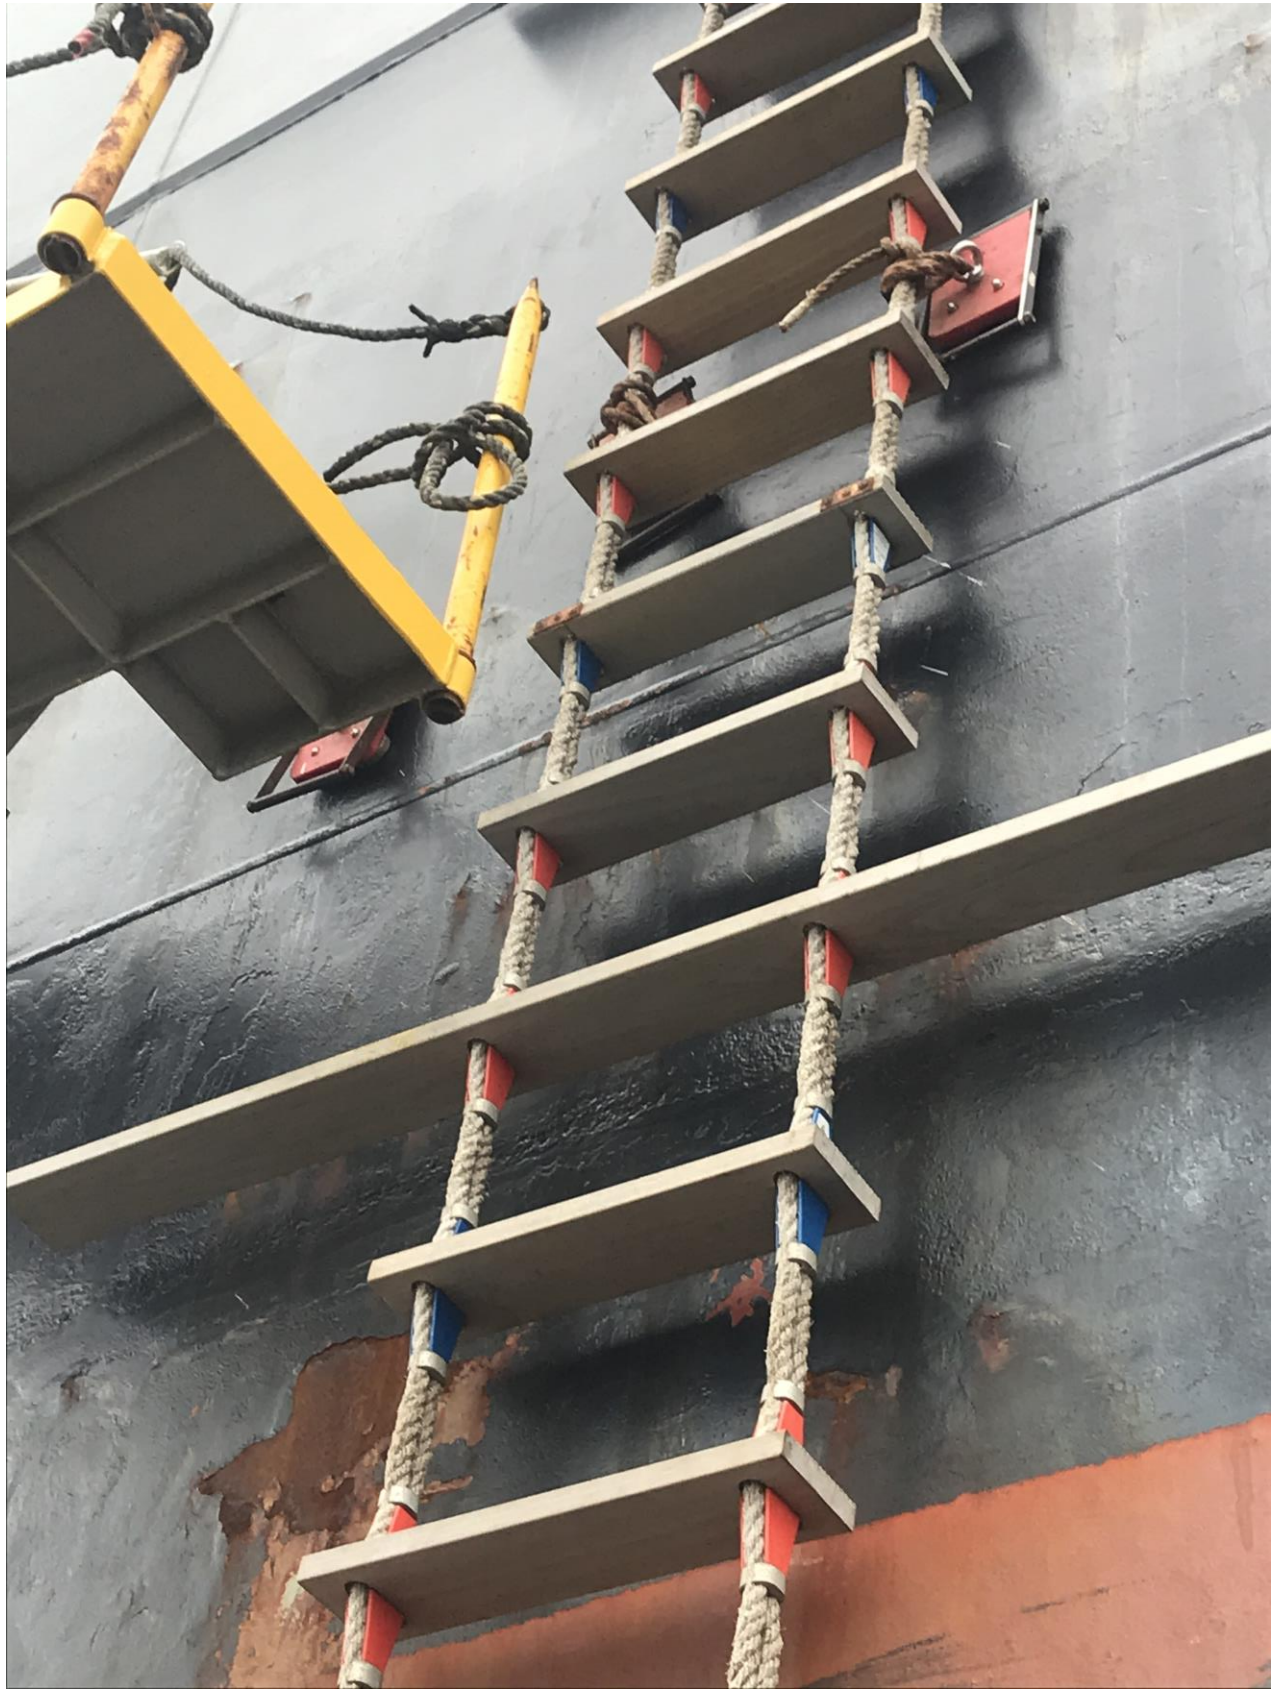
- ☒ PILOT LADDER (ie: Poor condition/wear, not resting on hull, poor rigging, etc.)

STEP OFF PLATFORM HAD A REPAIR CONSISTING OF

RUSTED METAL PLATES WITH SCREWS. NOT ALLOWED
PER IMO. FULL REPLACEMENT STEP MUST BE
USED. CAPTAIN NOTIFIED BY VHF AFTER DISEMBARKING
