PILOT BOARDING DEFICIENCY REPORT

DATE: 9 FEB 2020 TIME: 1630

VESSEL: MIRELLA S

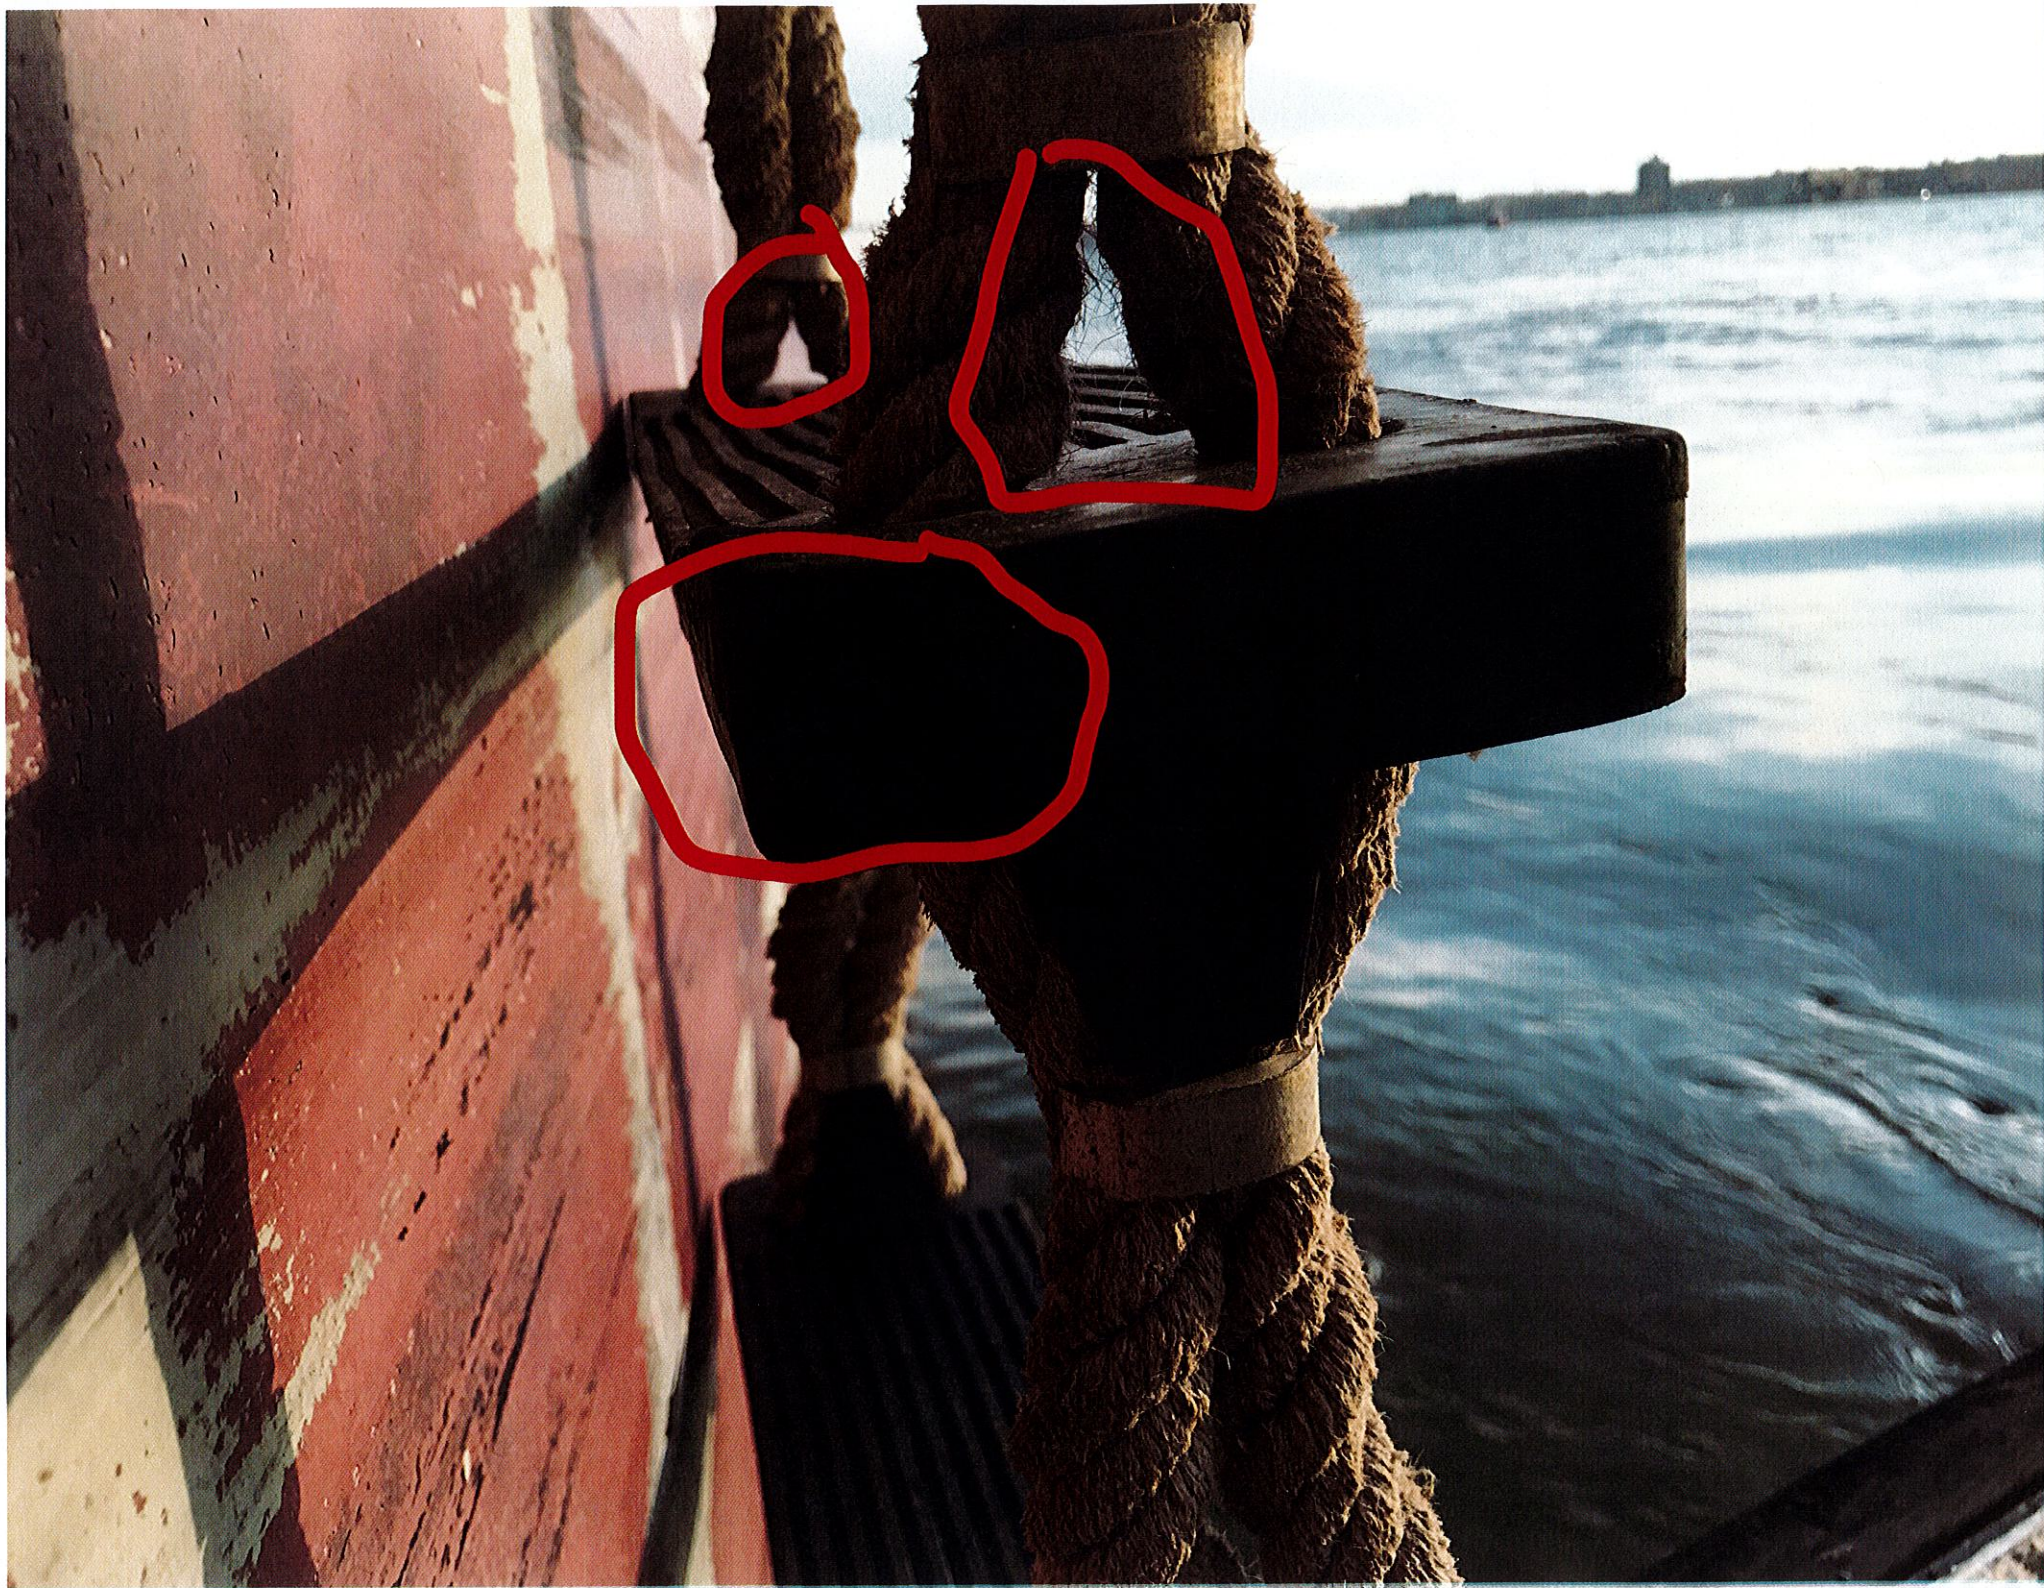
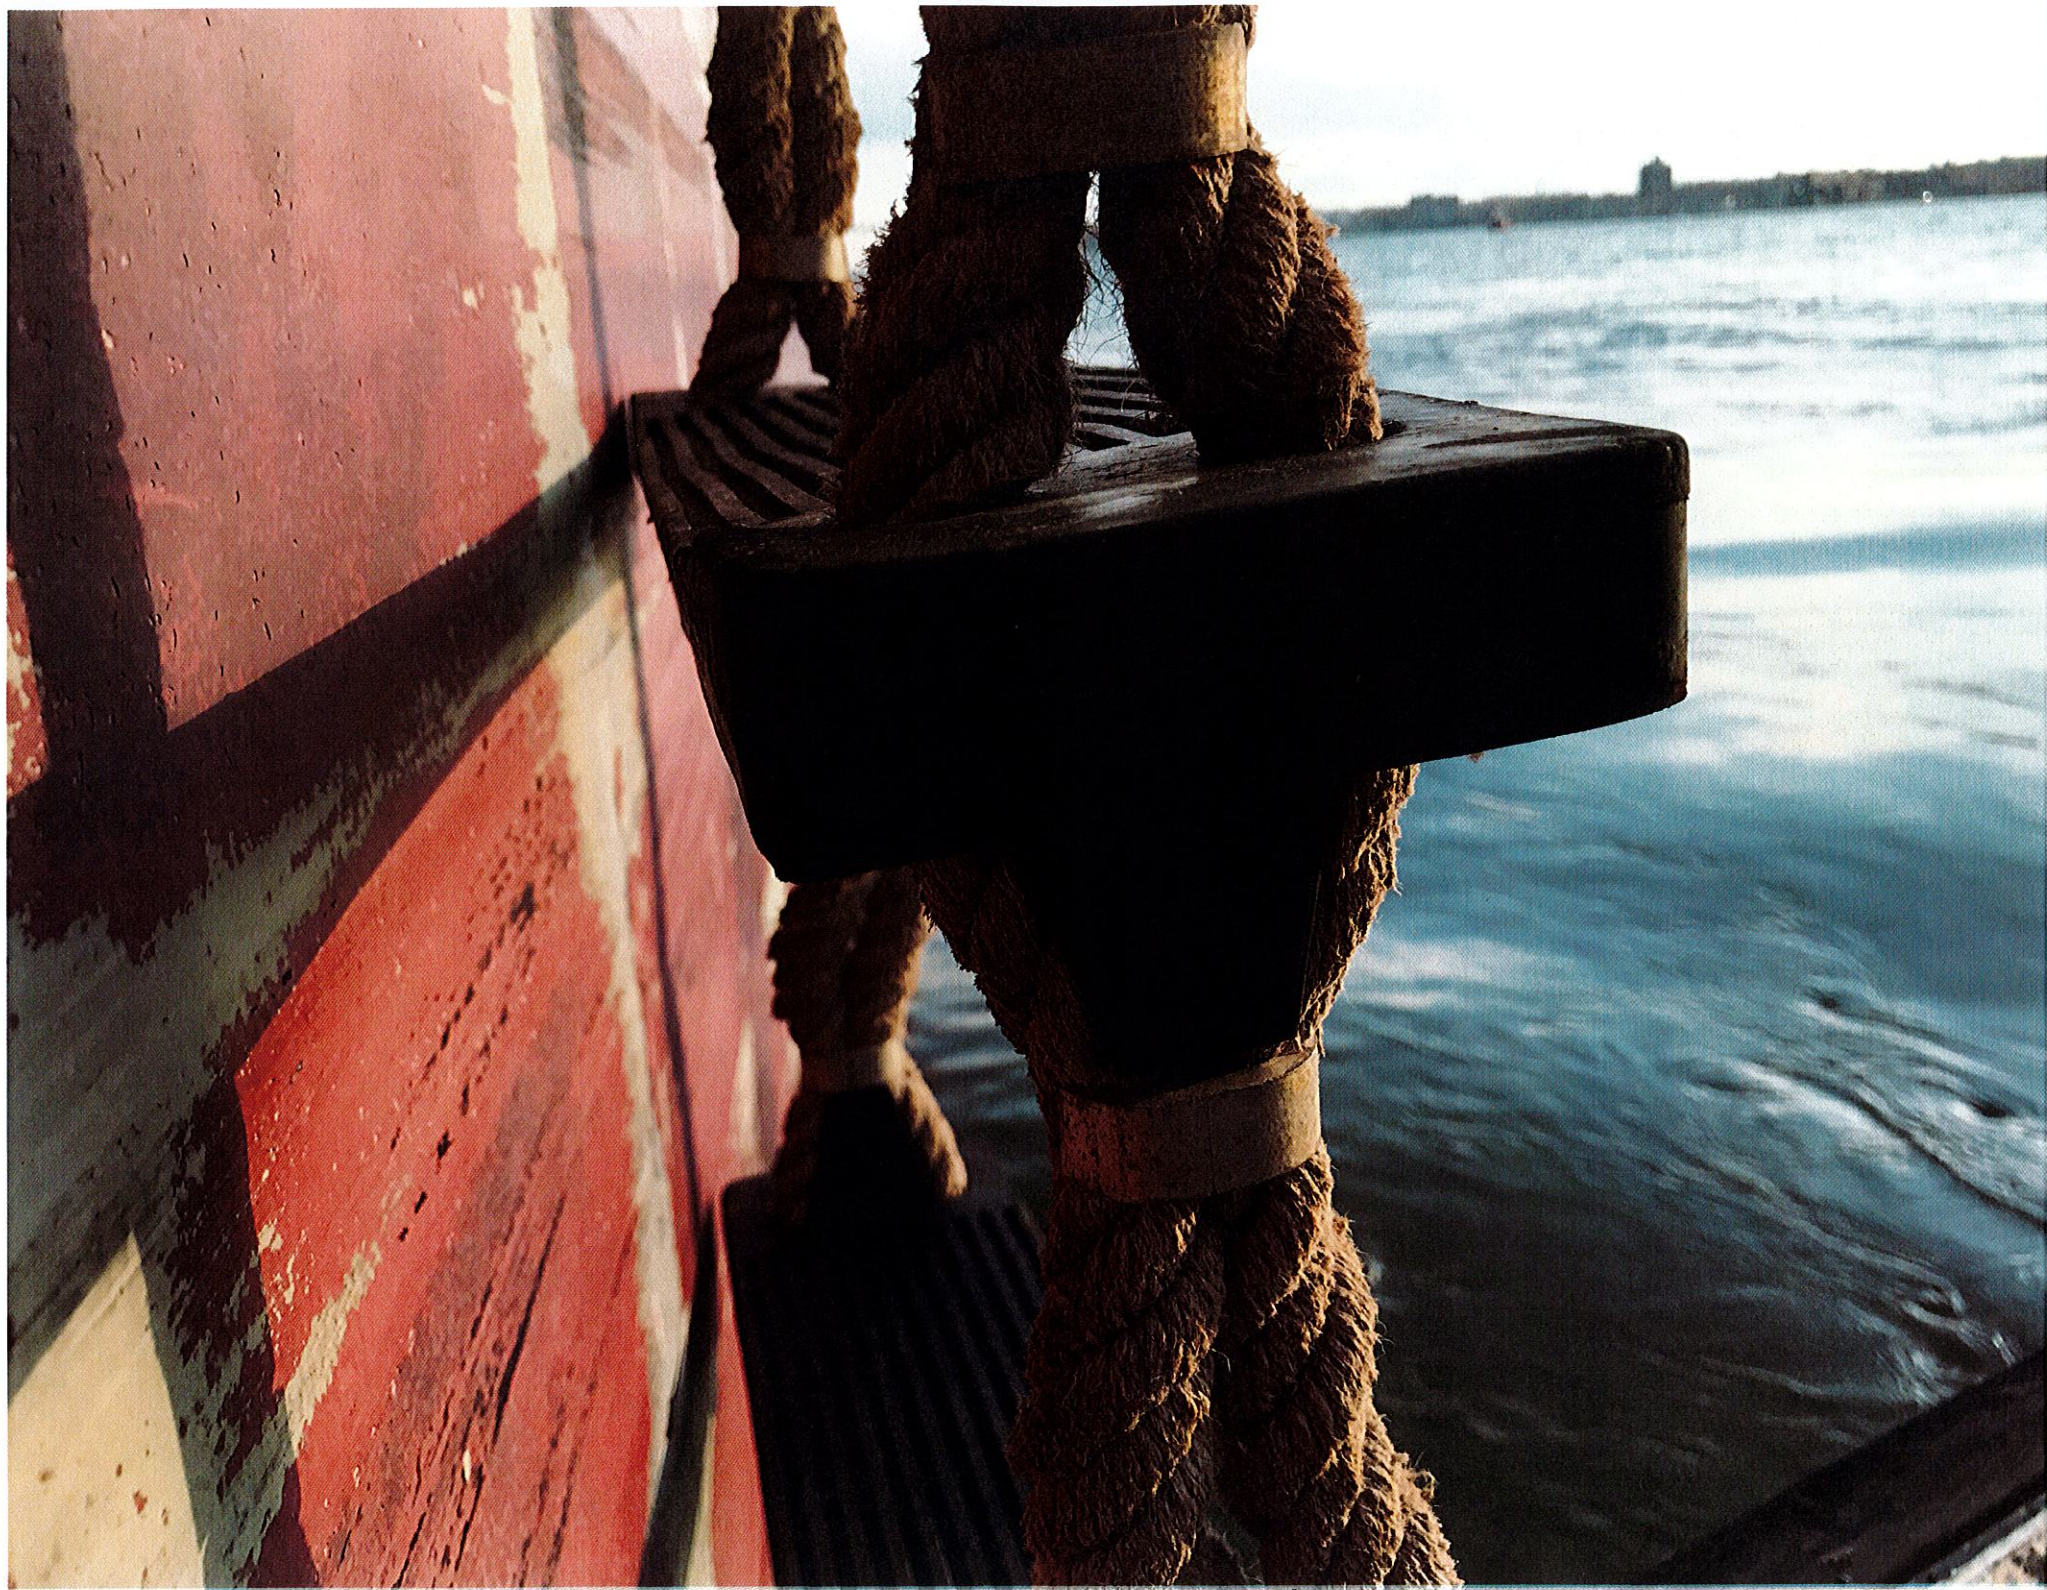
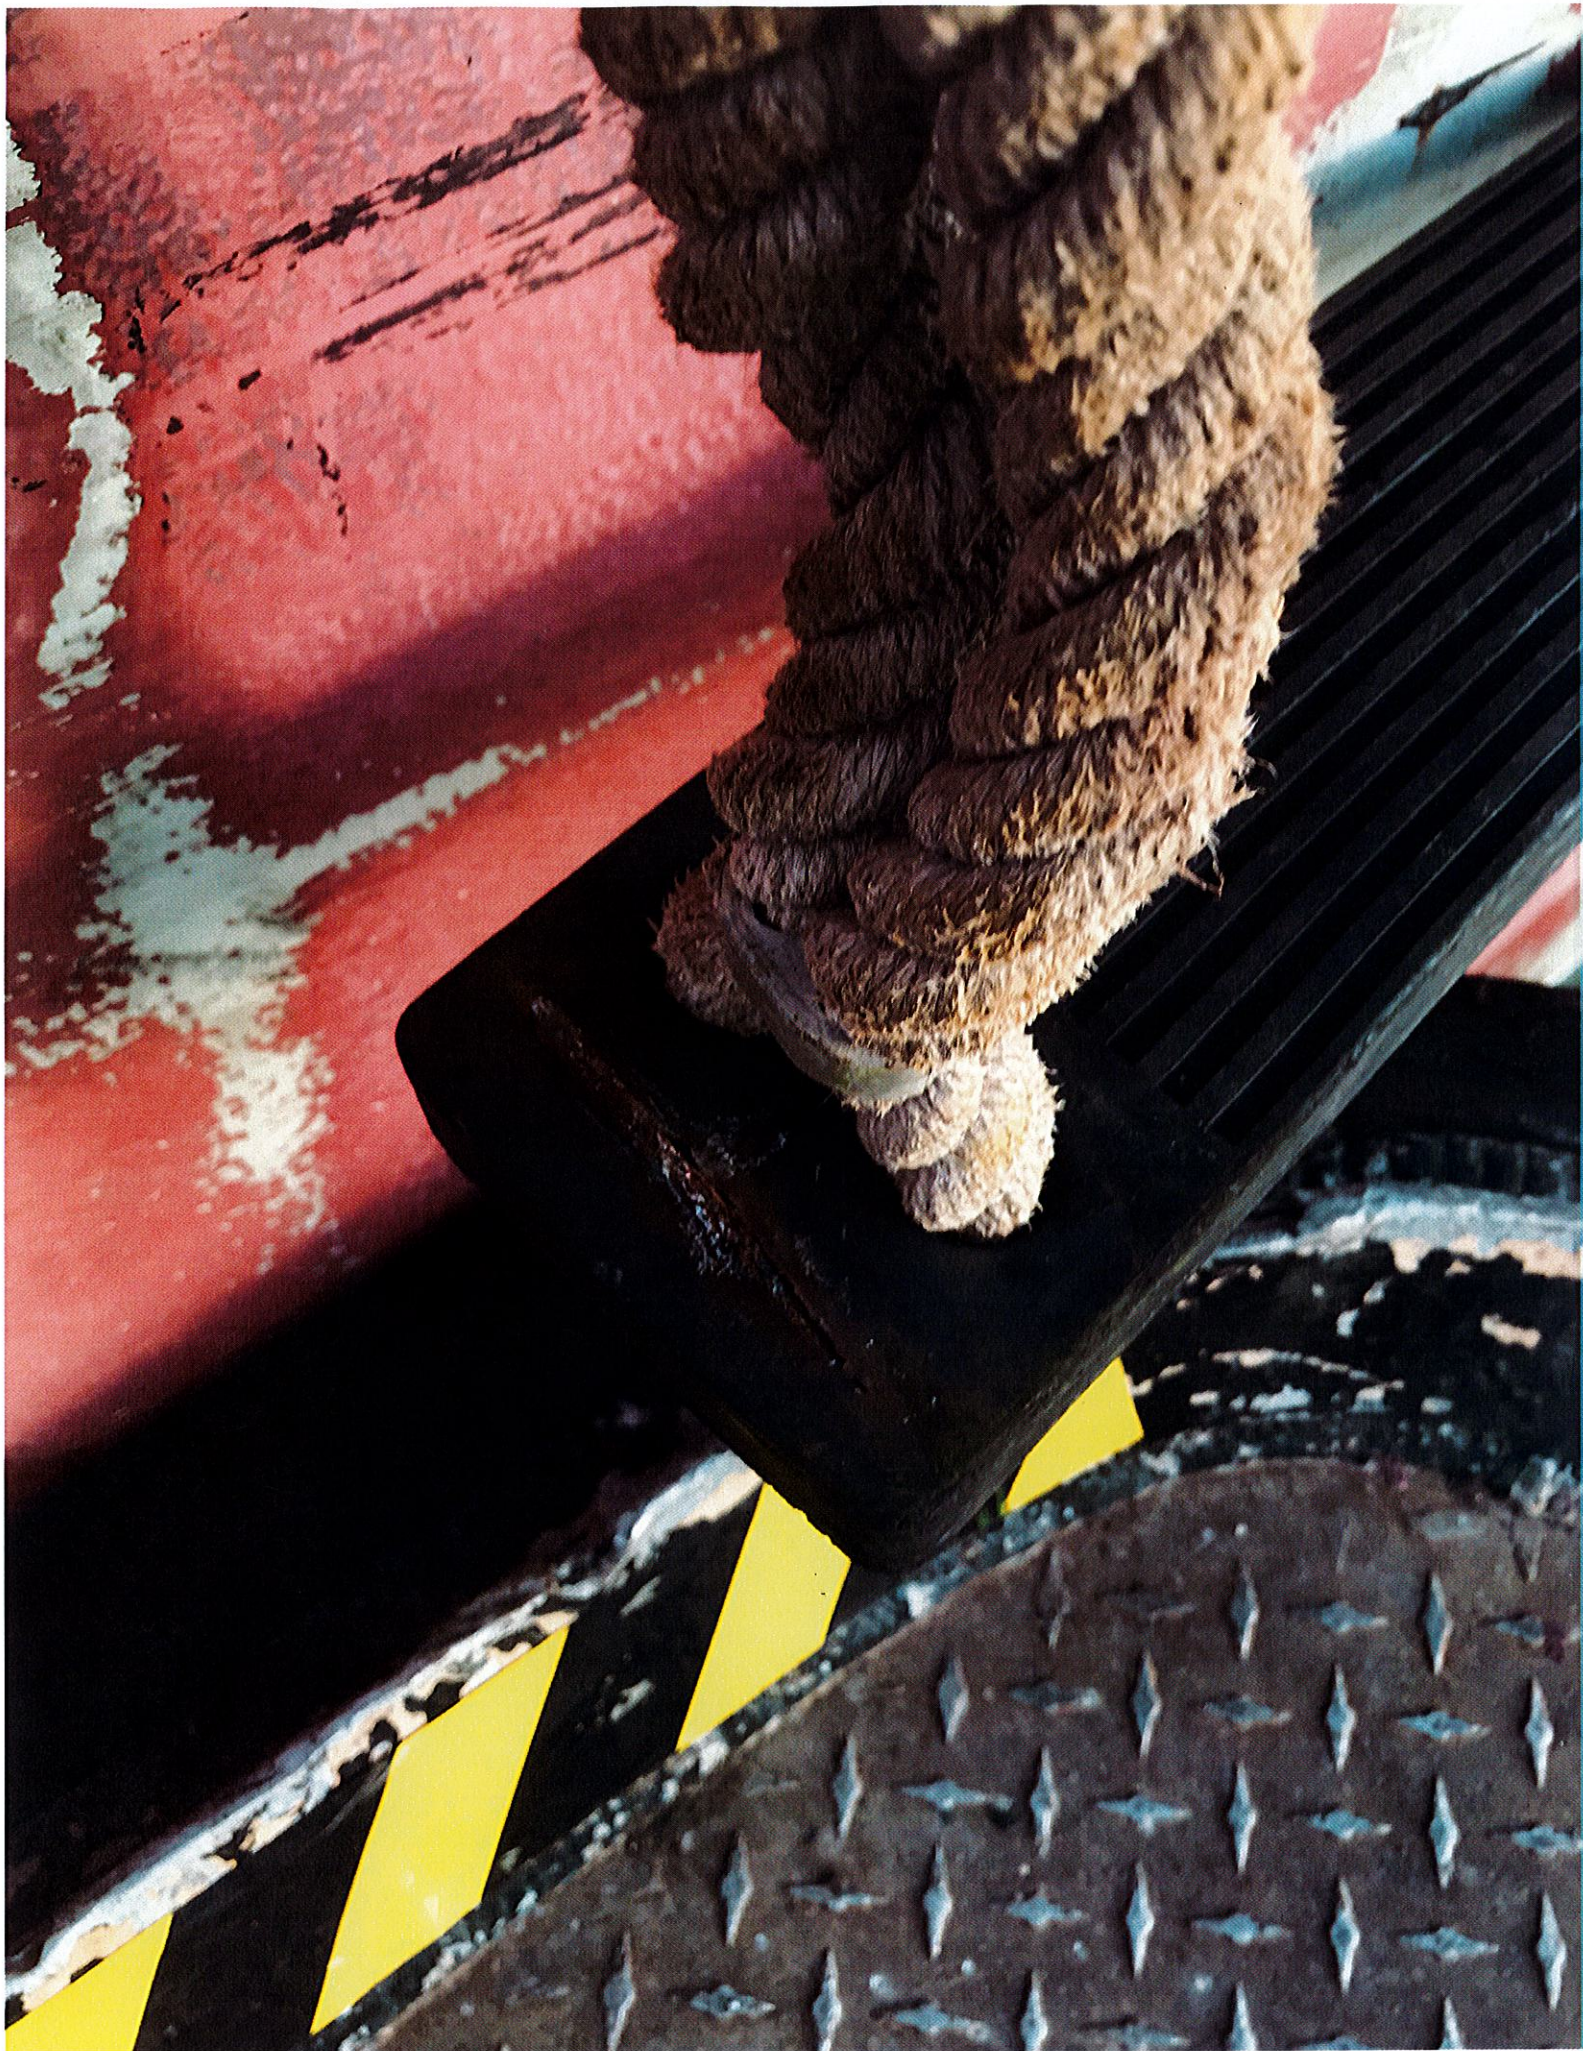
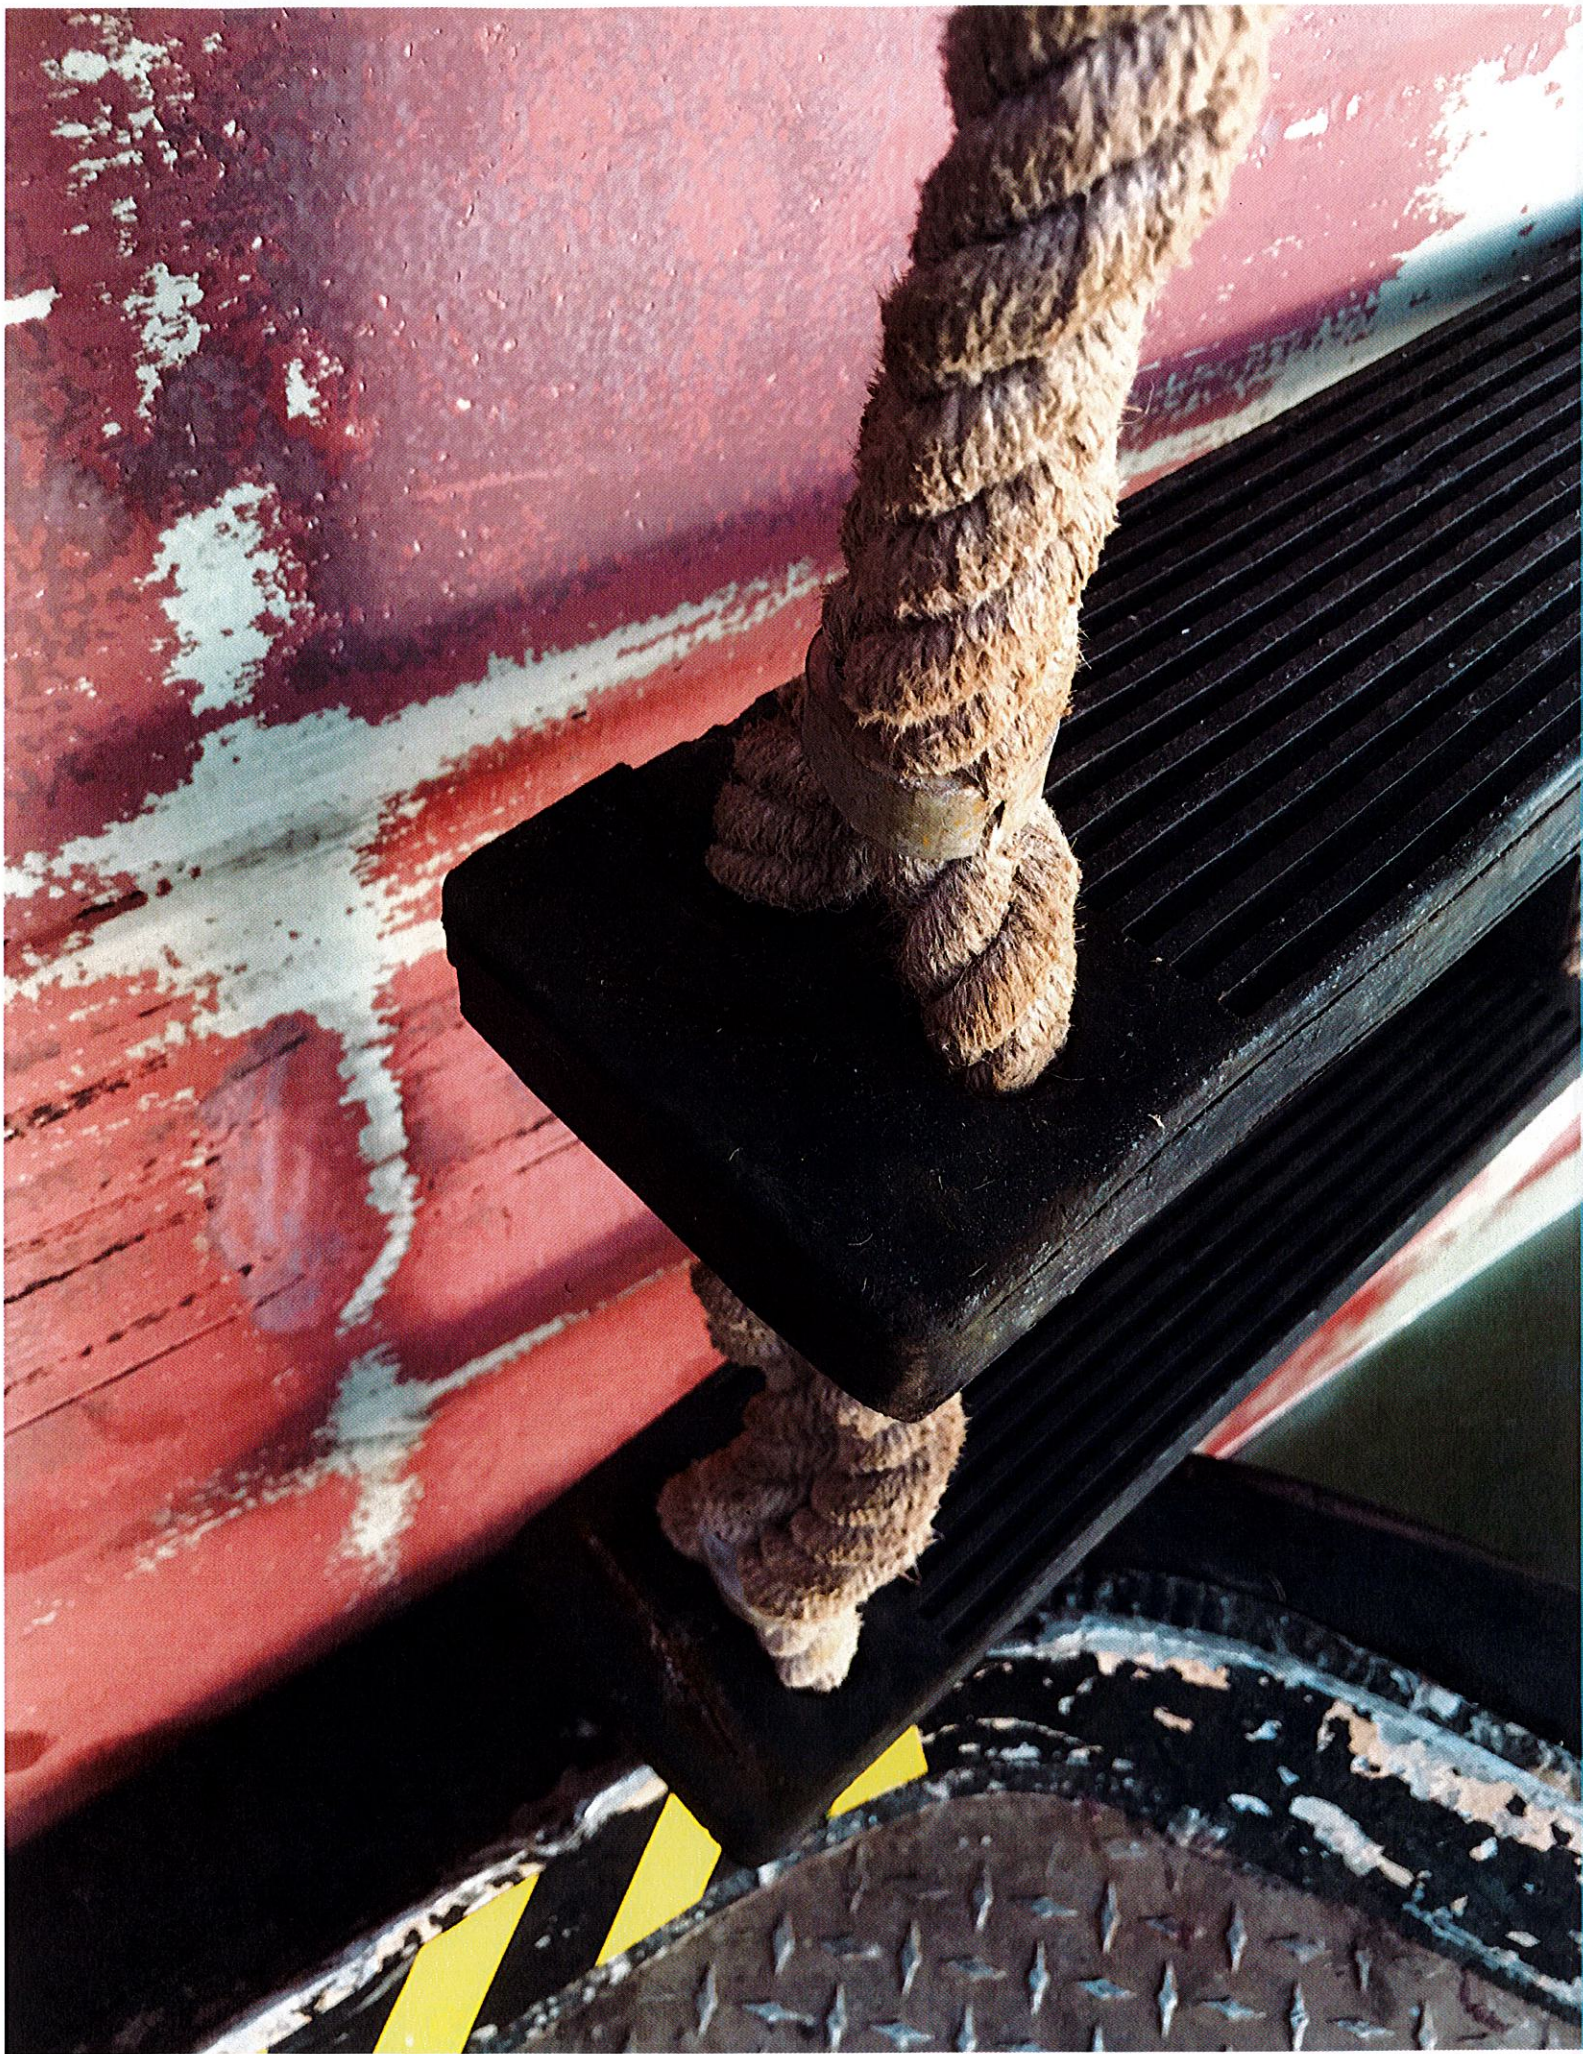
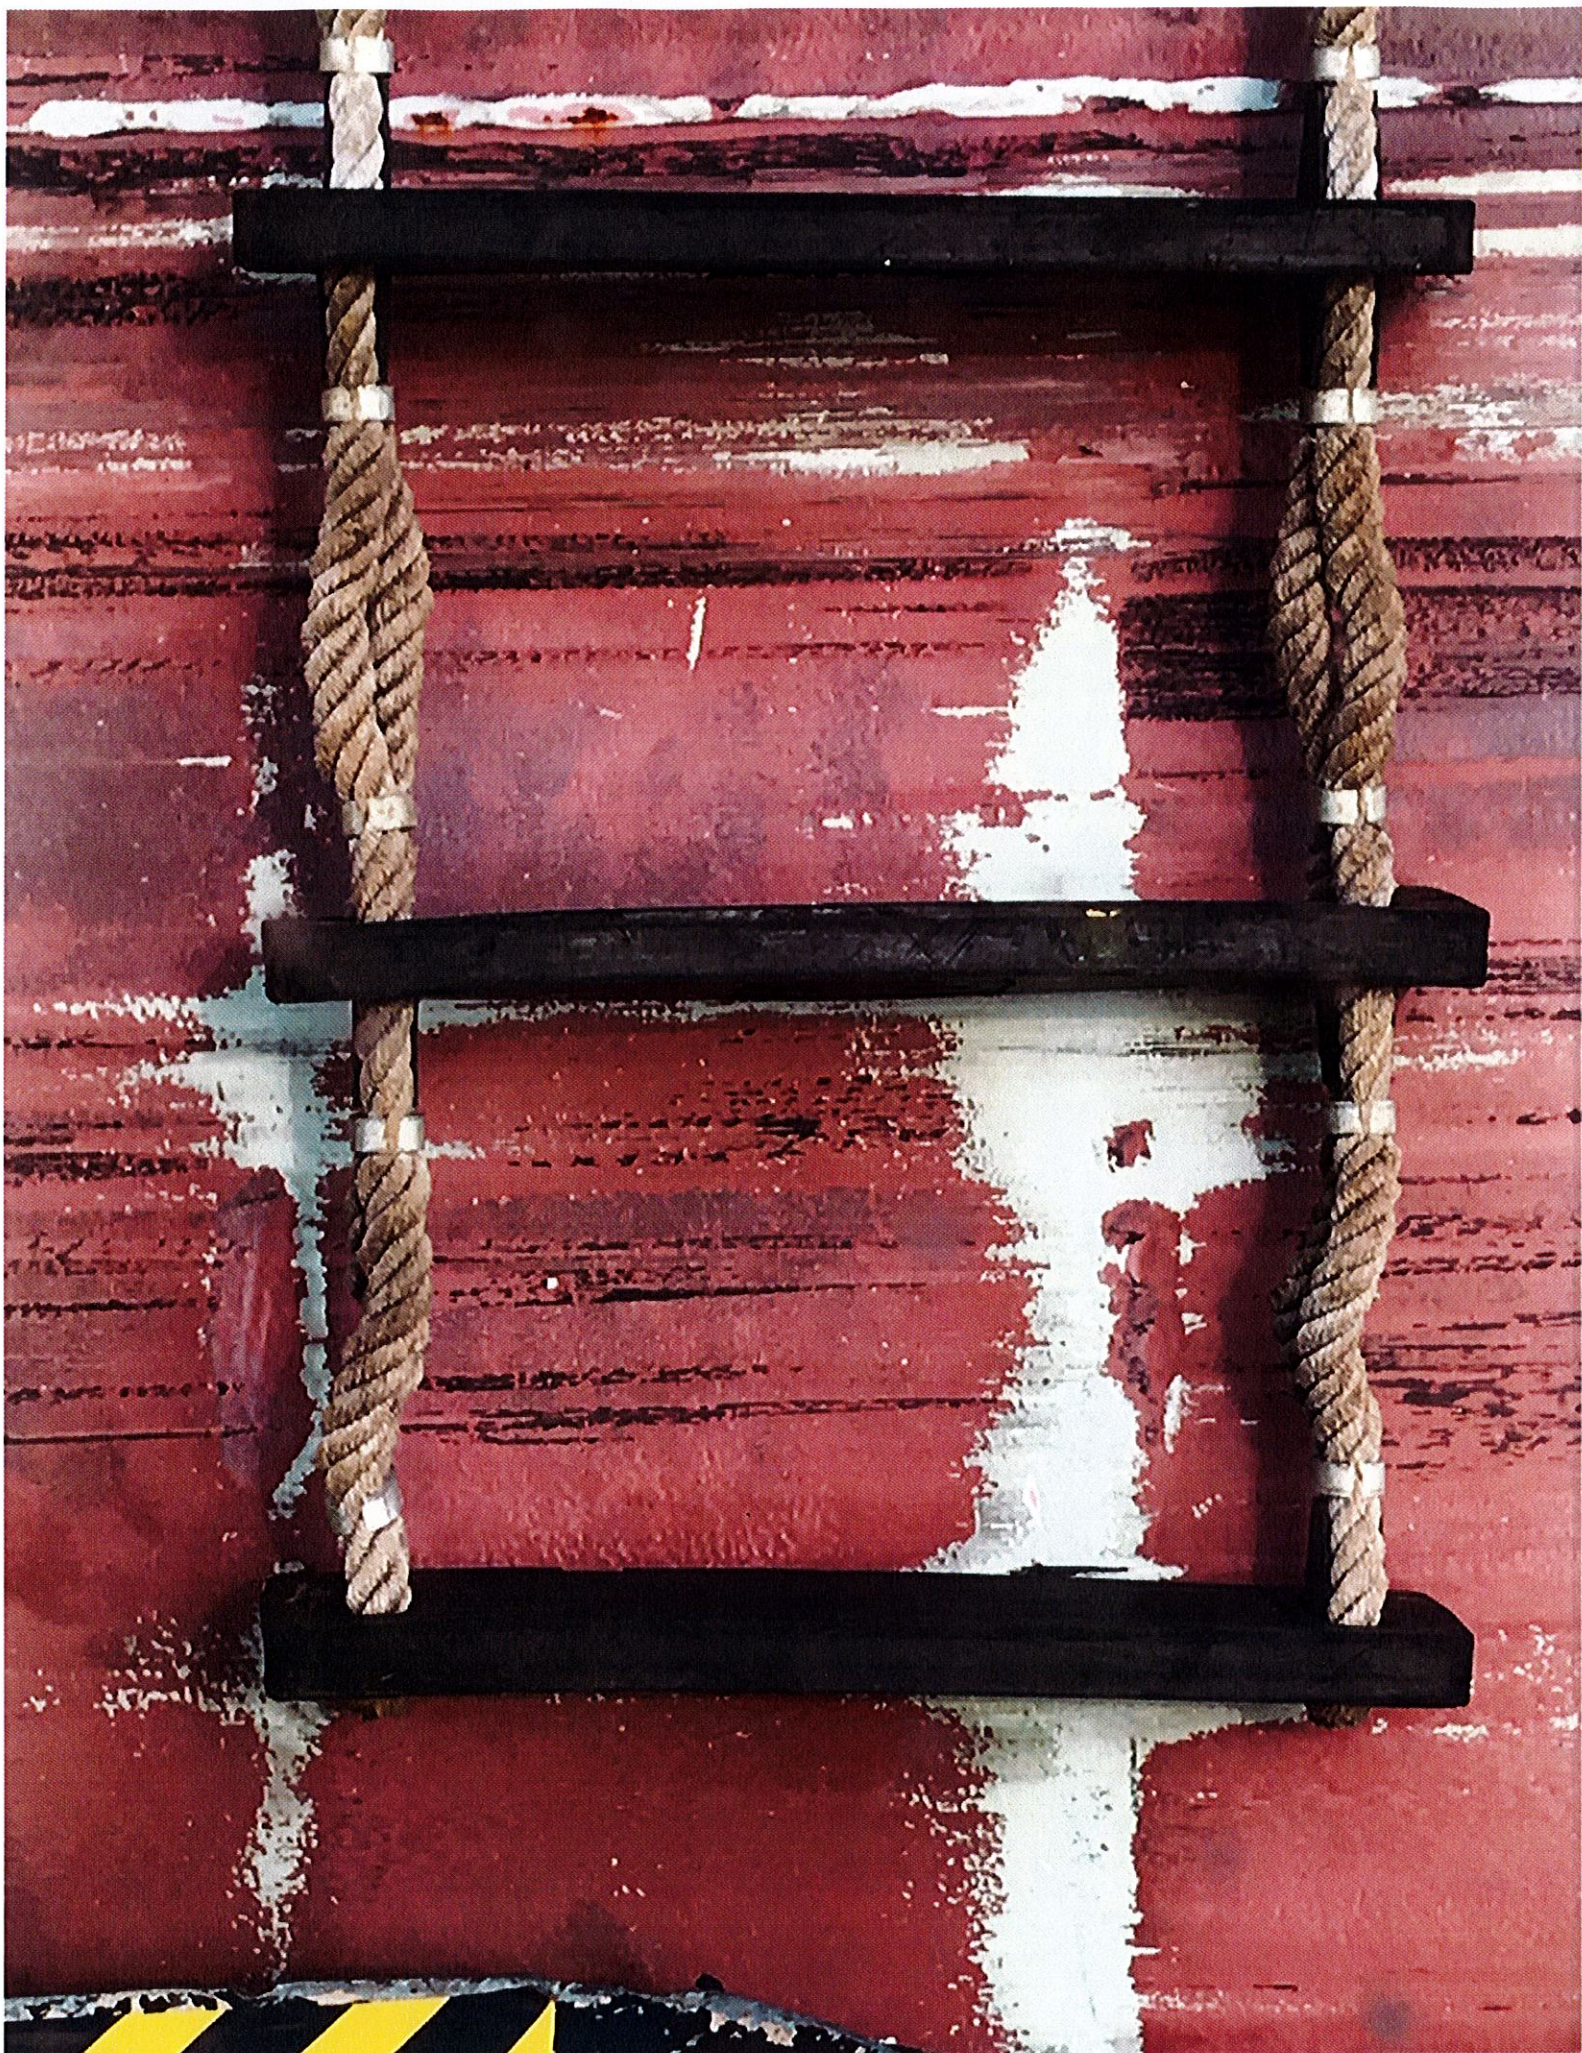
BOTTOM RUNG METAL PLATE GOING THRU STEP. 2ND FROM

BOTTOM STEP CRACKED & BROKEN. TOP & SECOND STEP MISSING
RUBBER SPACERS ON TOP OF STEP. I REFUSED TO CLIMB THE
LADDER CREW BROUGHT STARBOARD LADDER (IN GOOD CONDITION) TO
PORT SIDE. SHIP HAS ONE GOOD LADDER
