PILOT BOARDING DEFICIENCY REPORT

DATE: 11 Feb 2020 TIME: 1300

VESSEL: Navig8 Honor

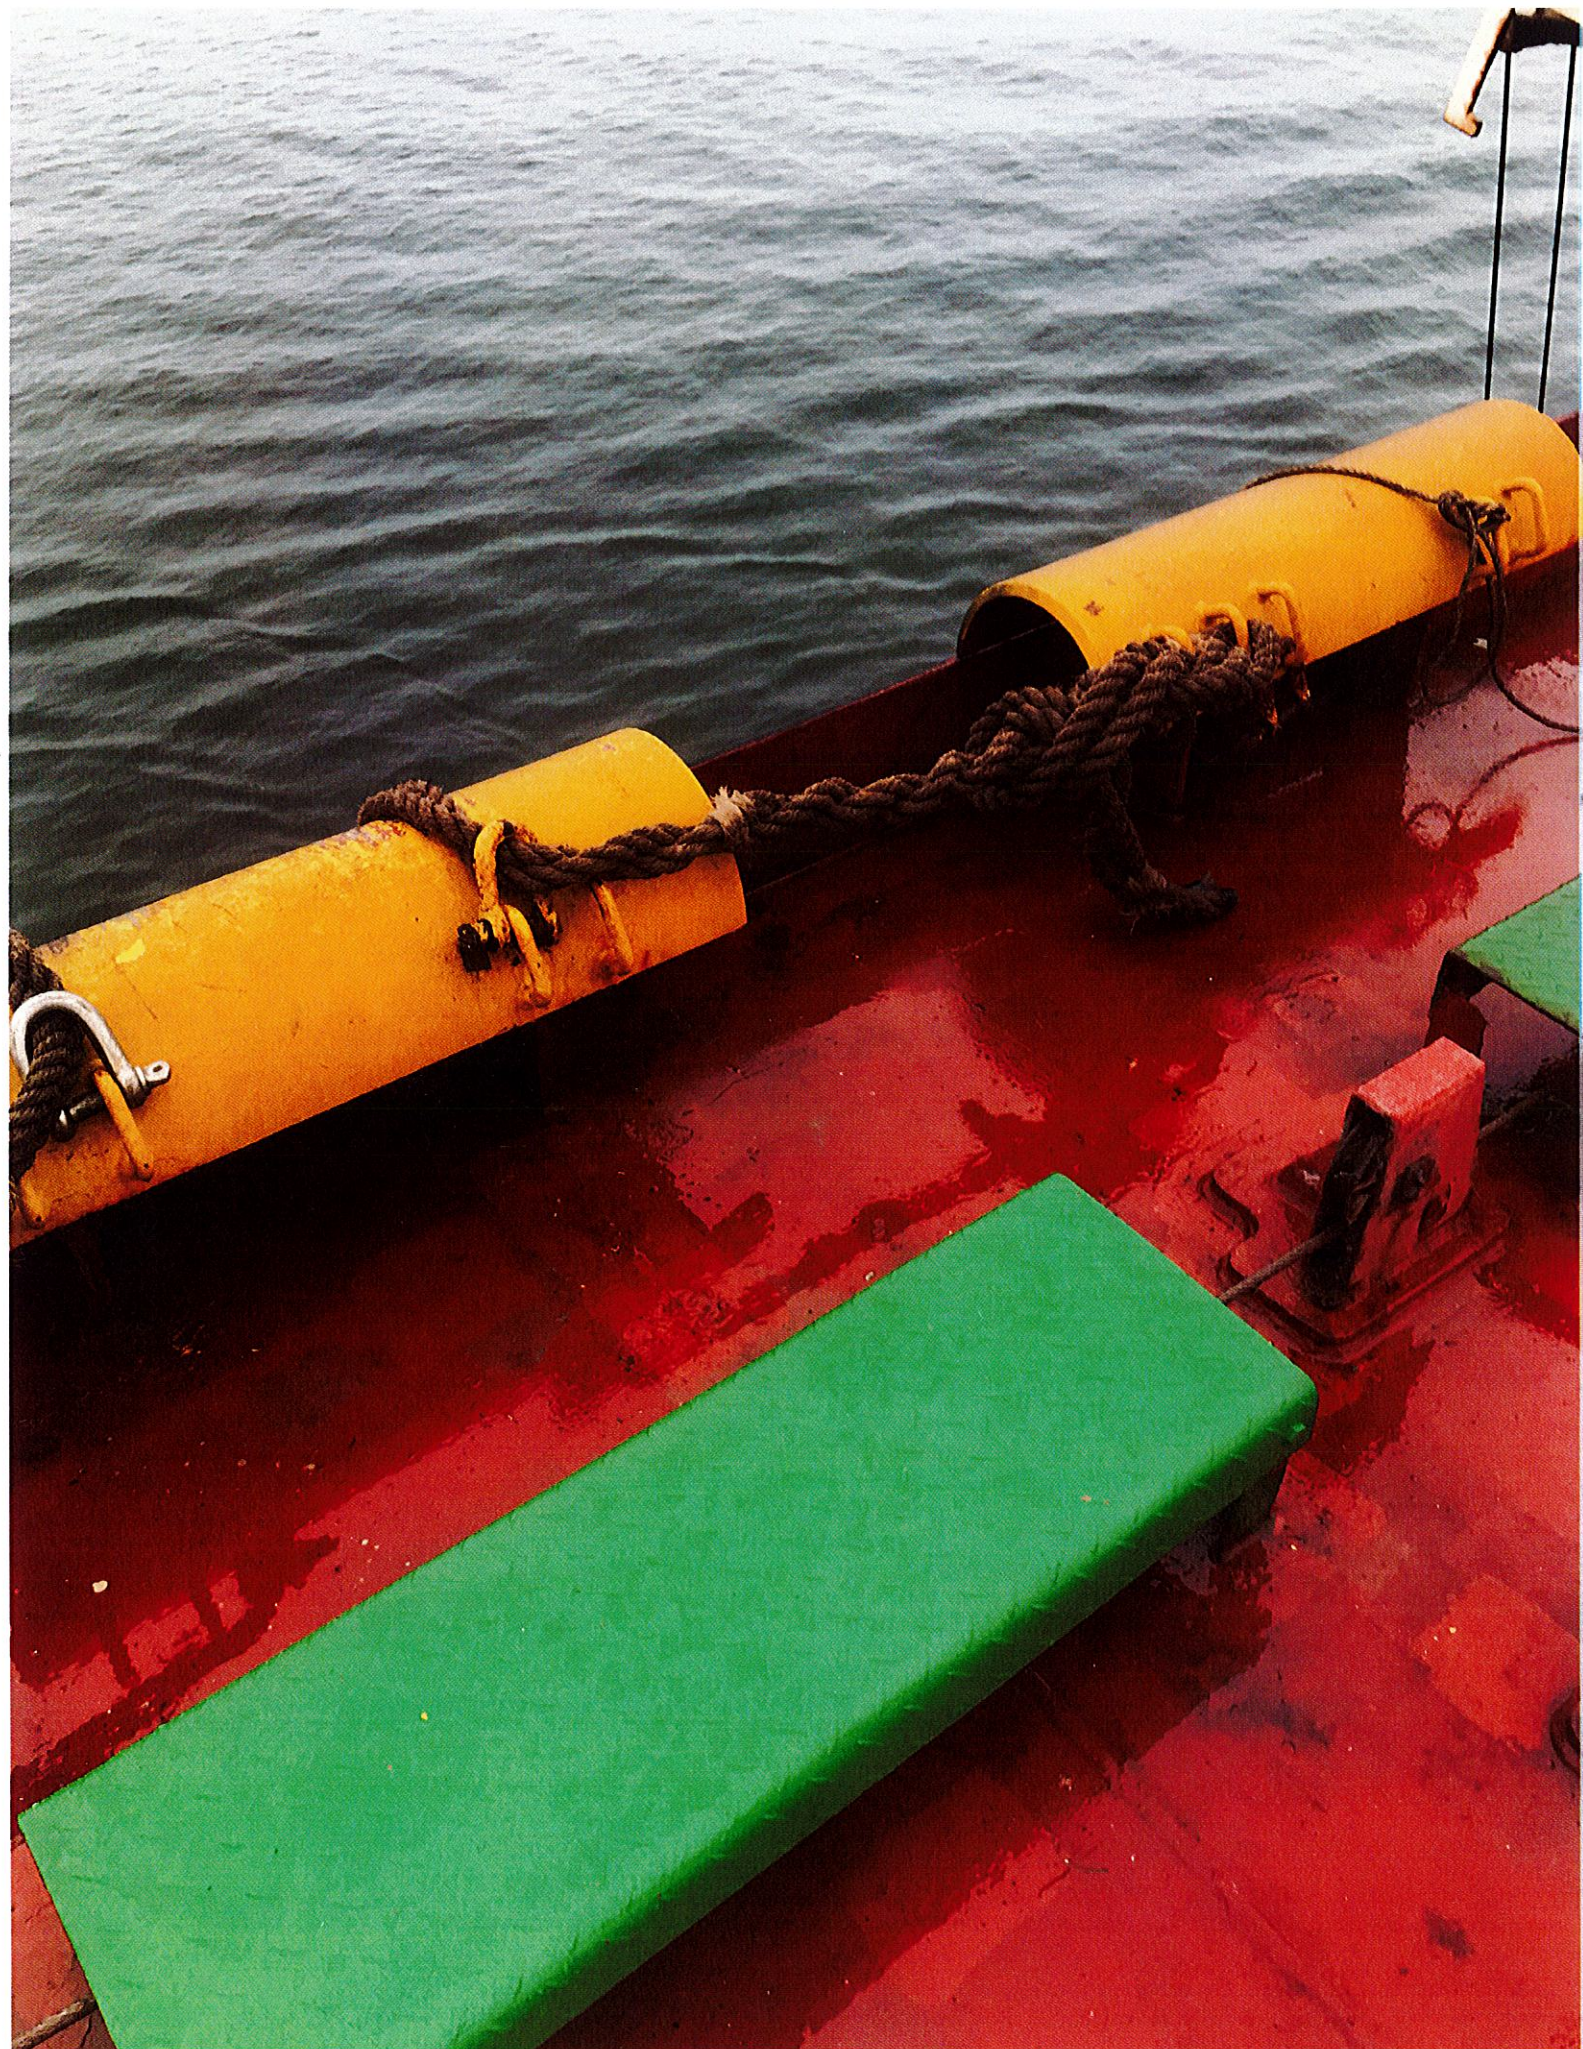
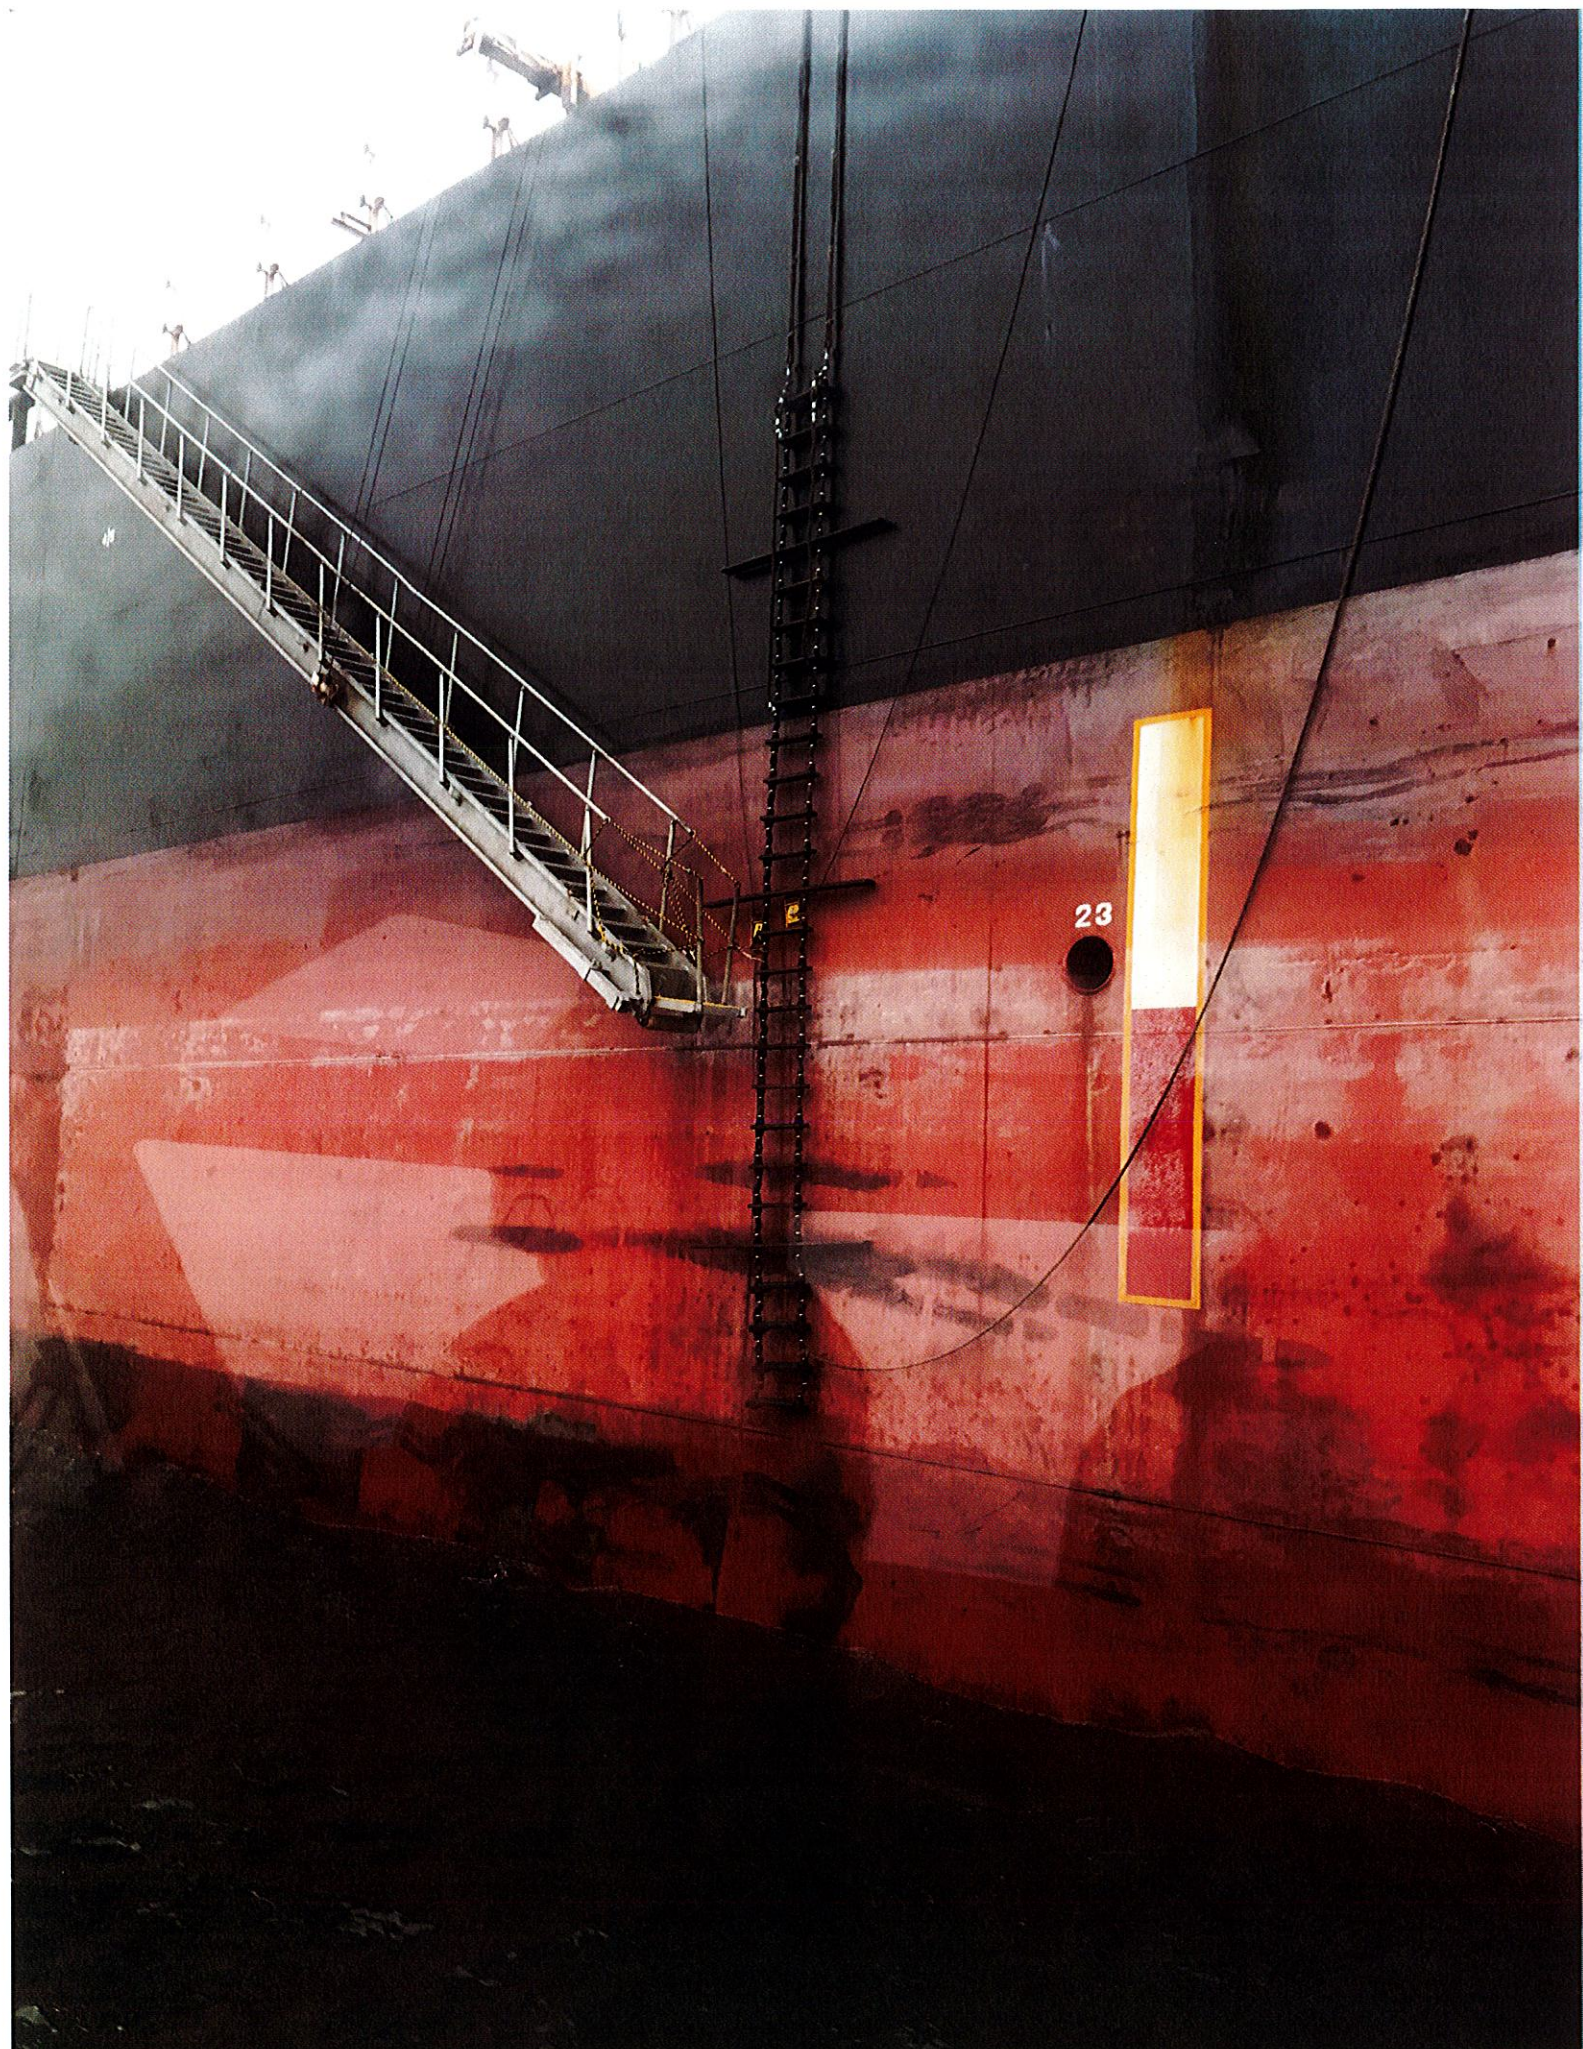
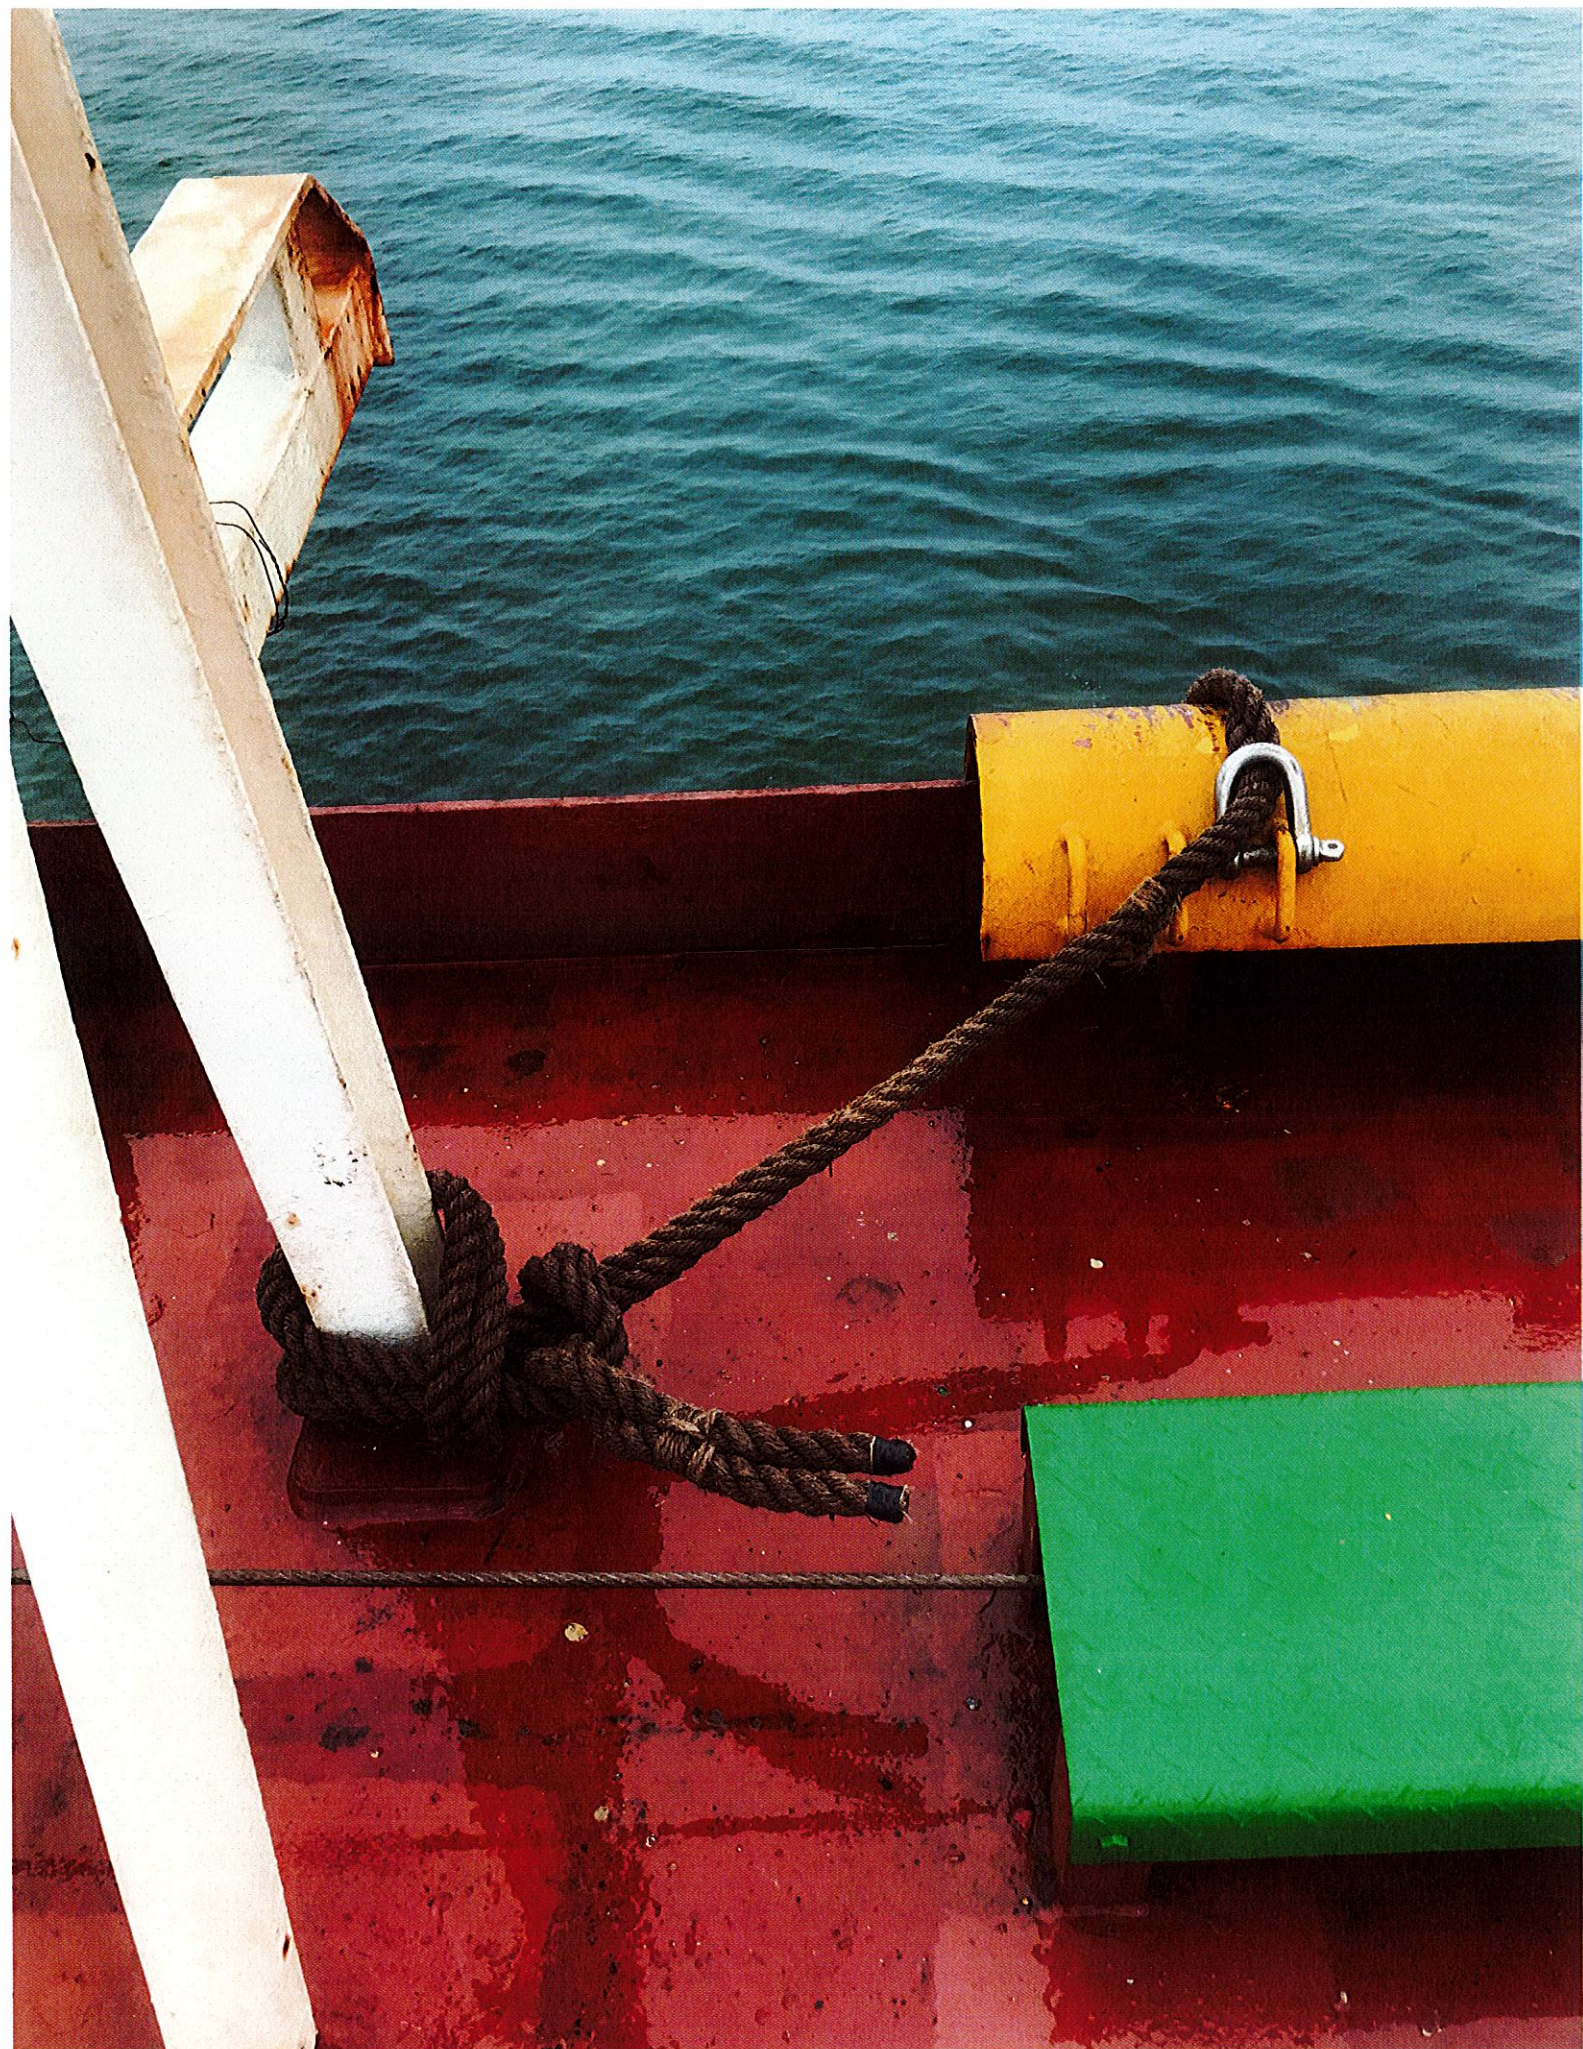
- ☒ GENERAL ARRANGEMENT (ie: Insufficient lighting, no officer, unsafe deck access, etc.)
tripping line must lead forward (not aft) at or above the lower spreader
- ☒ PILOT LADDER (ie: Poor condition/wear, not resting on hull, poor rigging, etc.)
Secured improperly. There are no available strong points on deck
- ☒ COMBINATION LADDER (ie: Poor condition/wear, not secured, platform too low, etc.)
magnets on ladder are not in proper position and in way of rungs
- ☐ MAN ROPES (ie: Poor condition/wear, incorrect diameter, poor rigging, etc.)

Ladder was originally tied to handrail. I saw it from the bridge told the captain
of the noncompliance and the pictures attached to this is how the ladder was
rigged. Ladder must be rigged to strongpoints on deck. None are available
