Comments to the Summary of Deficiencies

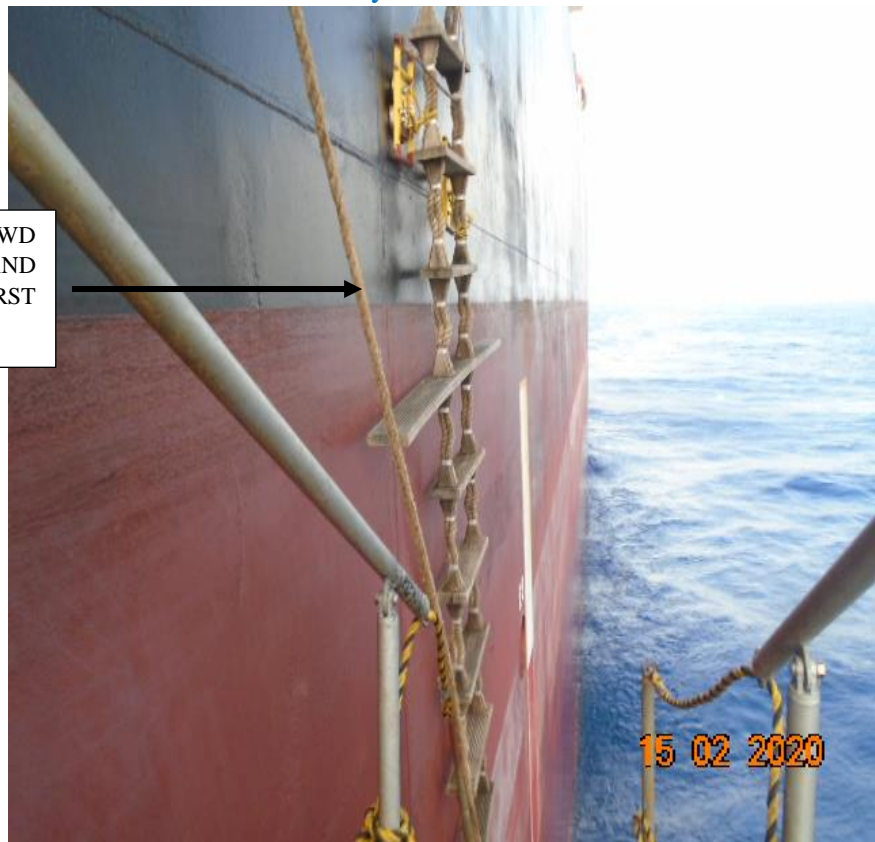
1. General arrangement:

Tripping line must lead forward (not aft) at or above the lower spreader

TRIPPING LINE LEADING FWD
OF THE LADDER AND
SECURED ABOVE FIRST
SPREADER STEP.

A through training carried out for the concerned staff involved with rigging of pilot ladder. All reminded to rig tripping line leading forward only. To ensure compliance, Officer on watch to cross check same. A poster showing the correct rigging has been placed in crew mess room as a ready reference

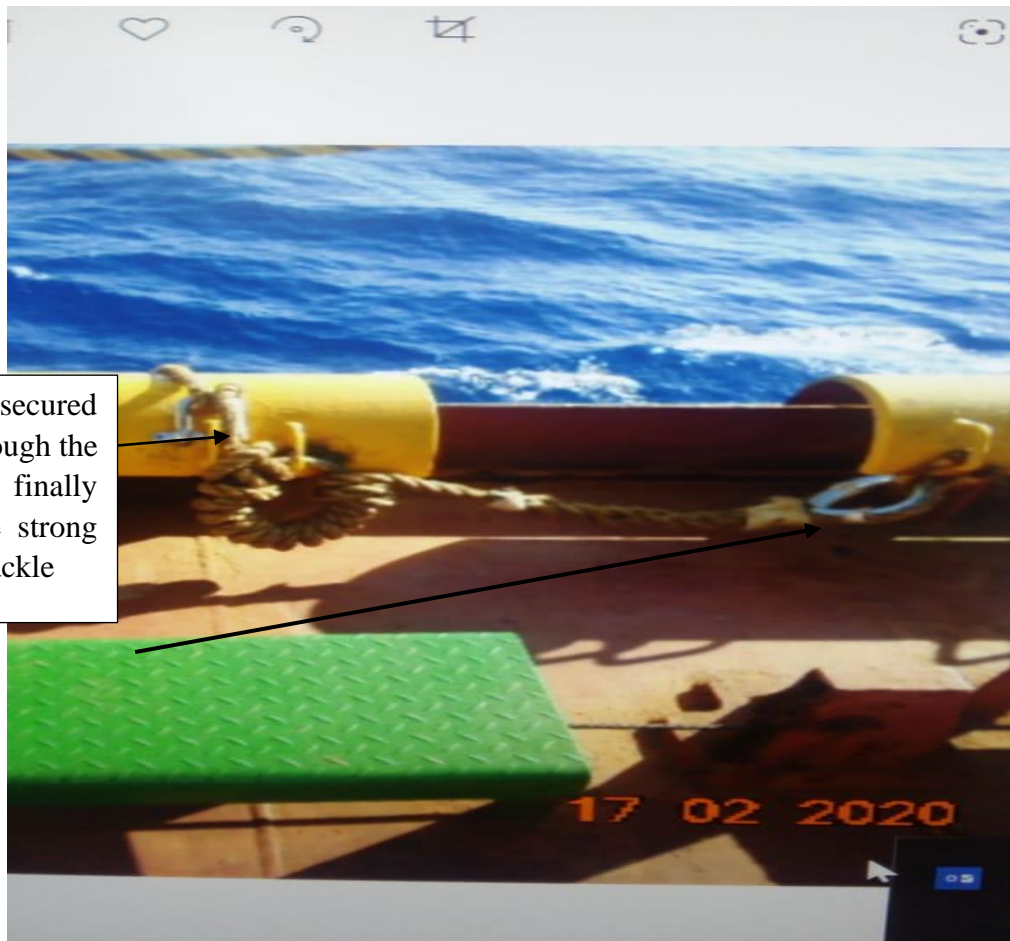
2. Pilot ladder

Secured Improperly. There are no available strong points on deck

Pilot ladder secured by passing through the ring and finally secured to the strong point using shackle

Corrective Action: Metal ring now made available around the strong point to facilitate securing of the pilot ladder side ropes.
Refer attached photographs, pilot ladder secured by passing through the ring and finally secured to the strong point using shackle

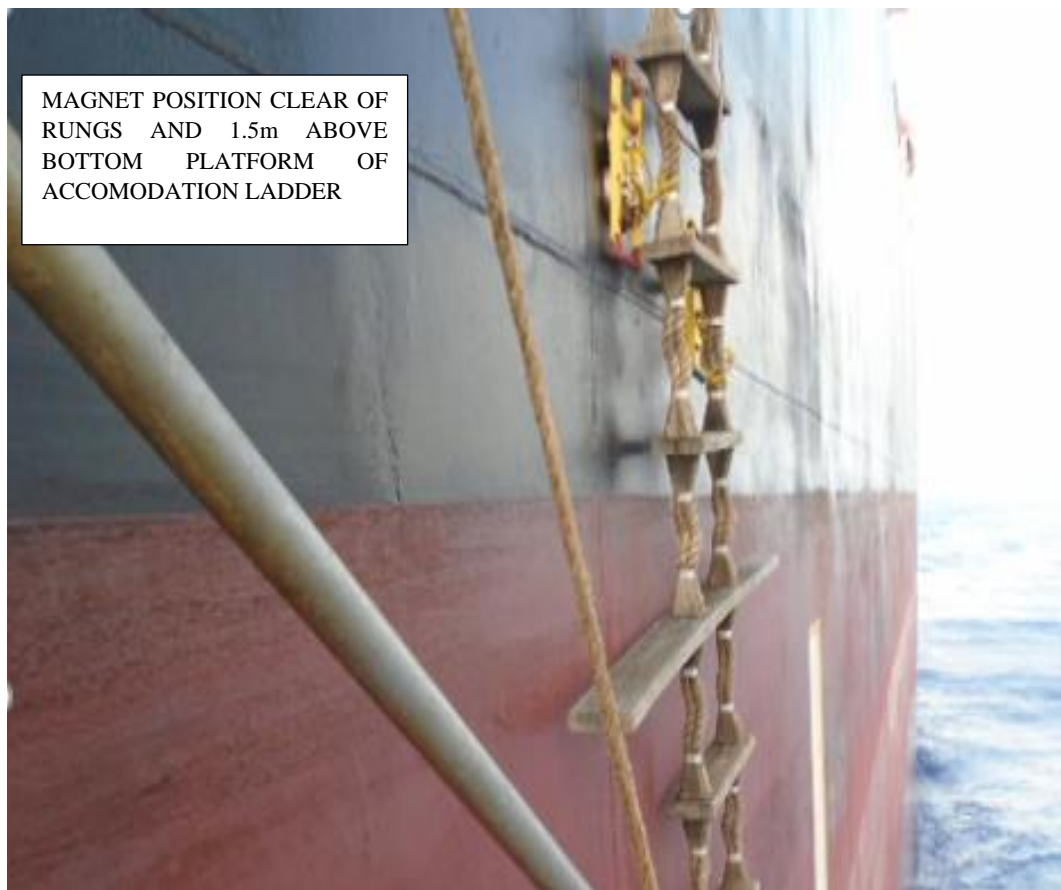
3. Combination ladder

Magnets on ladder are not proper position and in way of rungs

Ship staff has been trained to place magnets correctly to pilot ladder, i.e. clear of rungs, 1.5.m above bottom platform of accommodation ladder. Refer to attached photograph for correct magnets rigged by vessel.
