PILOT BOARDING DEFICIENCY REPORT

DATE: 3/29/19 TIME: ~1807

VESSEL: UNDINE

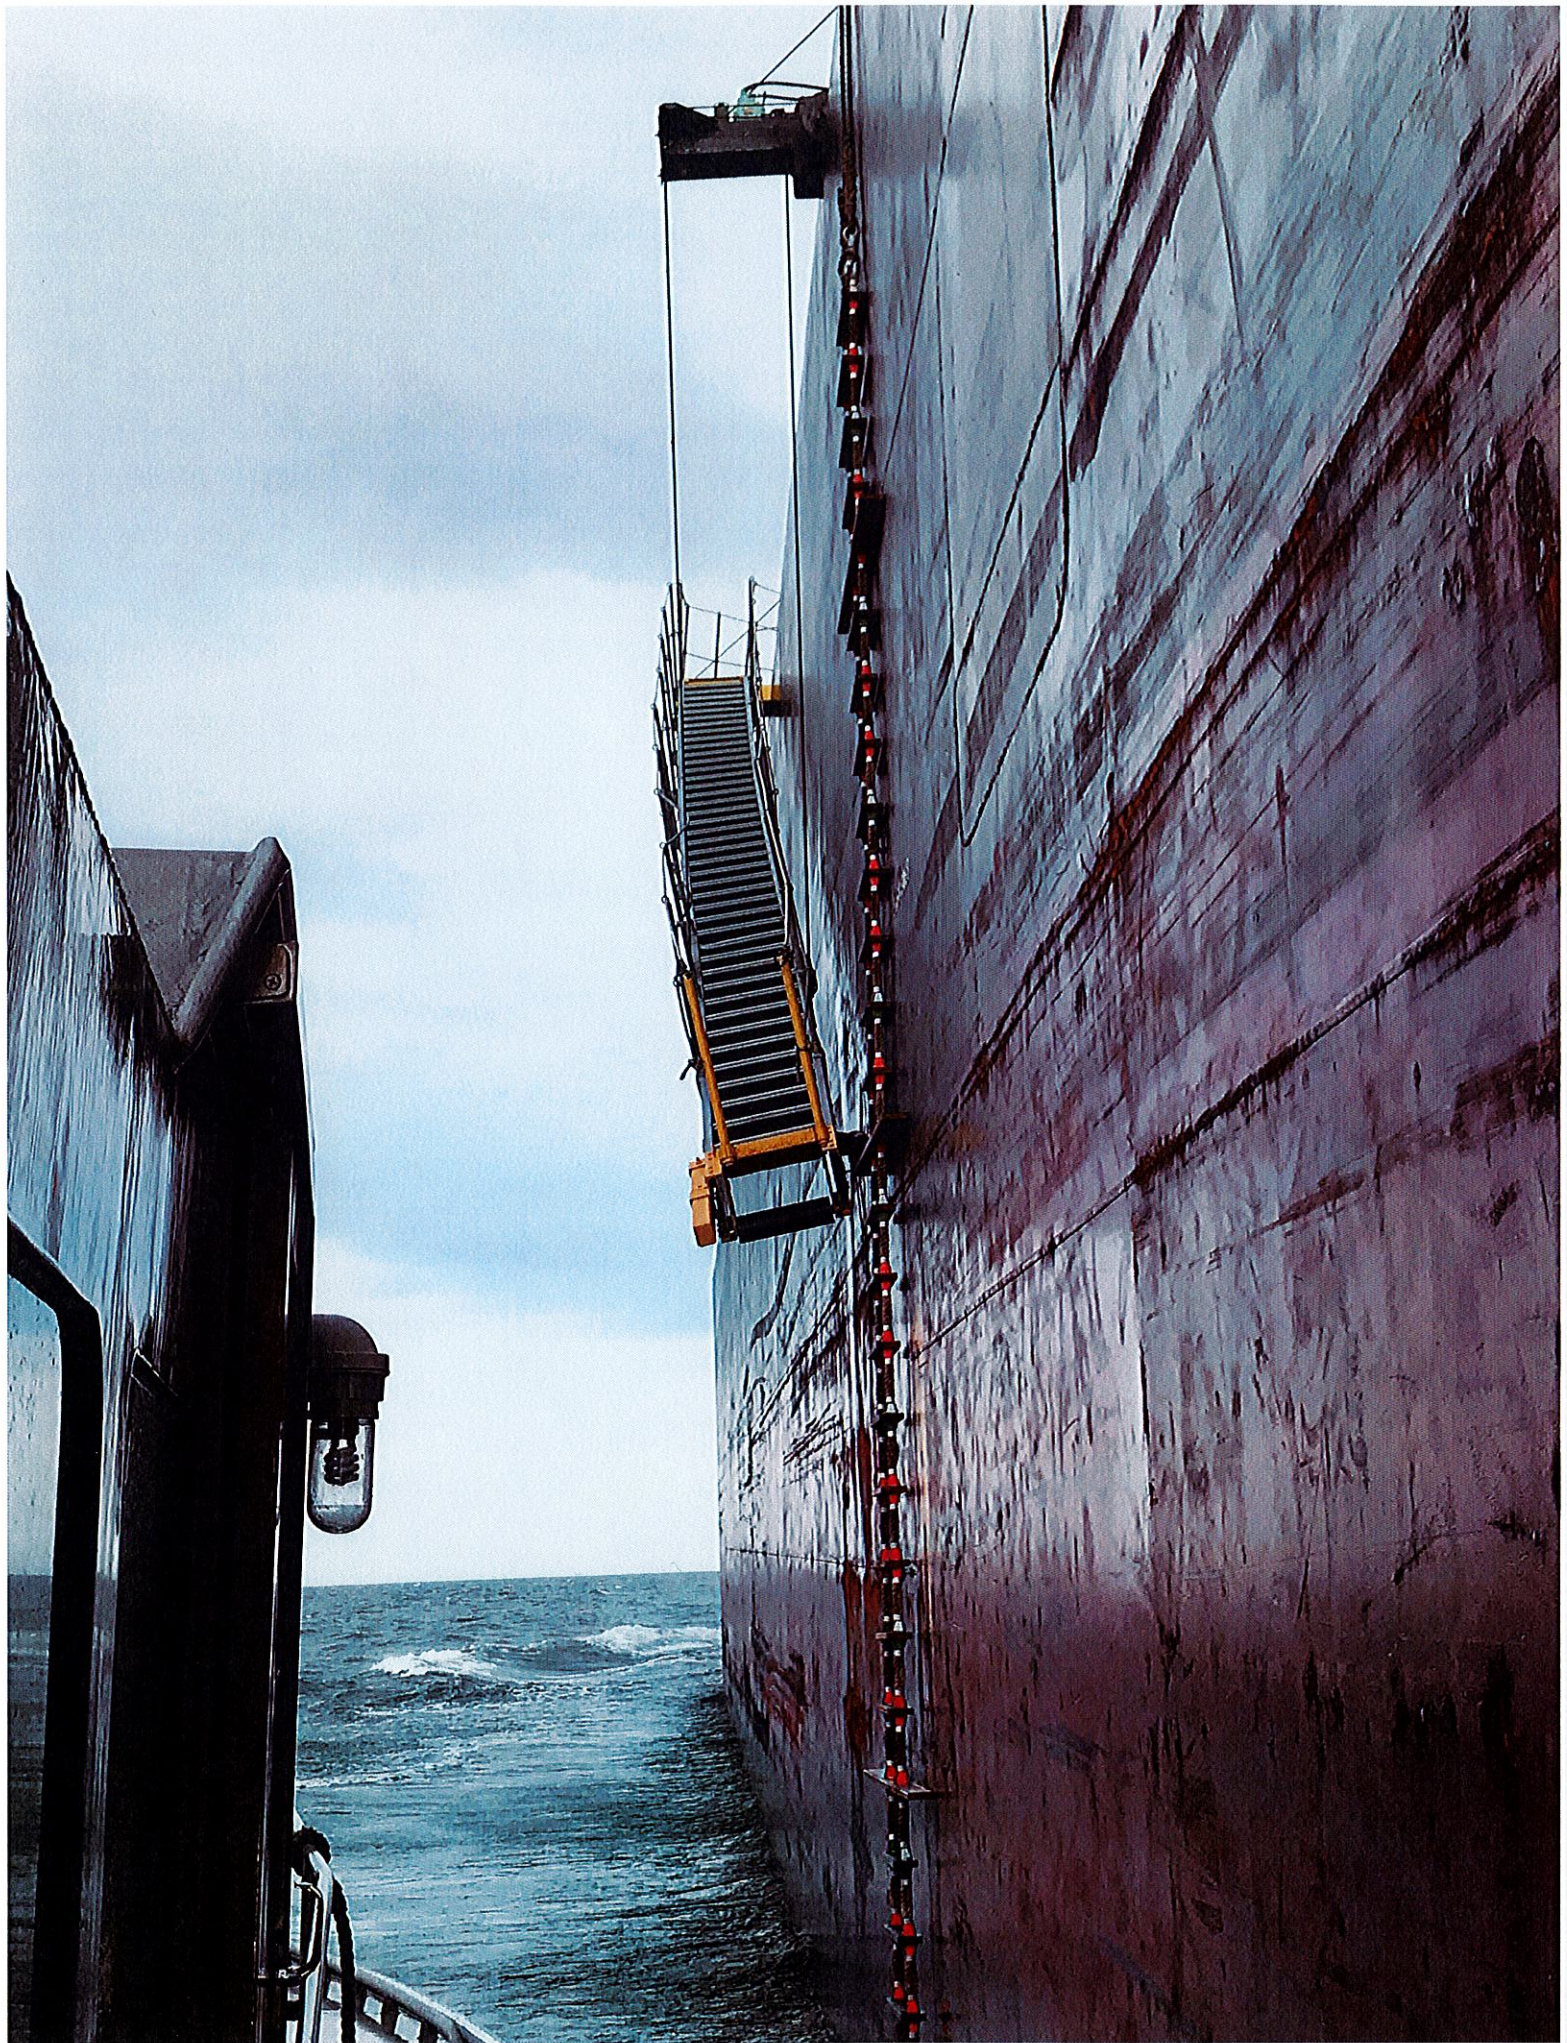
POOR CONDITION OF GANGWAY

AT SOMEPOINT GANGWAY WAS DAMAGED, STEPS ARE AT ANGLES OR BENT, WHOLE GANGWAY IS WARPED. WIRES FOR GANGWAY ARE IN WAY OF HANDROPES. (SEE PHOTO)
