PILOT BOARDING DEFICIENCY REPORT

DATE: 02/19/2020 TIME: 1430

VESSEL: Anton Schulte

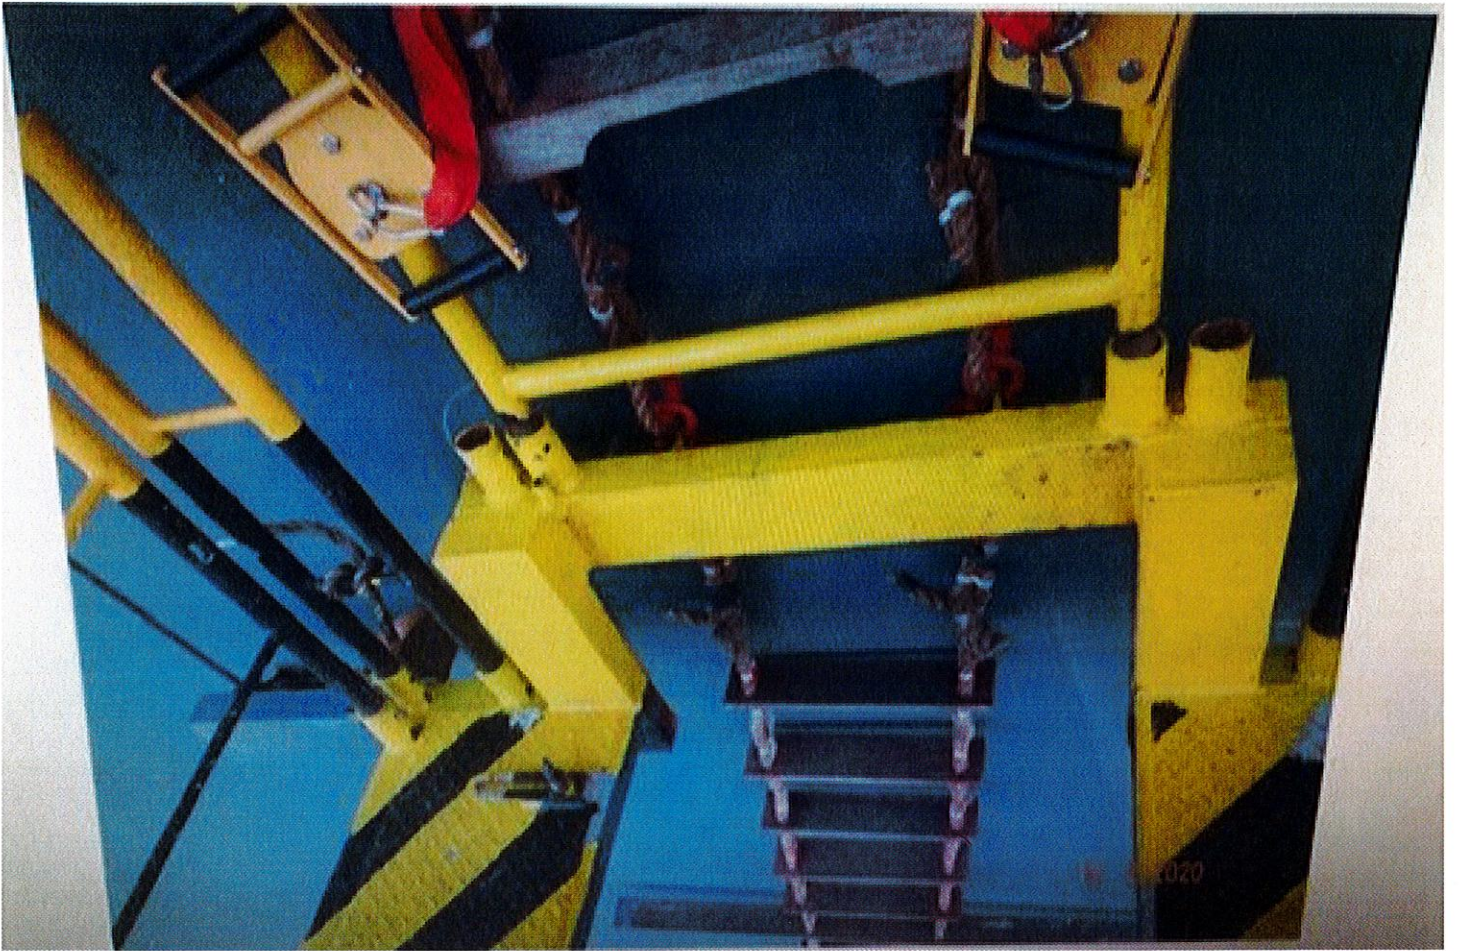
- ☒ COMBINATION LADDER (ie: Poor condition/wear, not secured, platform too low, etc.)
Trap door configuration not rigged properly

See Pics. Pilot ladder secured beneath the platform. Second pilot ladder secured to the top of the platform but behind the grab bars.
