PILOT BOARDING DEFICIENCY REPORT

DATE: 6/18/20 TIME: 2200

VESSEL: CHESAPEAKE HIGHWAY

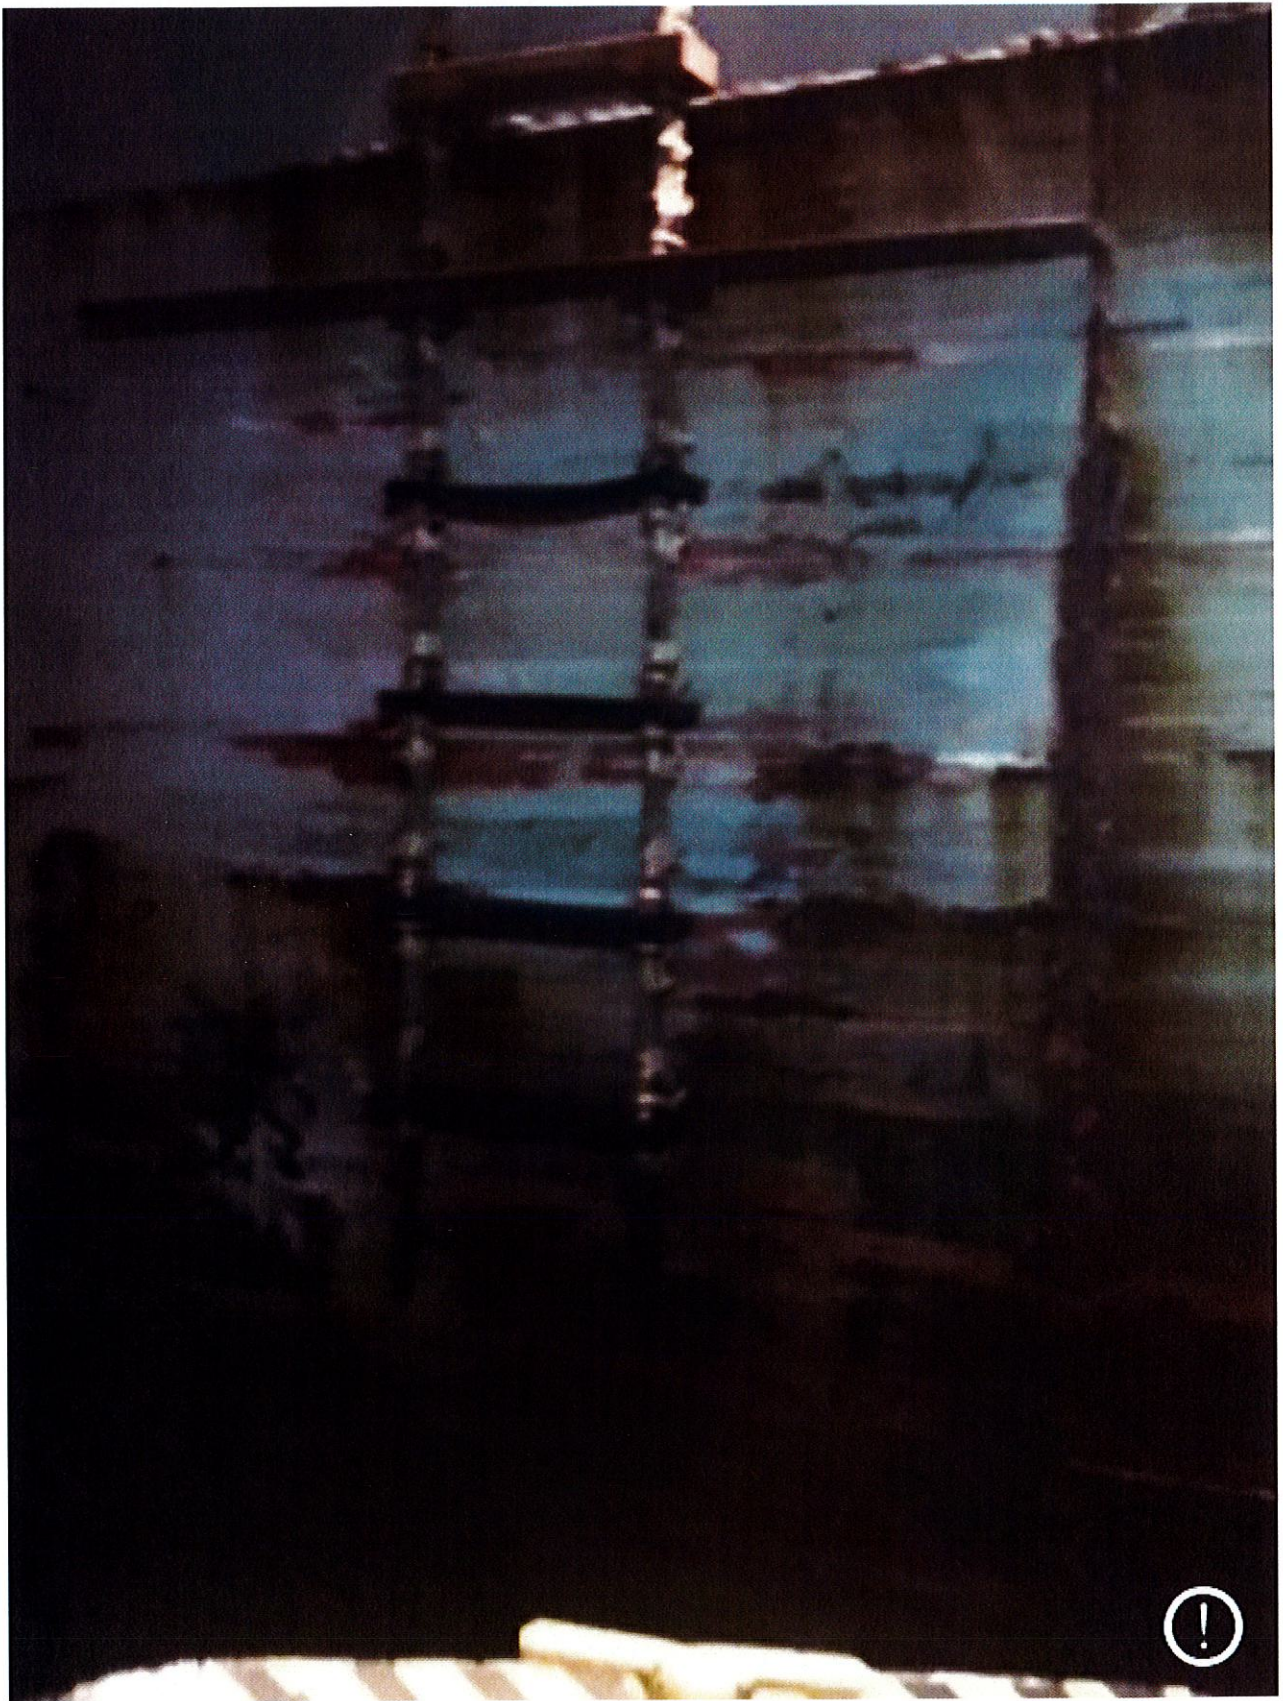
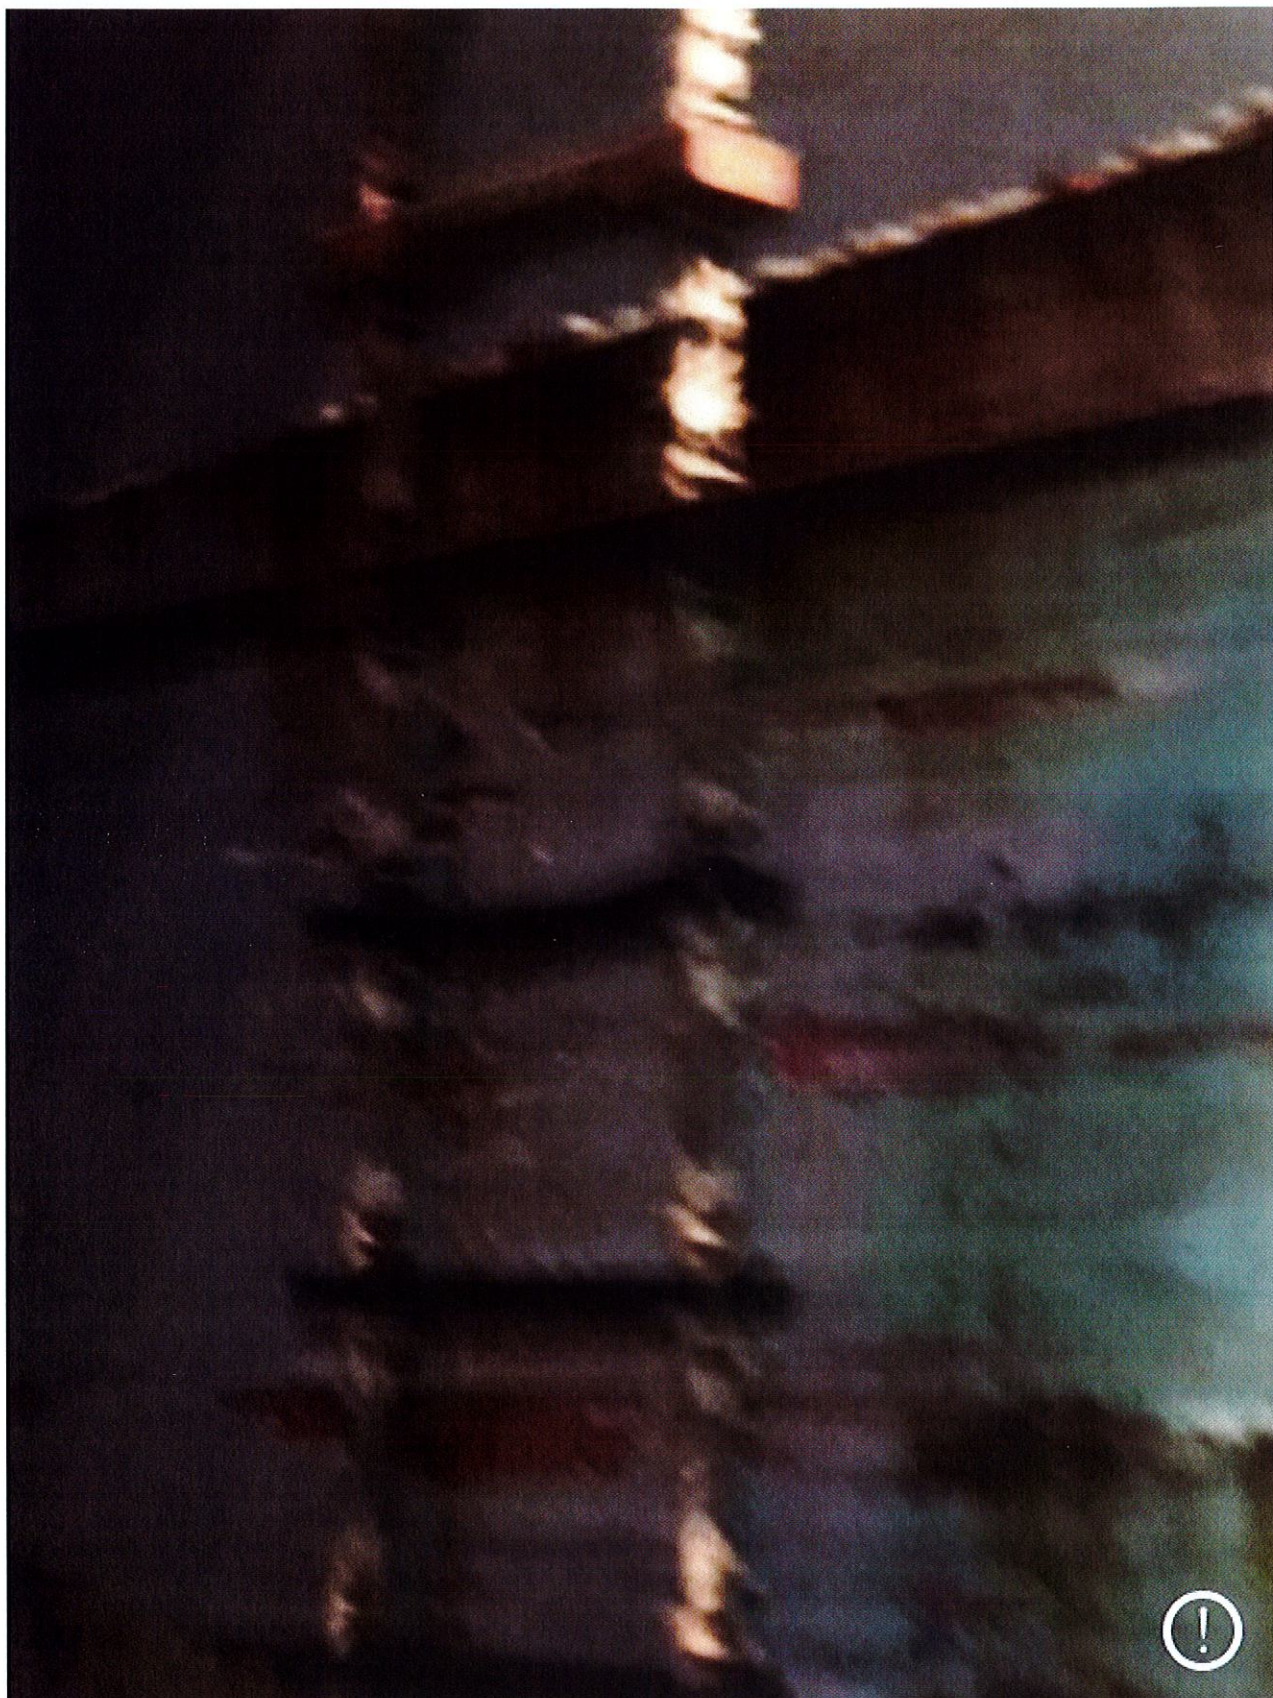
4TH STEP FROM BOTTOM PORT SIDE BENT (NEEDS TO BE REPLACED)
