## PILOT BOARDING DEFICIENCY REPORT

DATE: 9 September 2019 TIME: 1300

VESSEL: Dank Silver

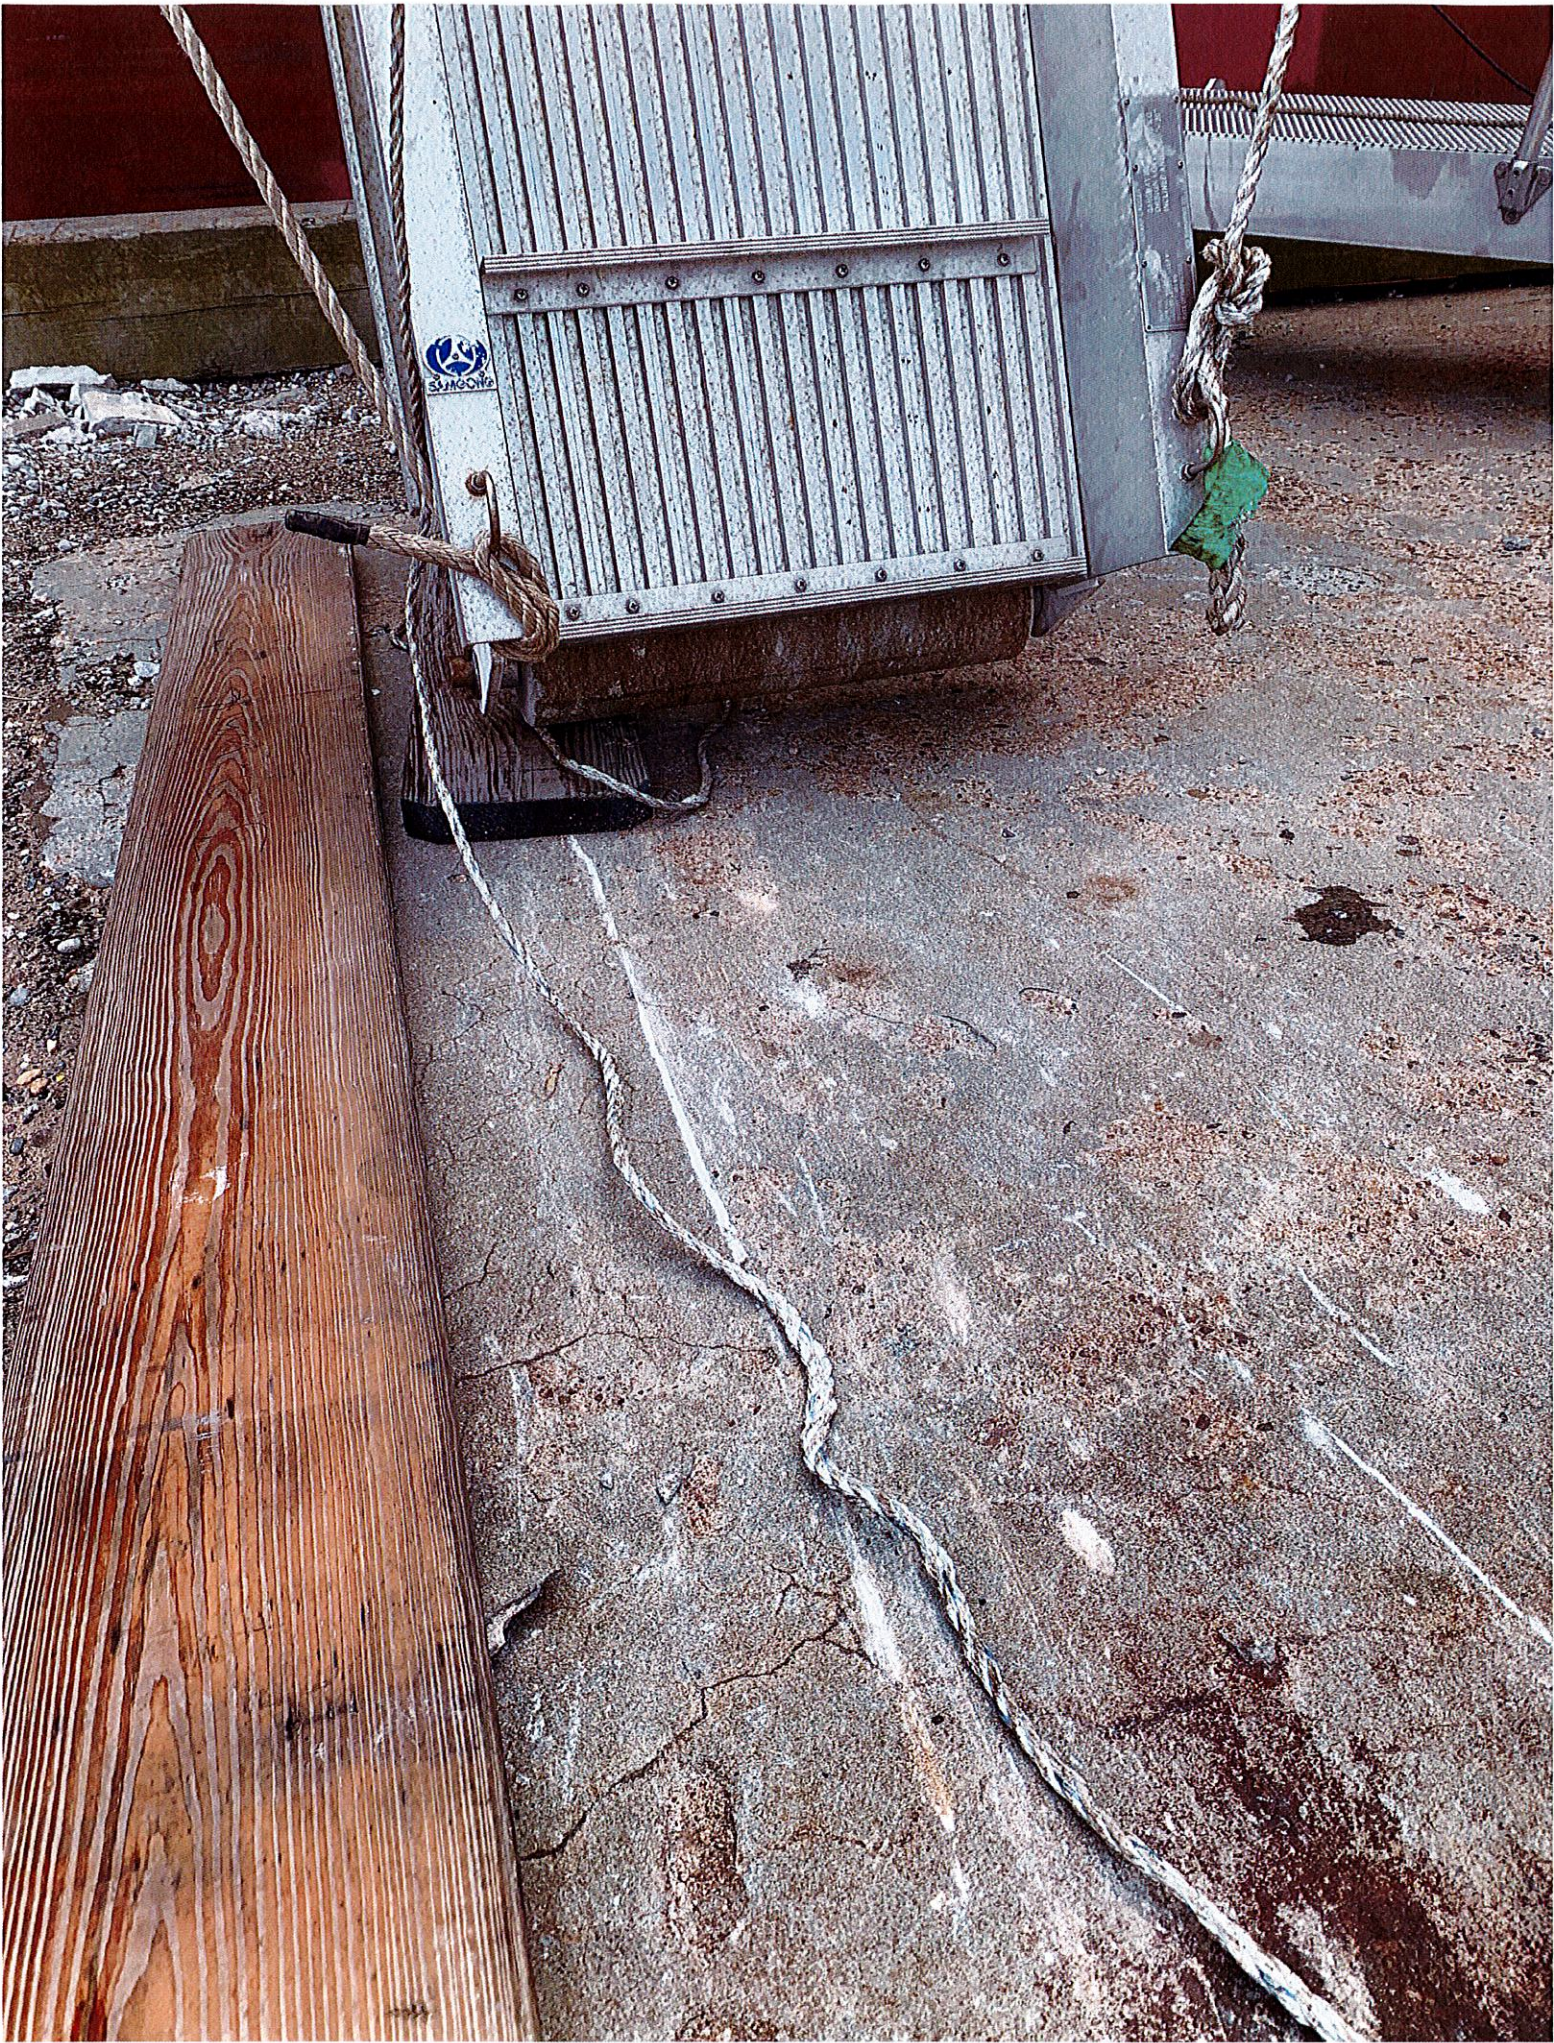
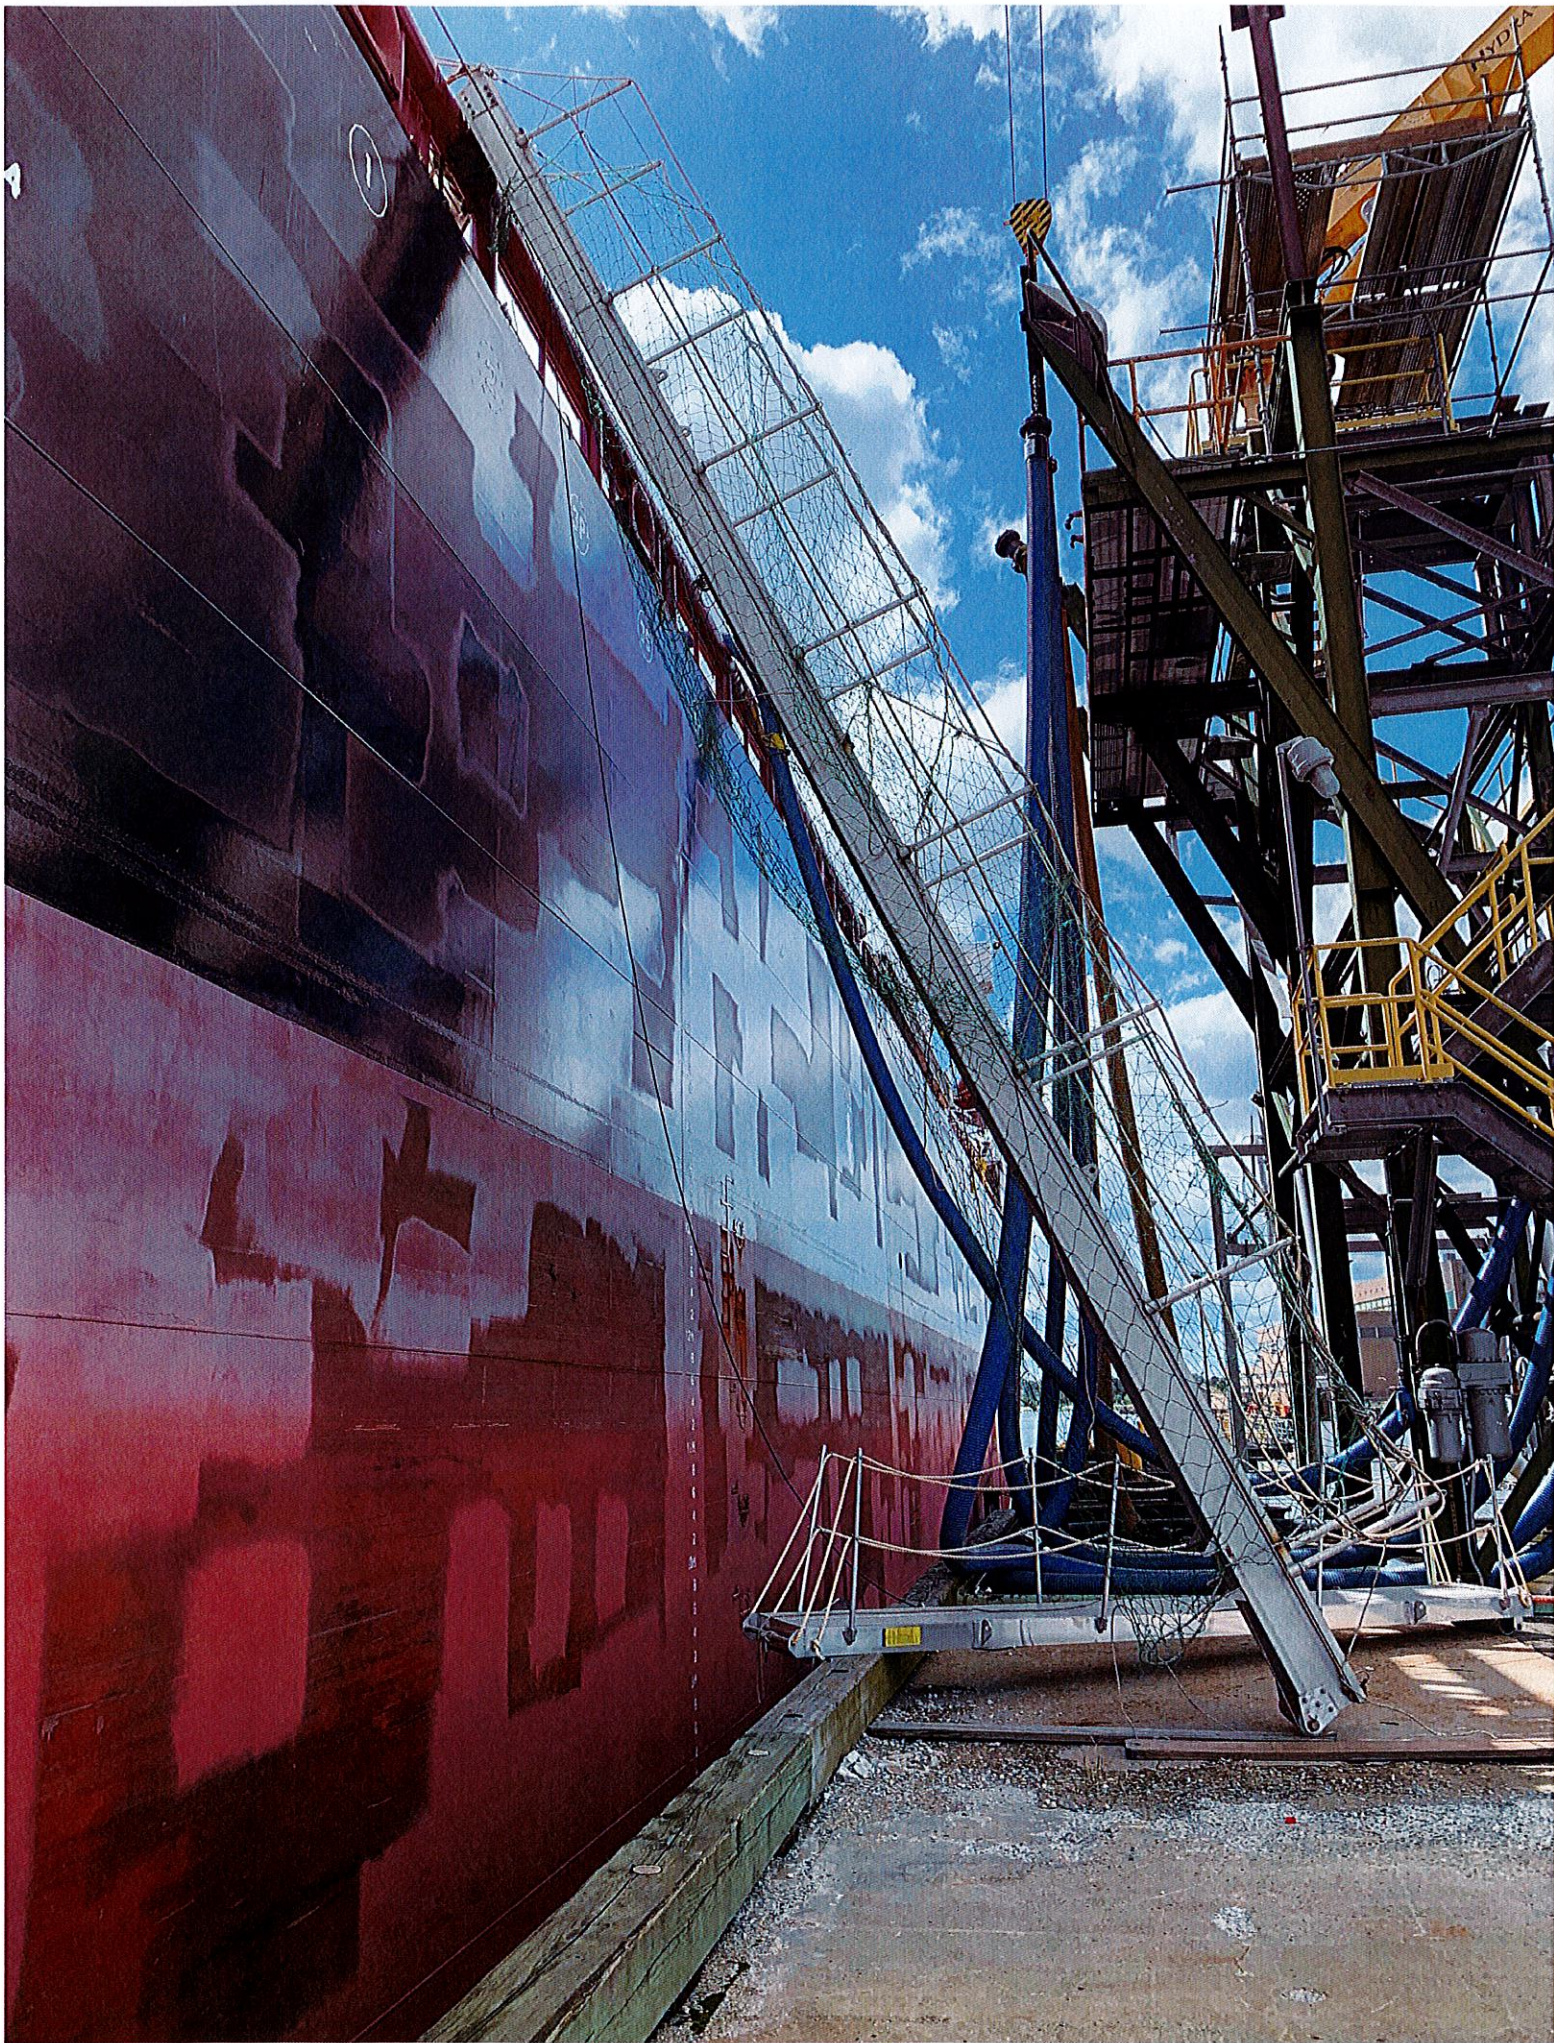
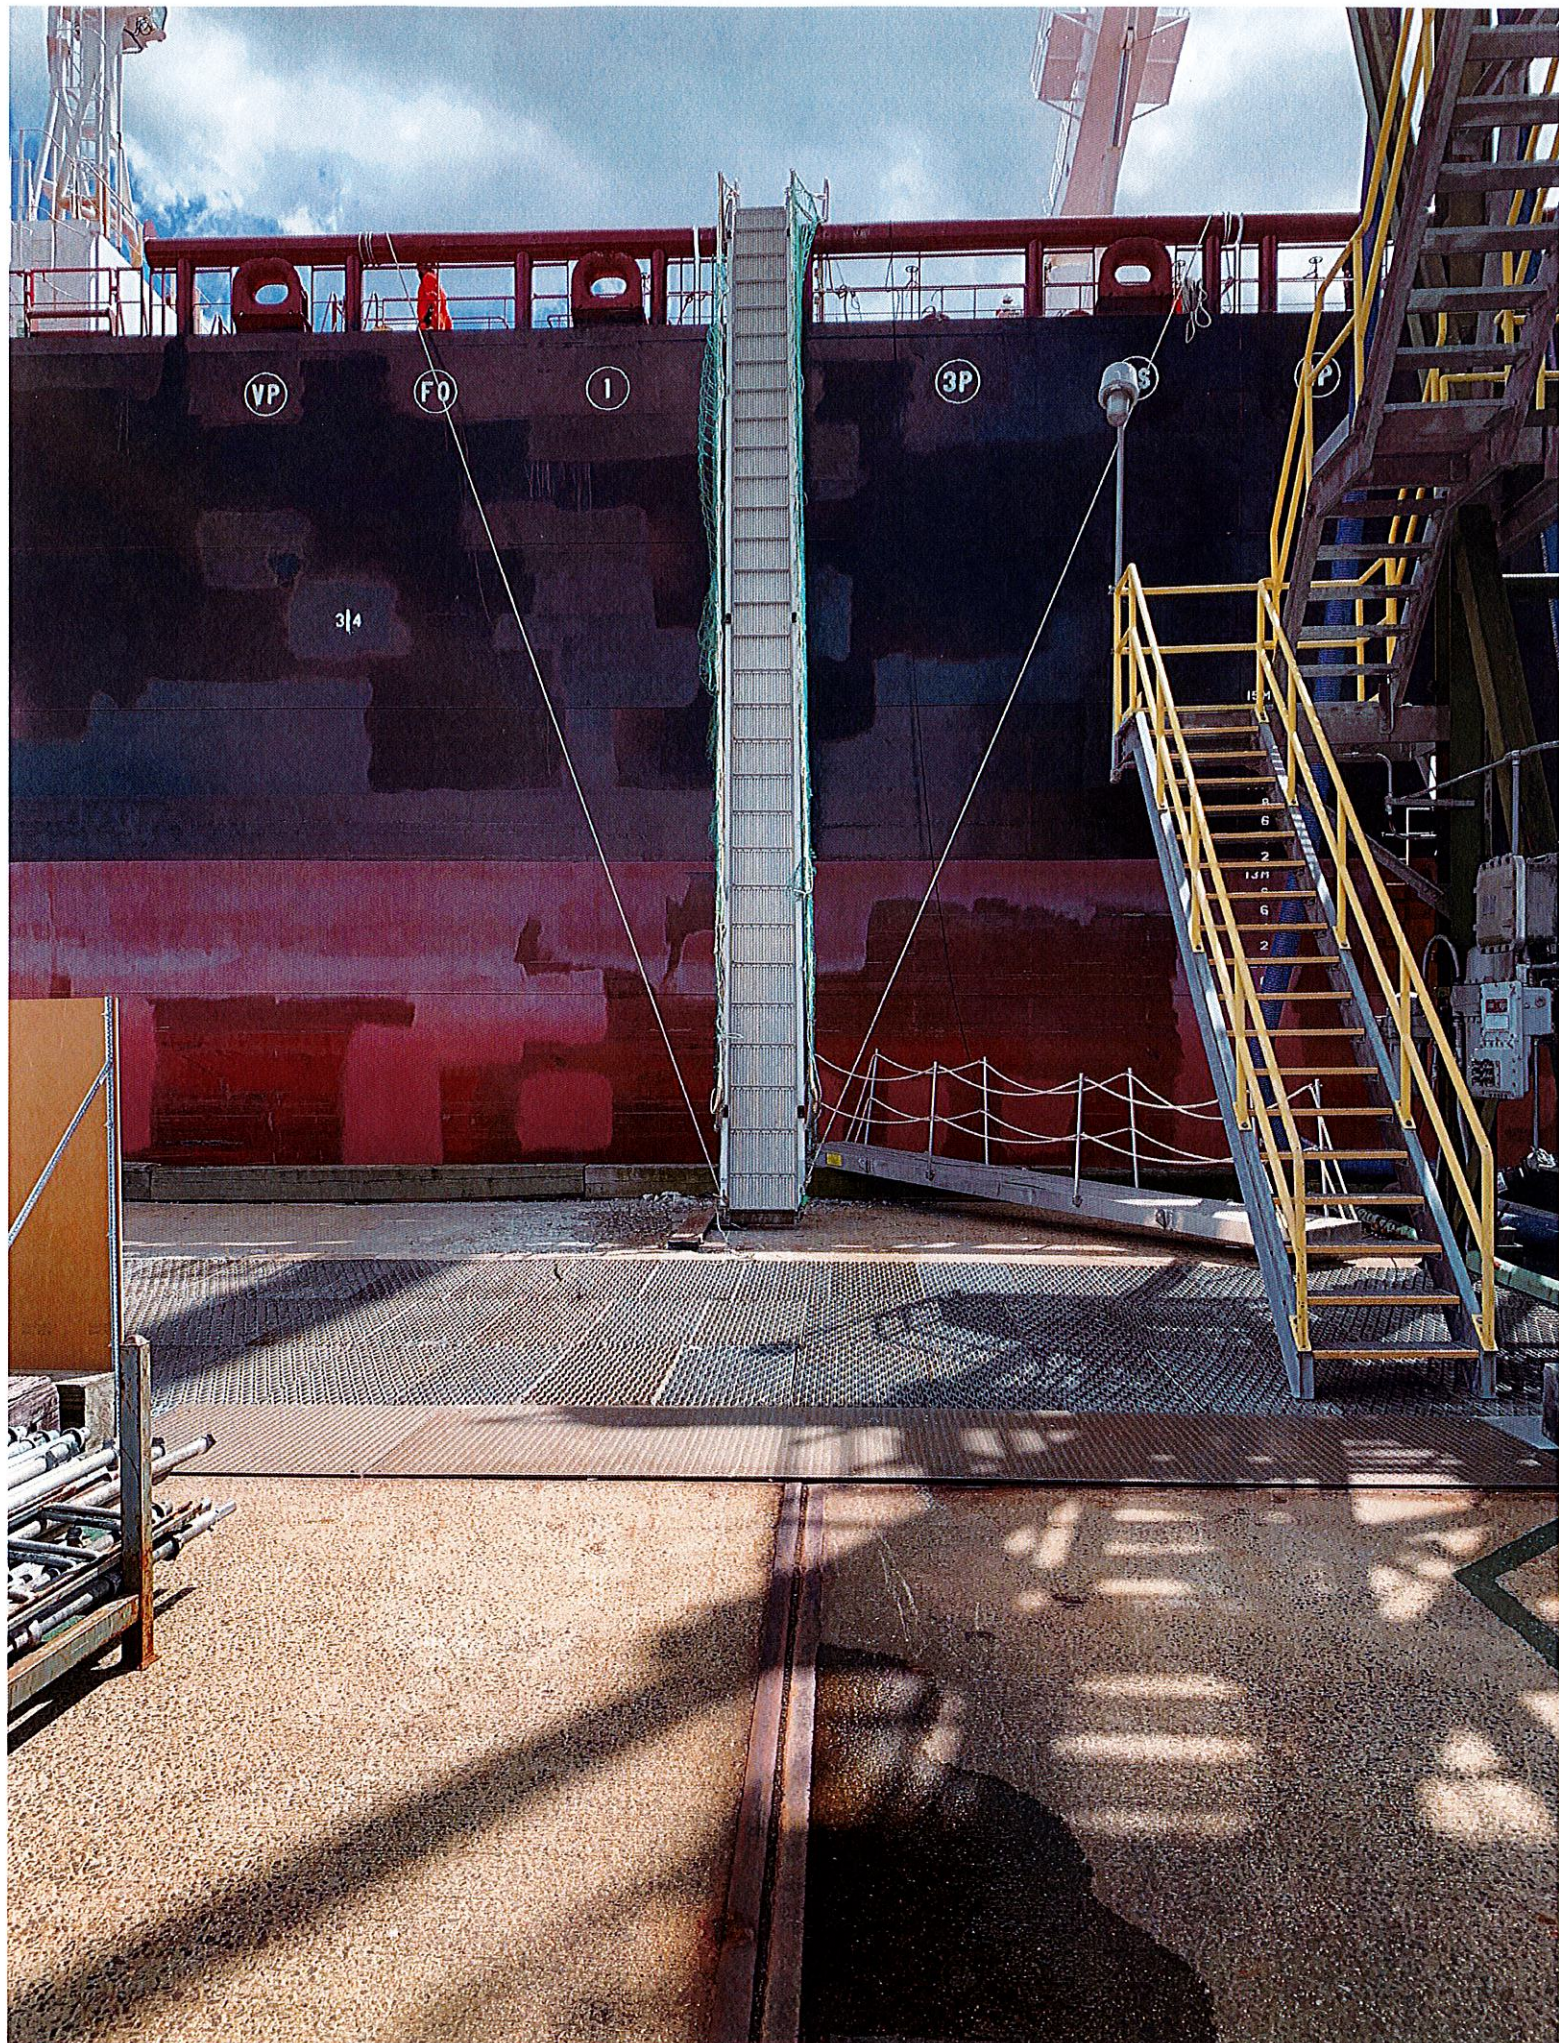
Severe angle, pivoting on a piece of wood on dock.

This ship was in ballast condition. The gangway was too steep to climb. It was also unstable. The wood planks it had been riding on had shifted as the ship lightered causing the gangway to pivot and swing in an unsafe manner.
