# PILOT BOARDING DEFICIENCY REPORT

DATE: 2/15/2020 TIME: 2115  
VESSEL: Gustov Maersk  
MASTER: \_\_\_\_\_  
PILOT: M. P. Haley  
CONDITIONS: Light-moderate SSW'ly

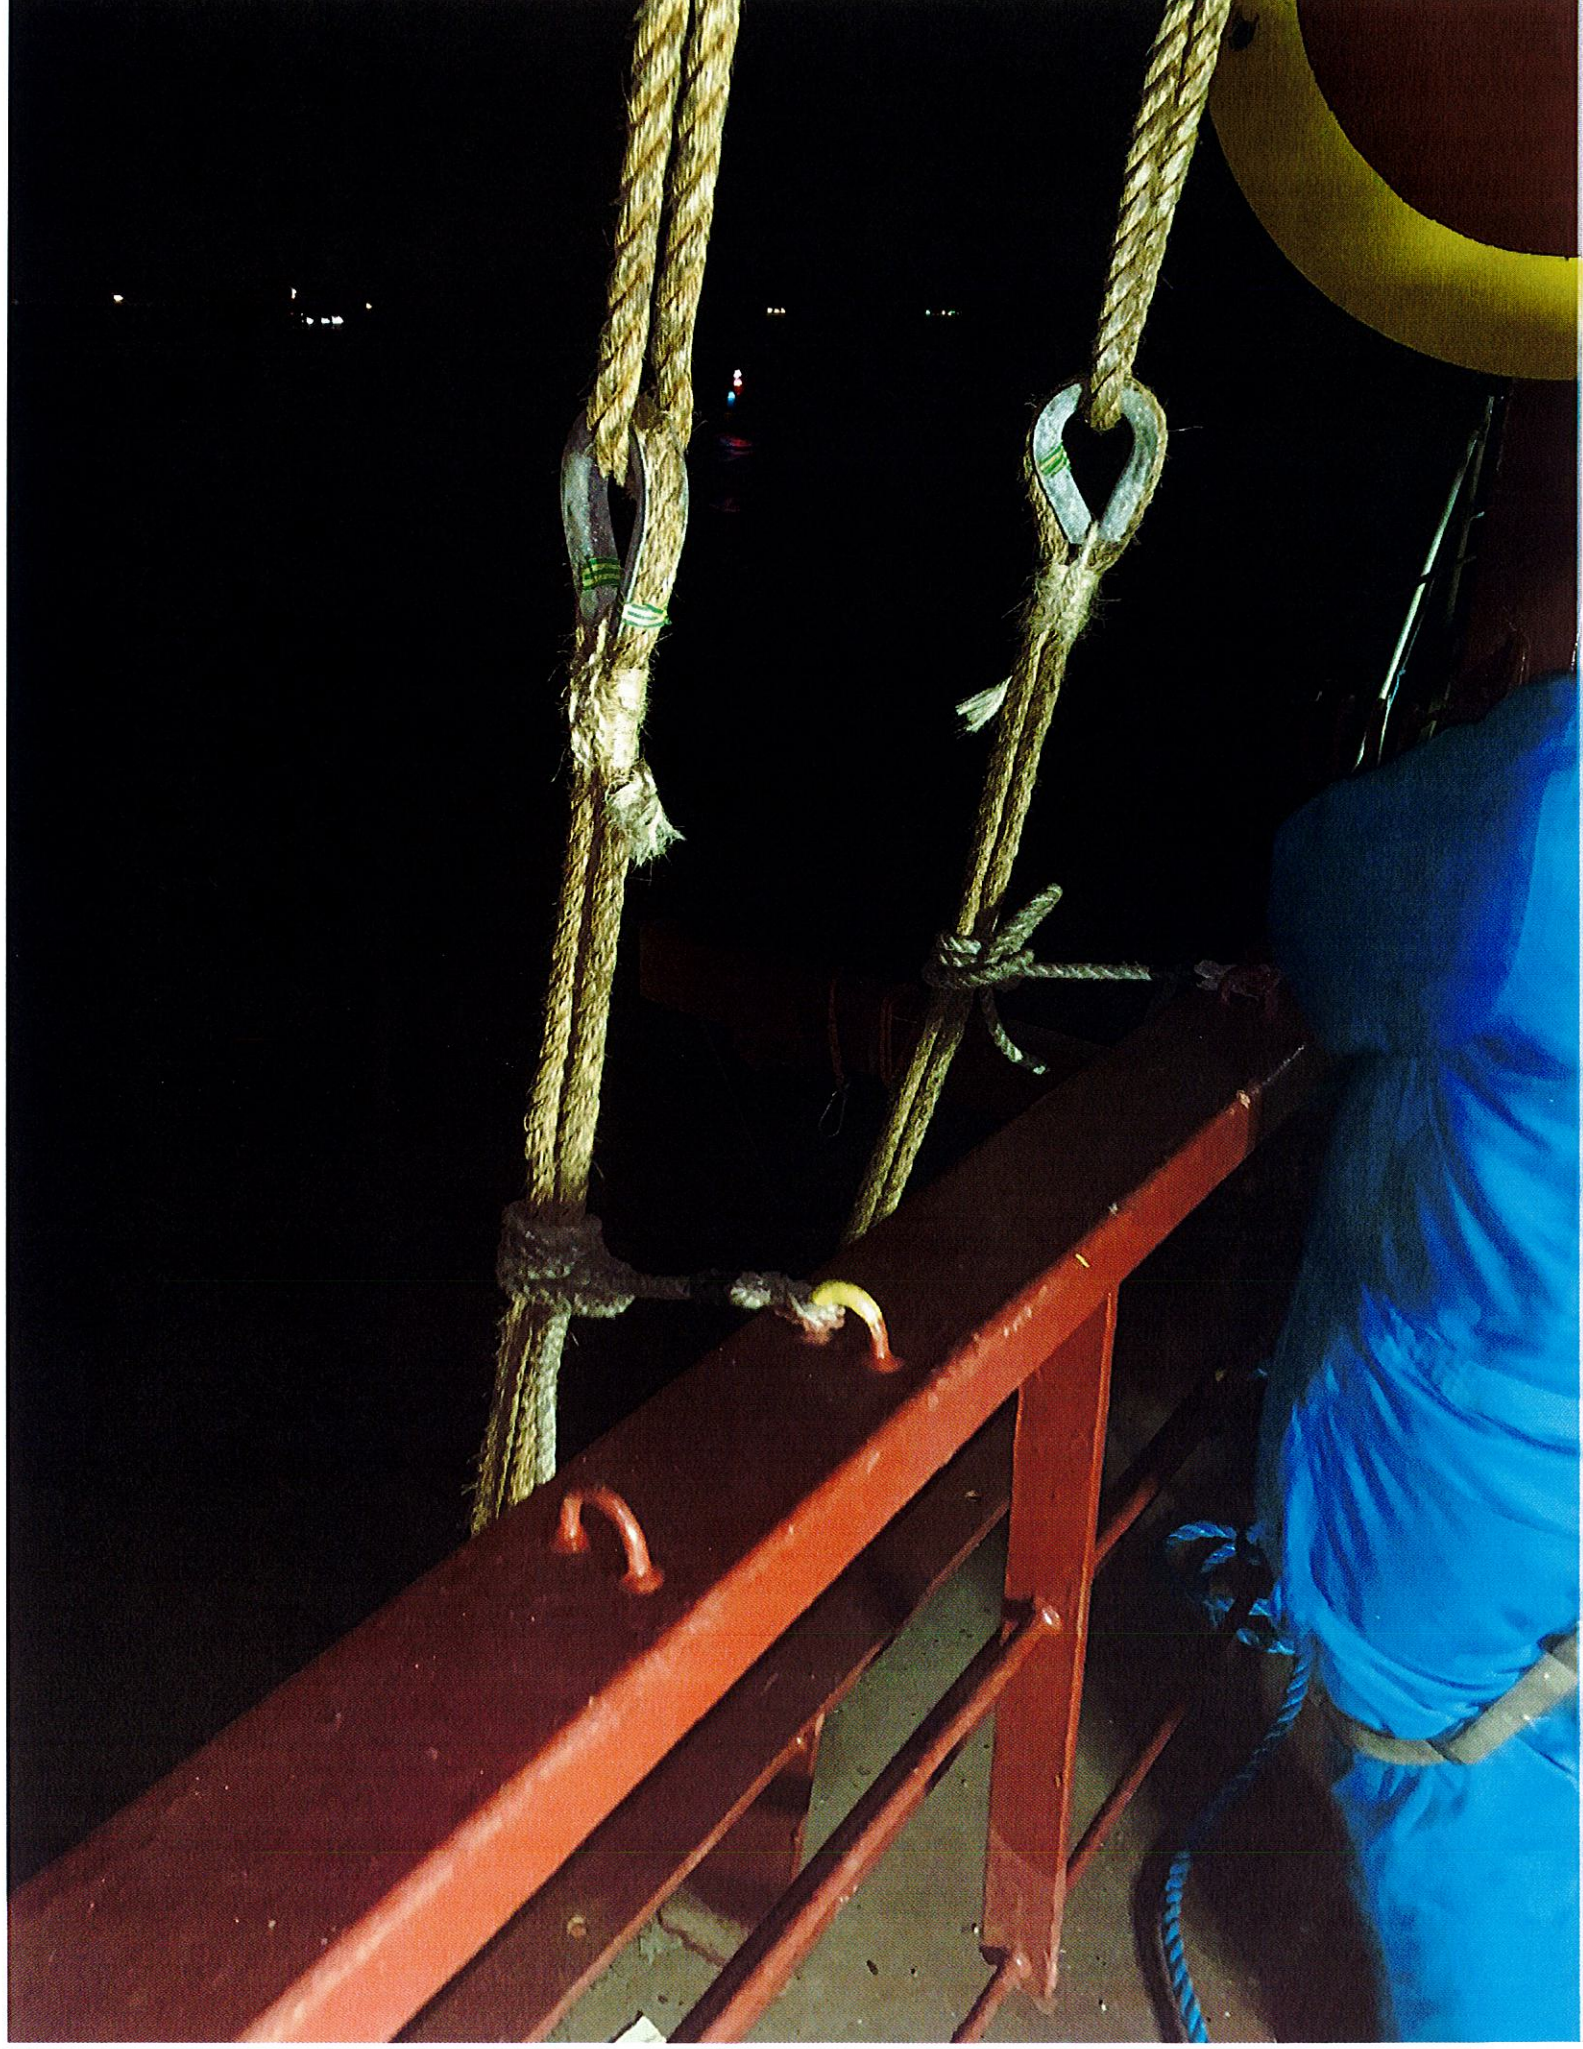
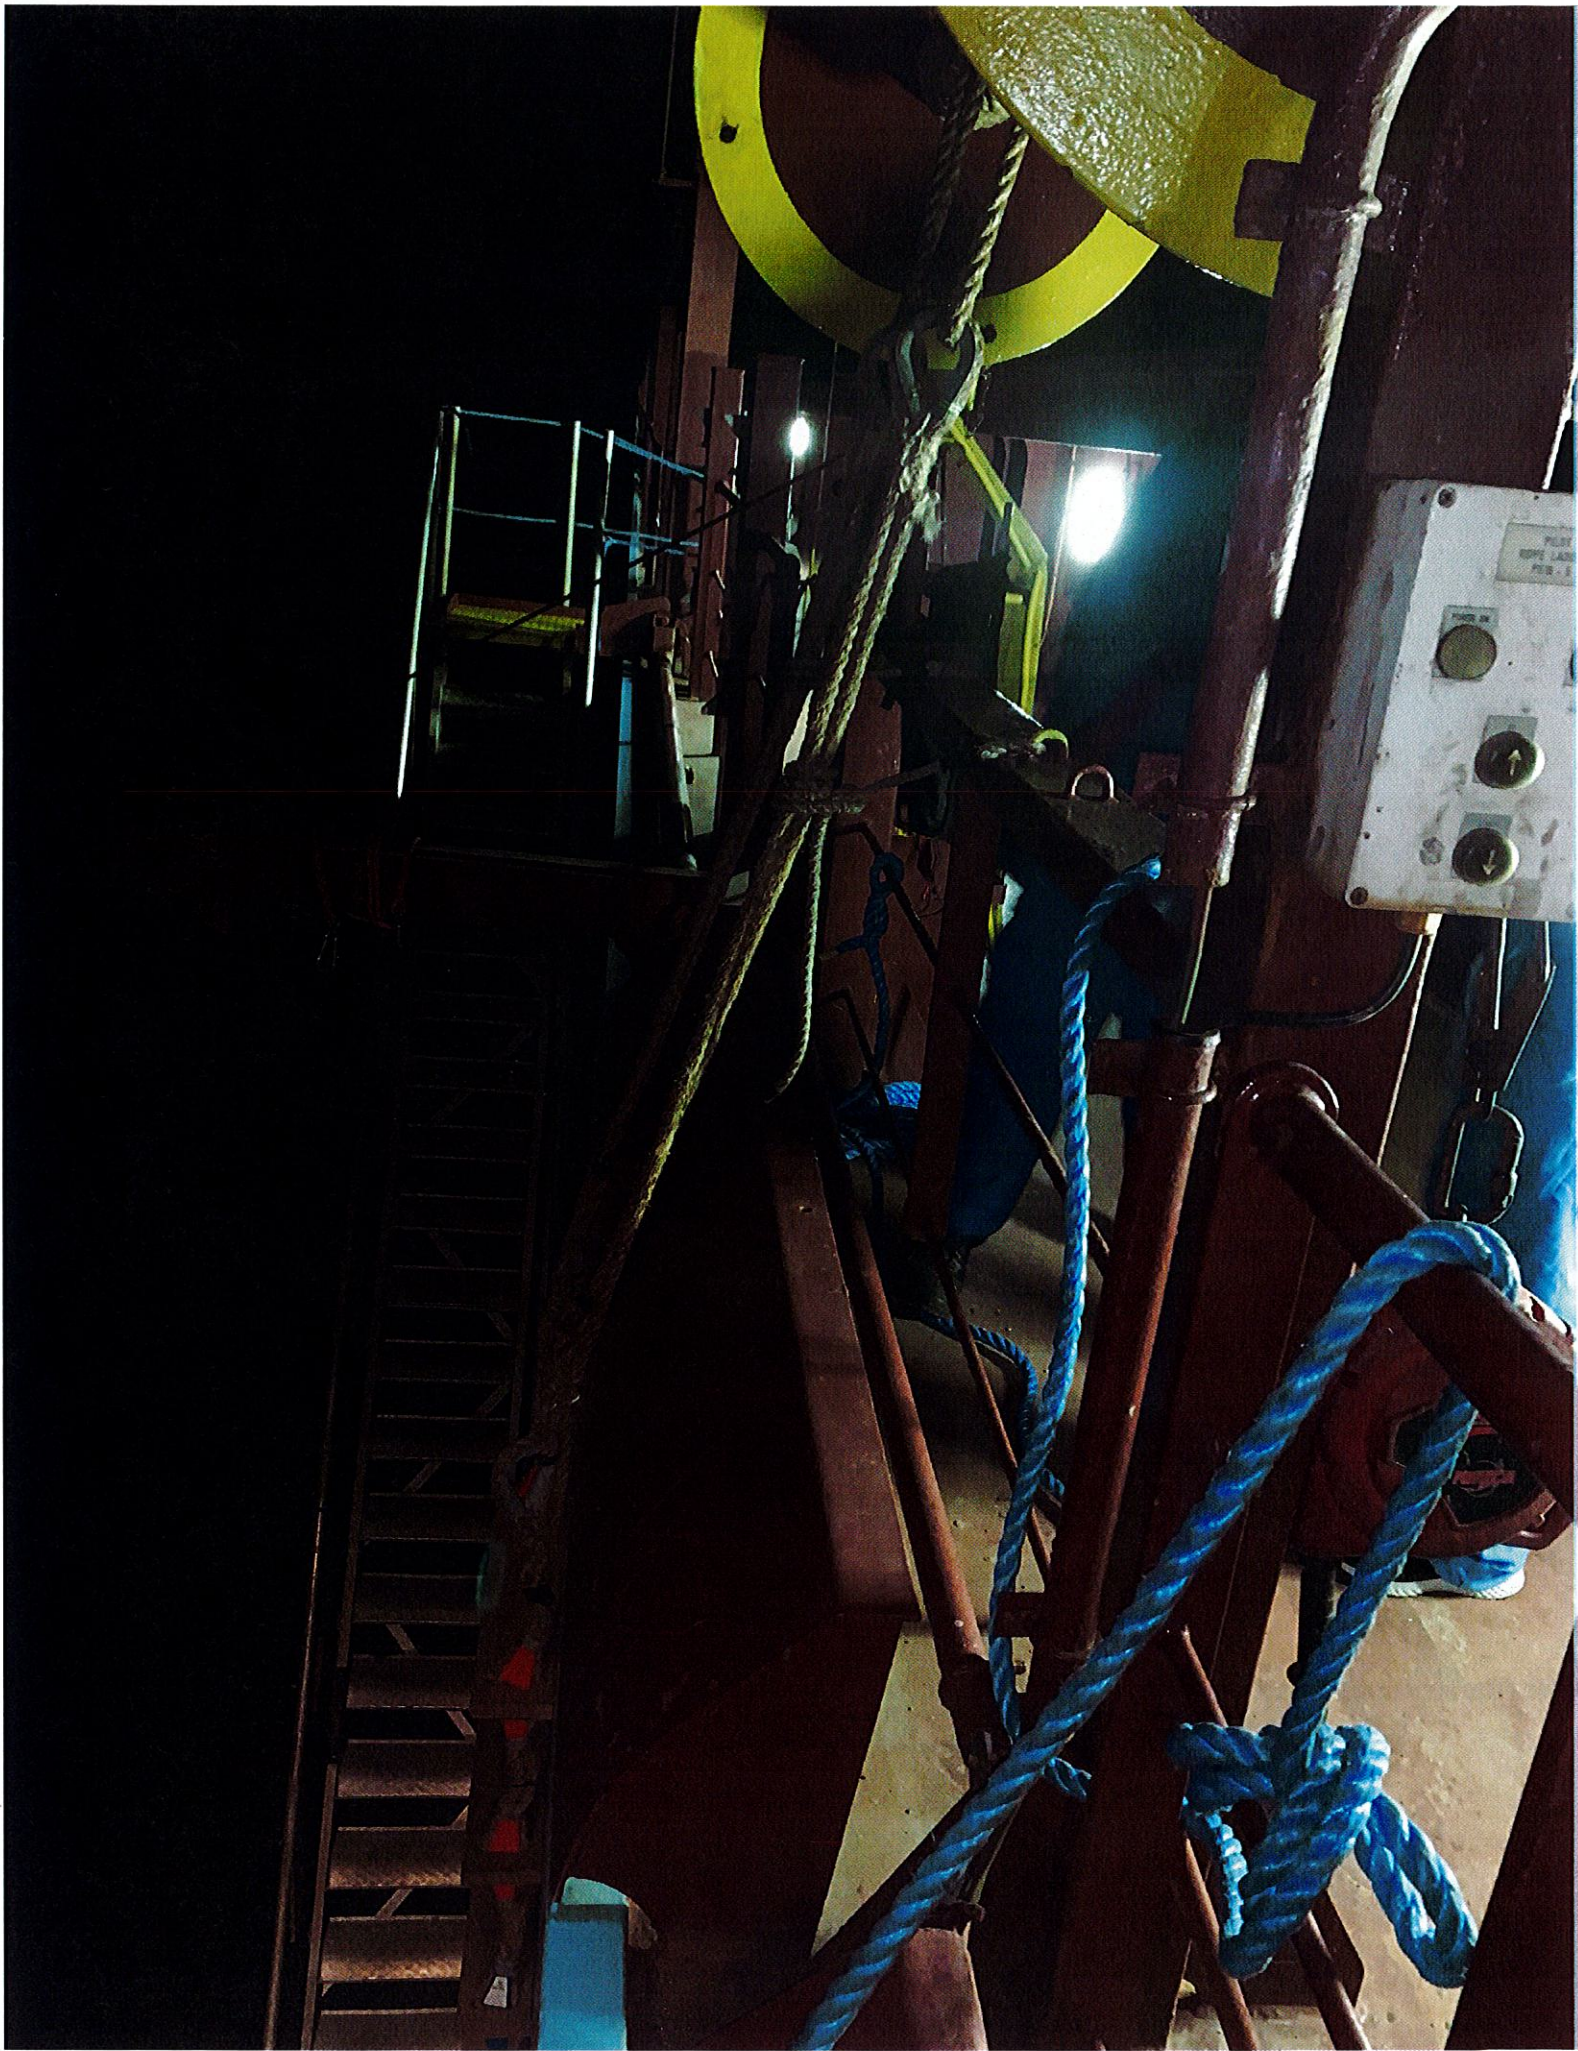
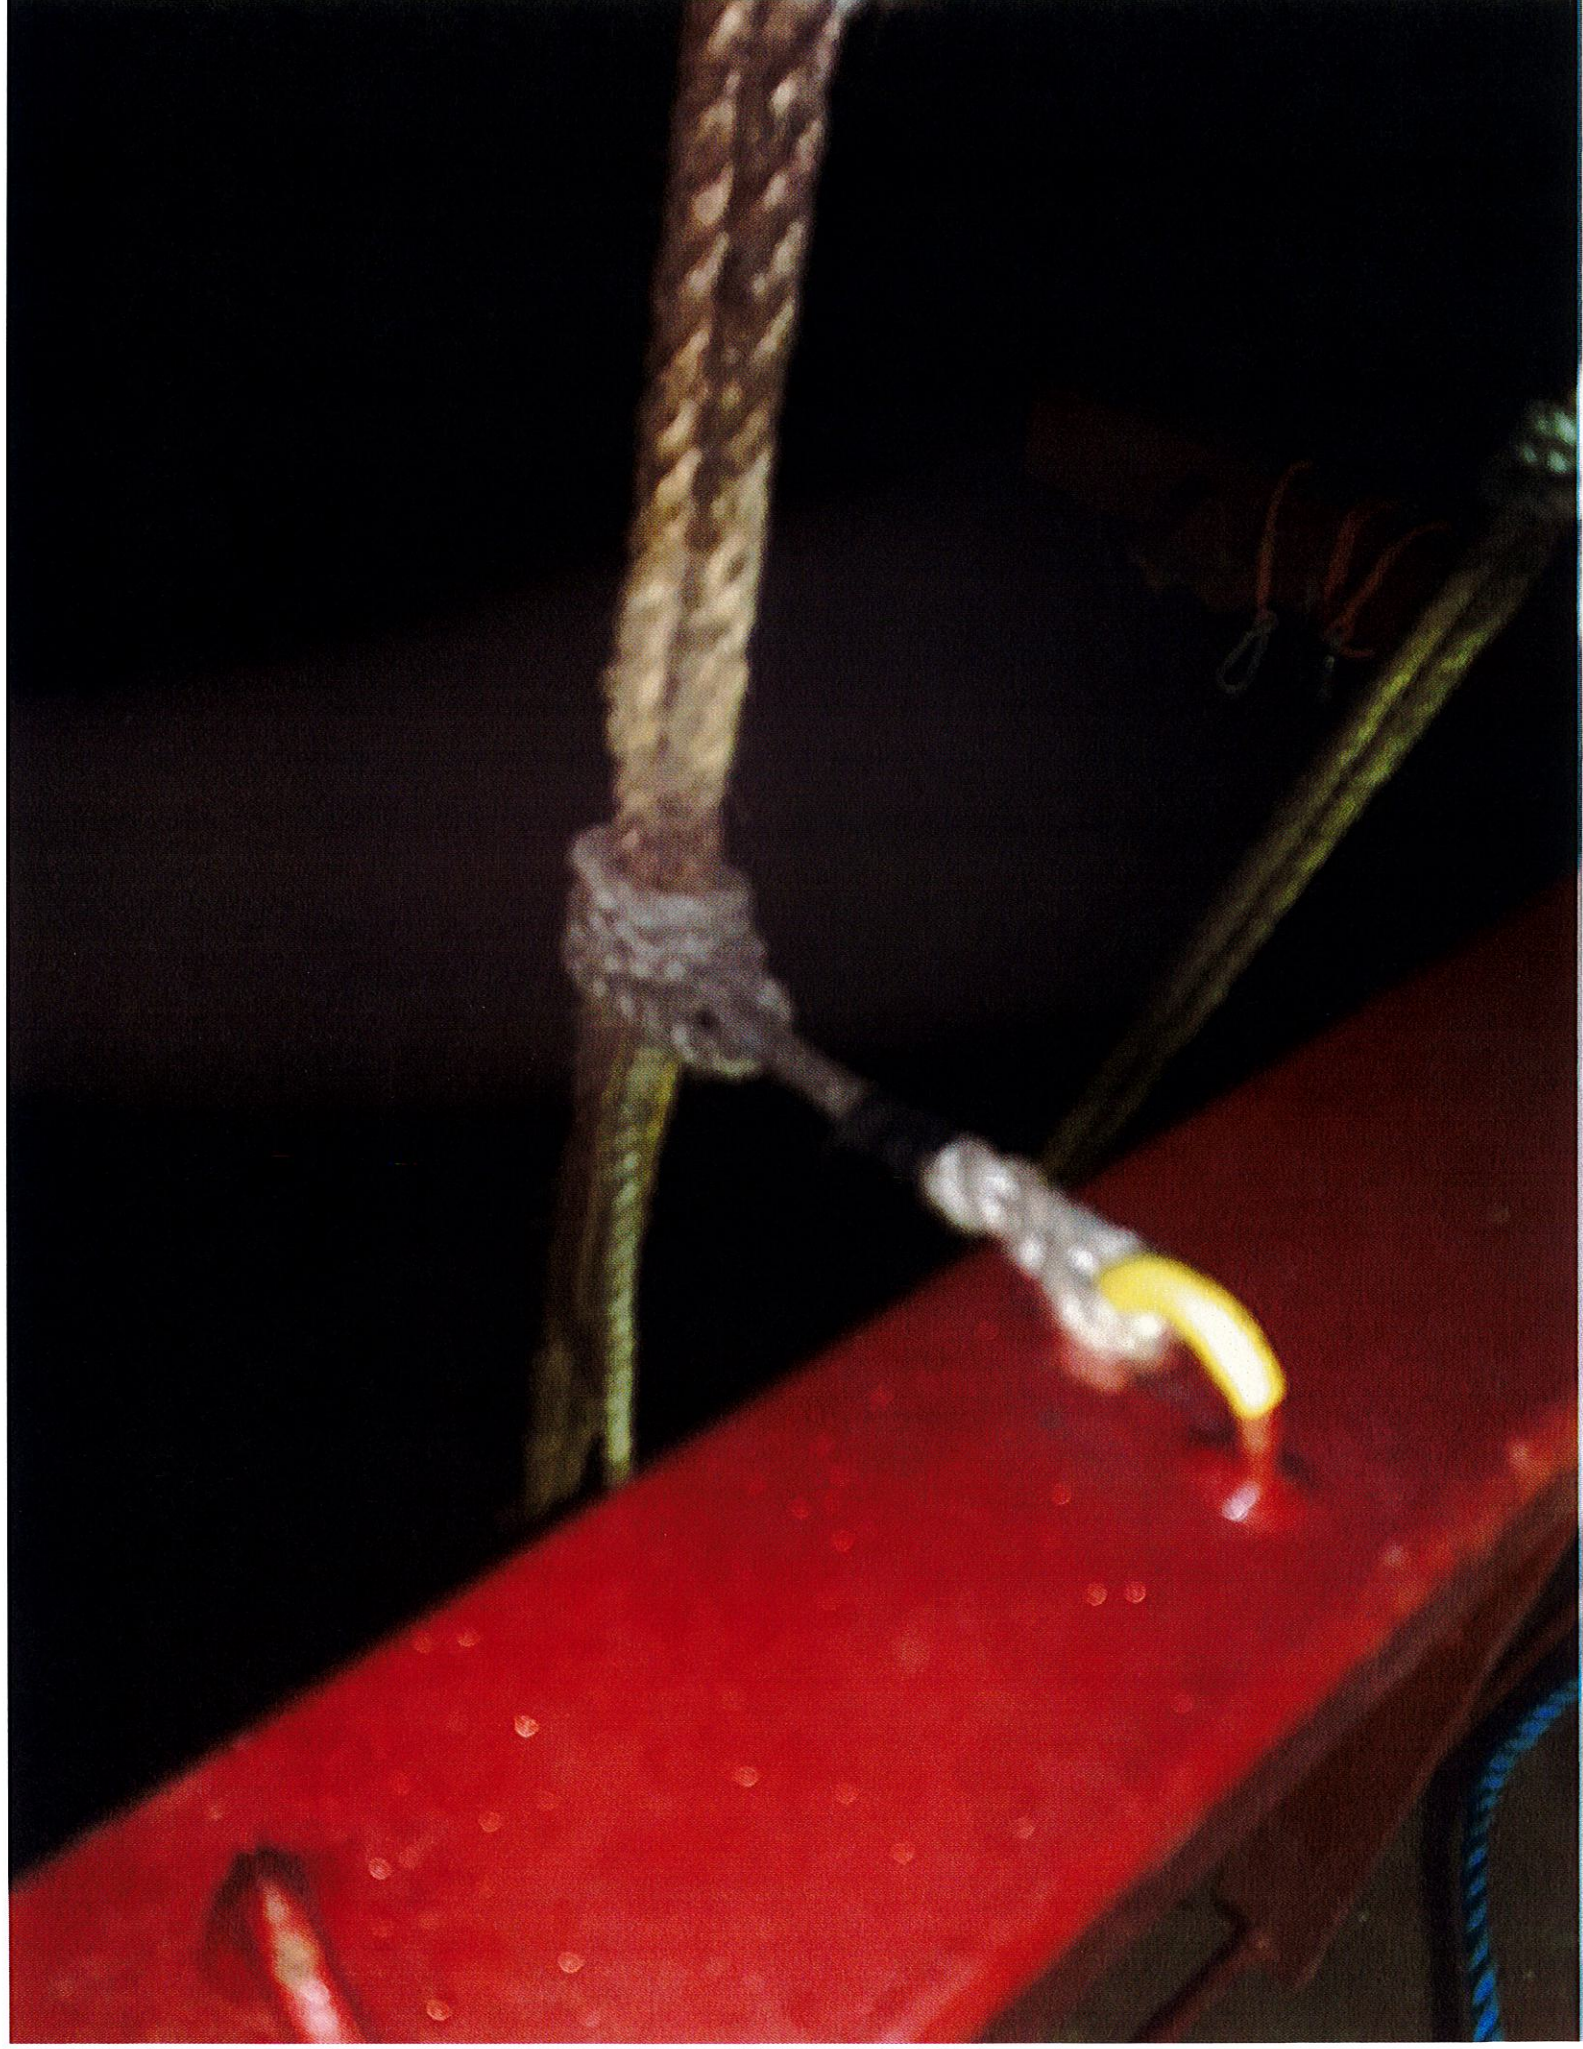
Ladder not properly secured from strong point on deck to side ropes. Not independent of ladder.

Small insufficient line tied from side rope to flimsy metal ring on railing and not to deck strong point. (Strong pt not avail)

Ladder not independently secured from ladder reel. When Asked how it was secured Other than the reel the

Response was "magnets on the hull." Explained to crew. See pictures.
