PILOT BOARDING DEFICIENCY REPORT

DATE: 5/12/2020 TIME: 2315

VESSEL: Maersk Hartford

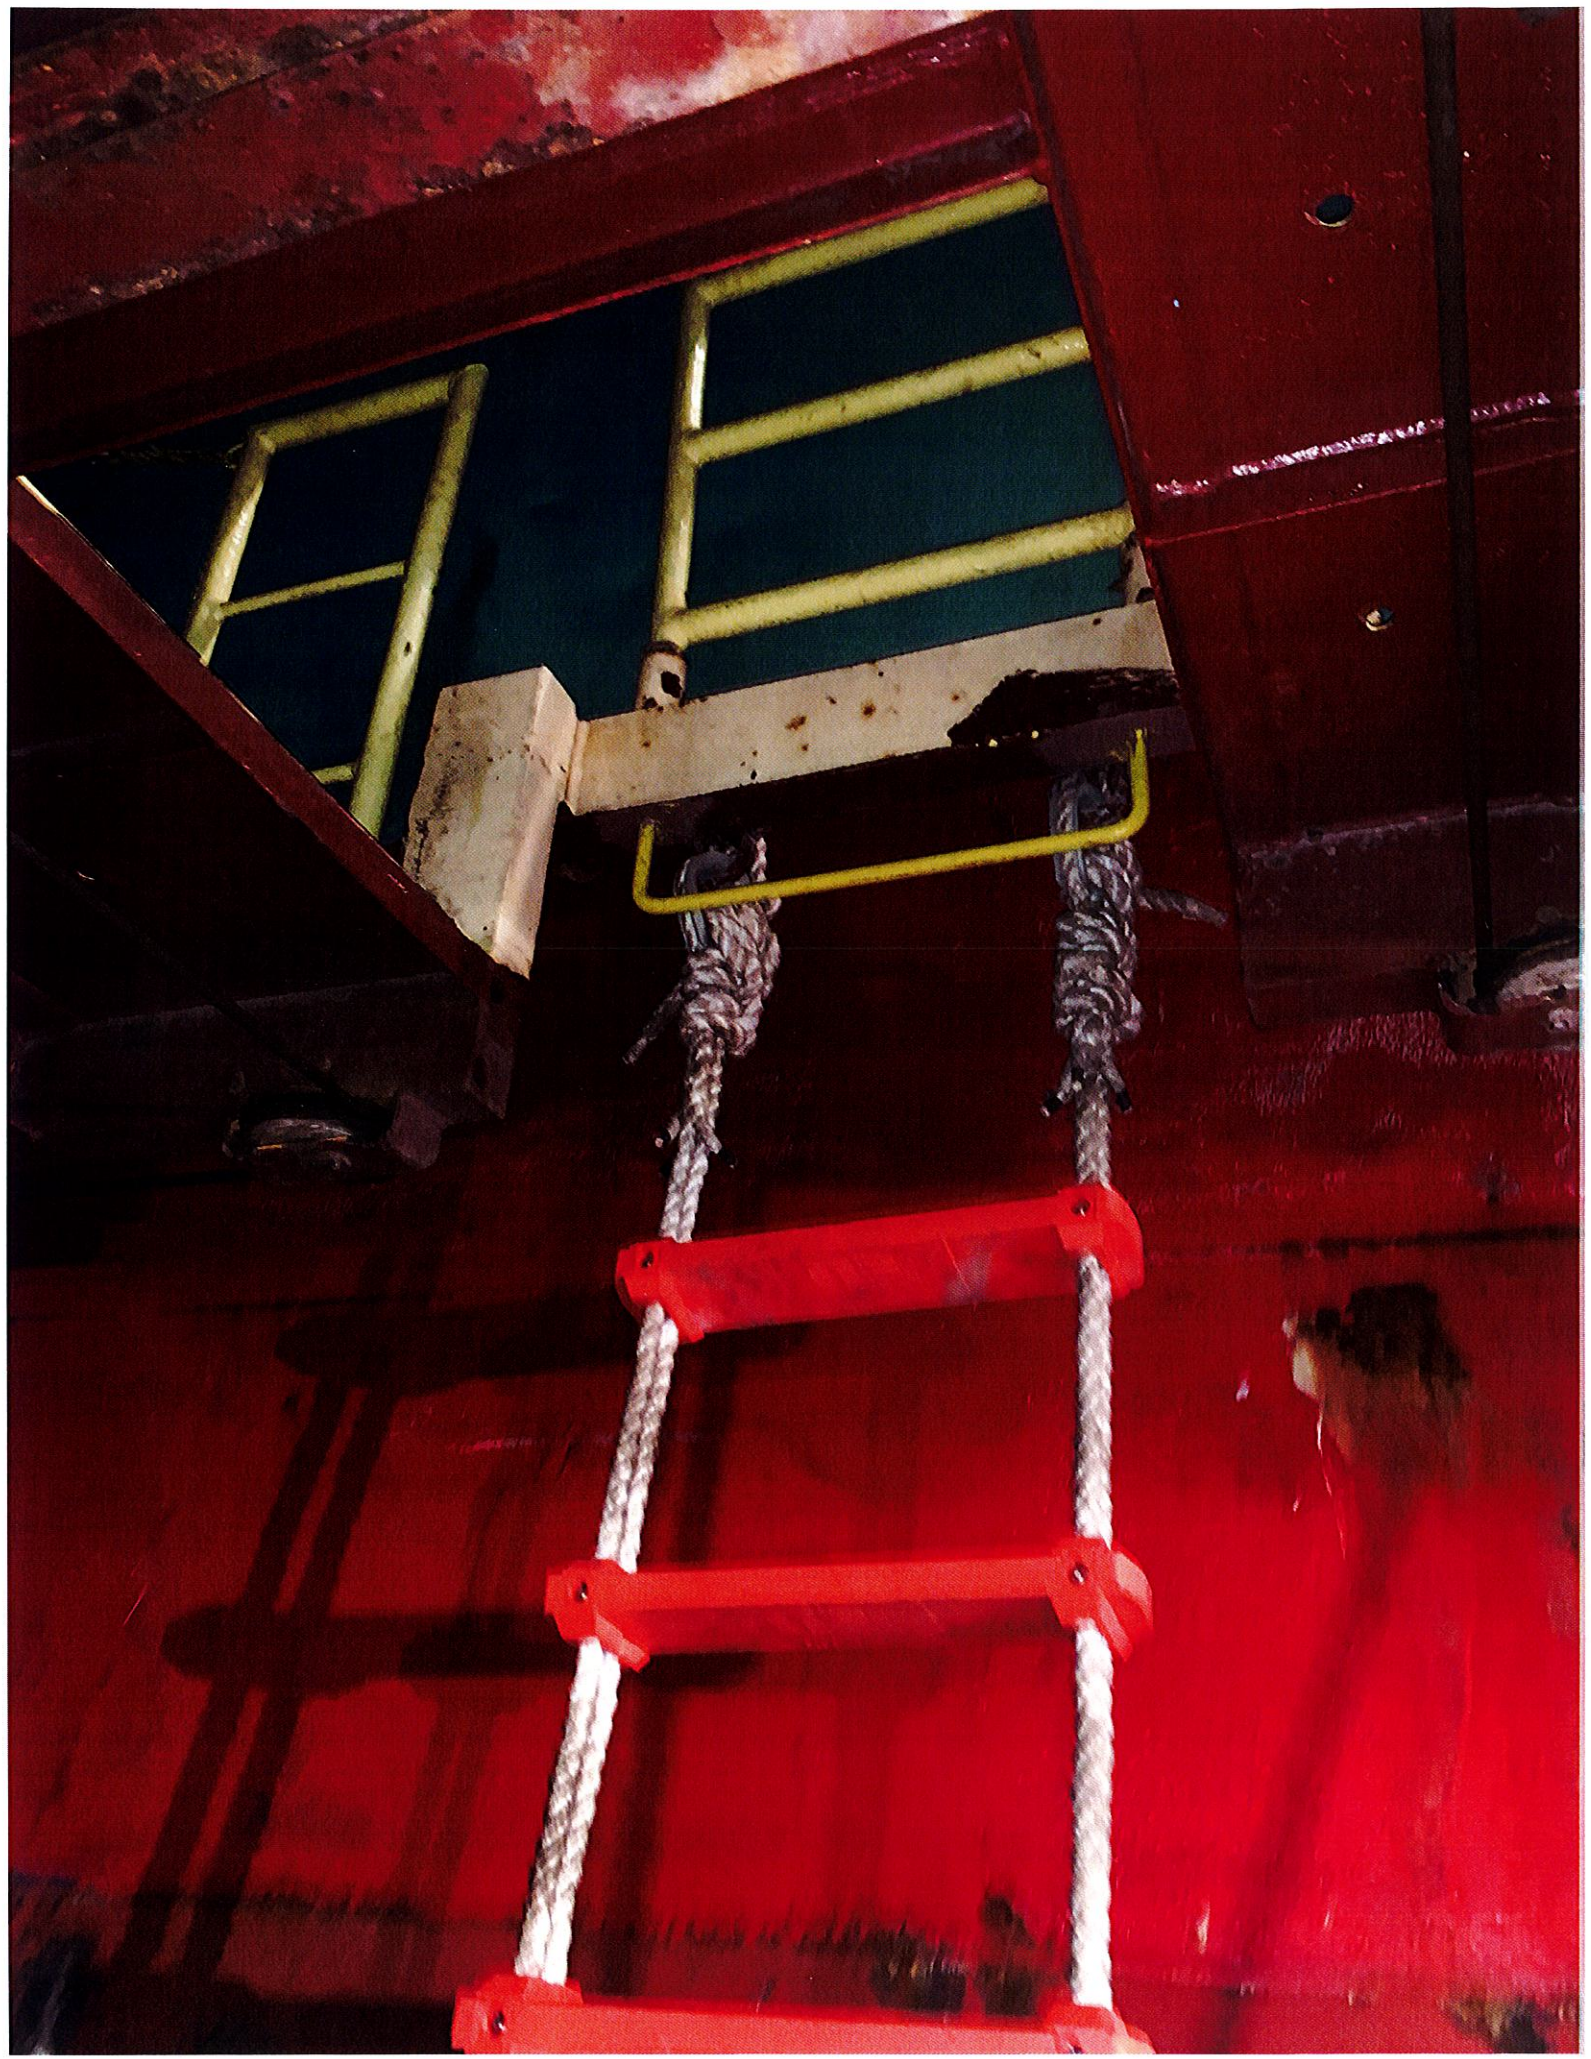
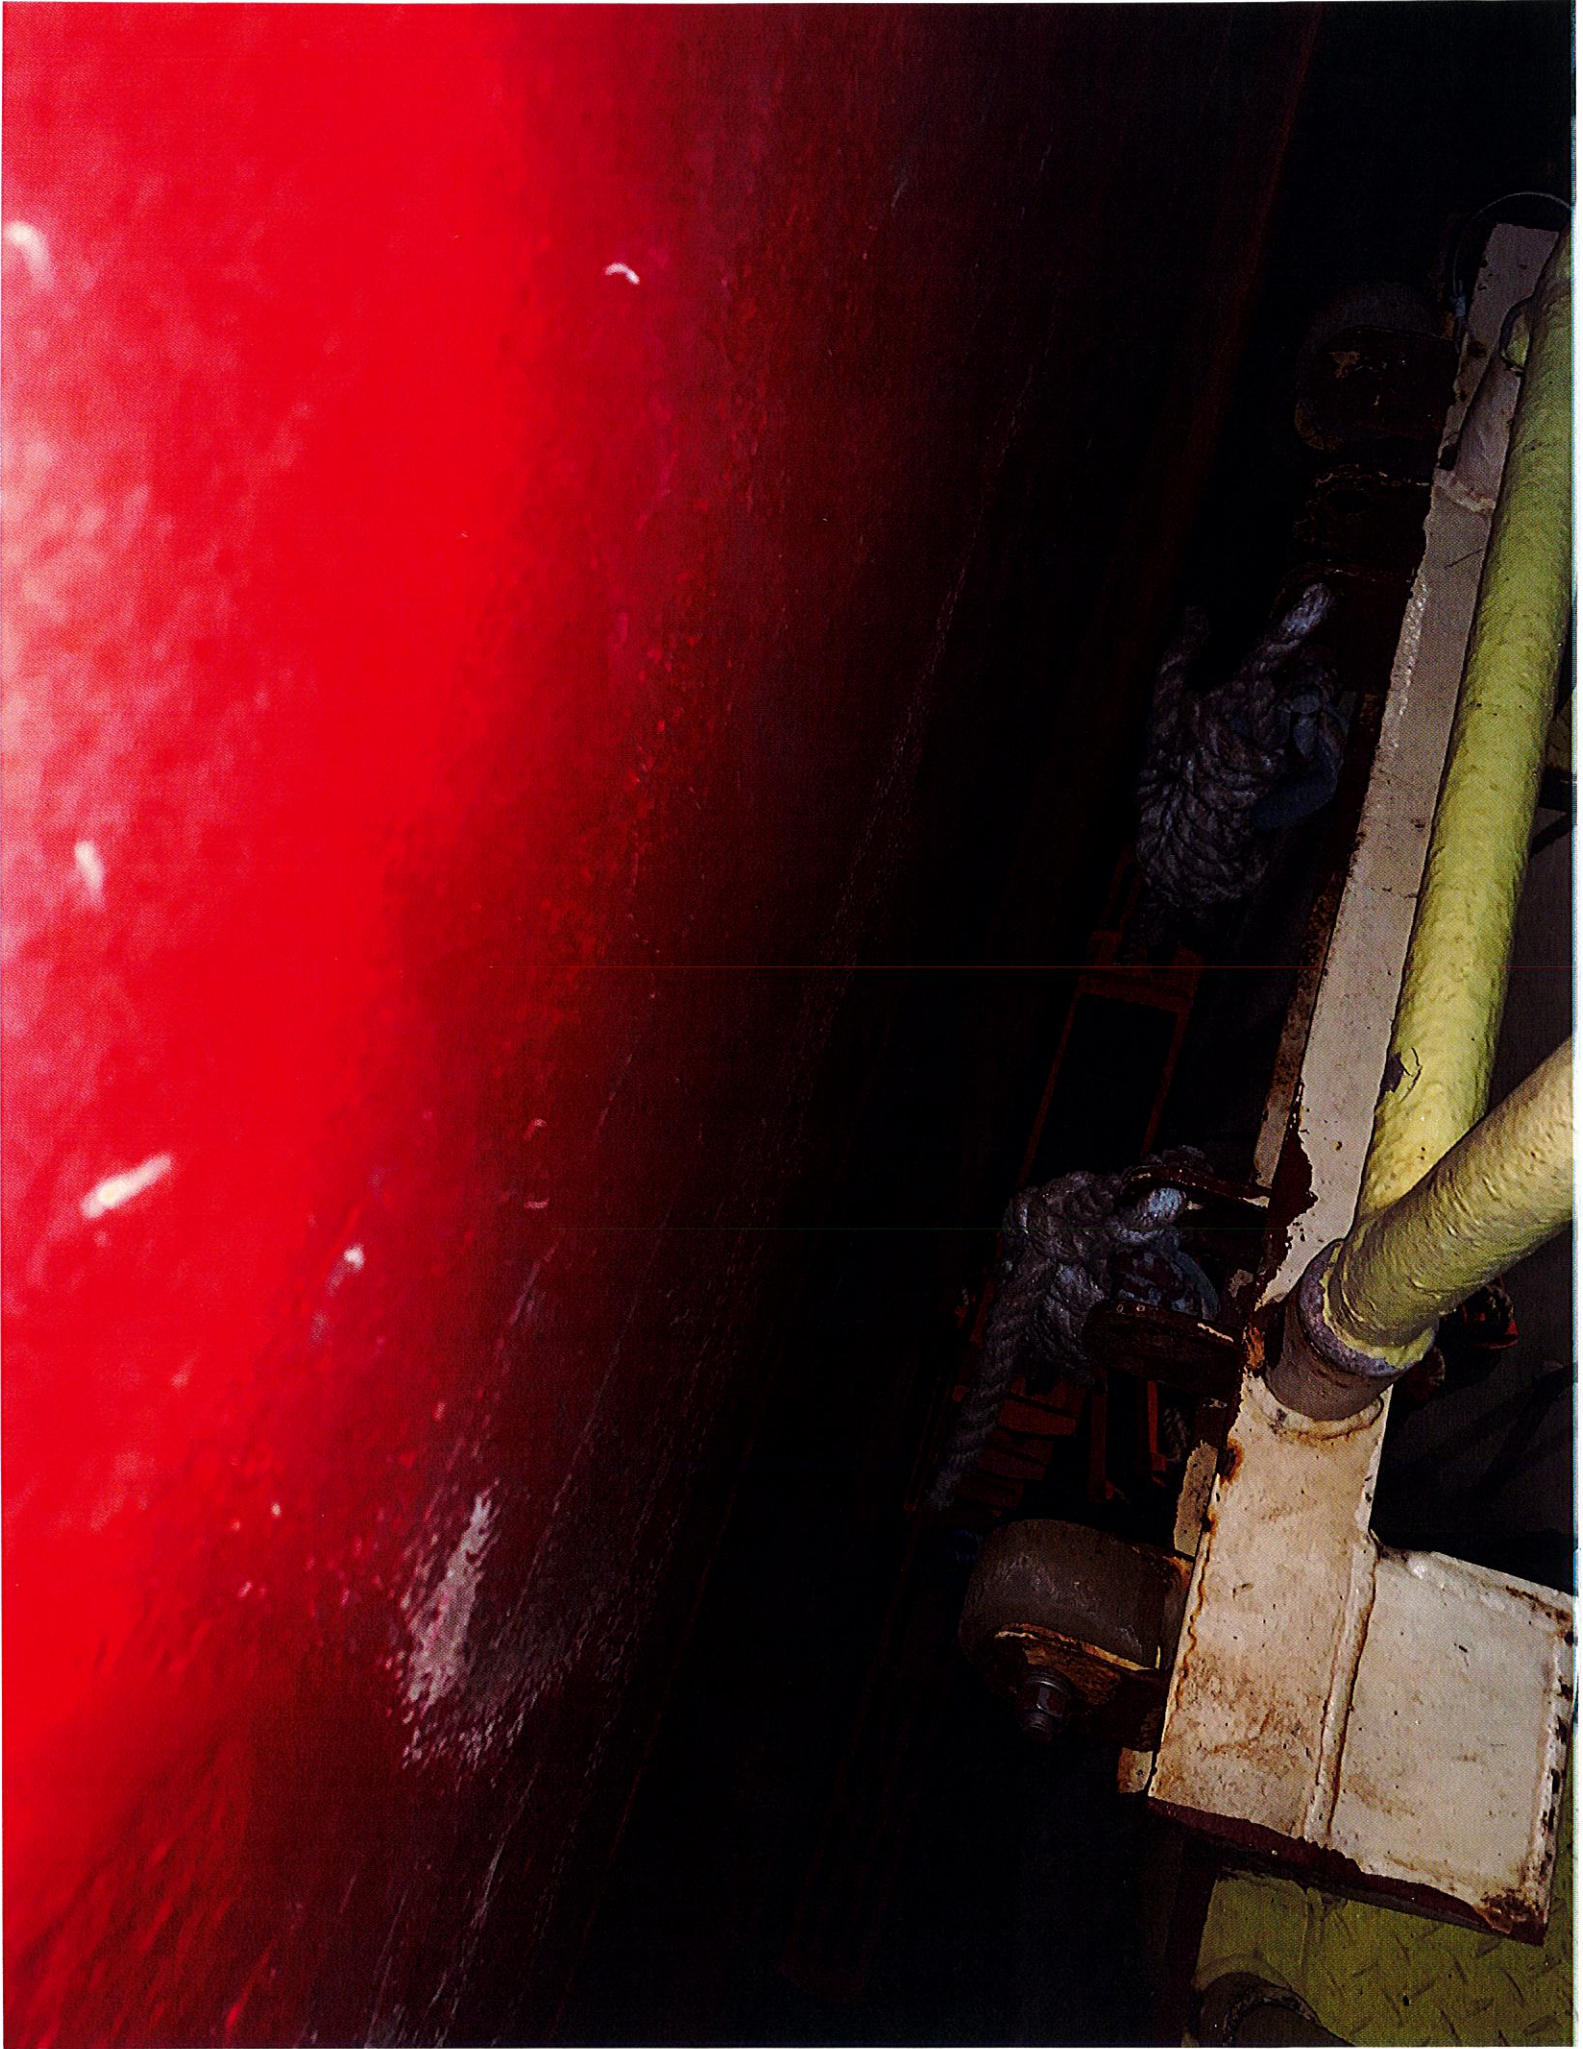
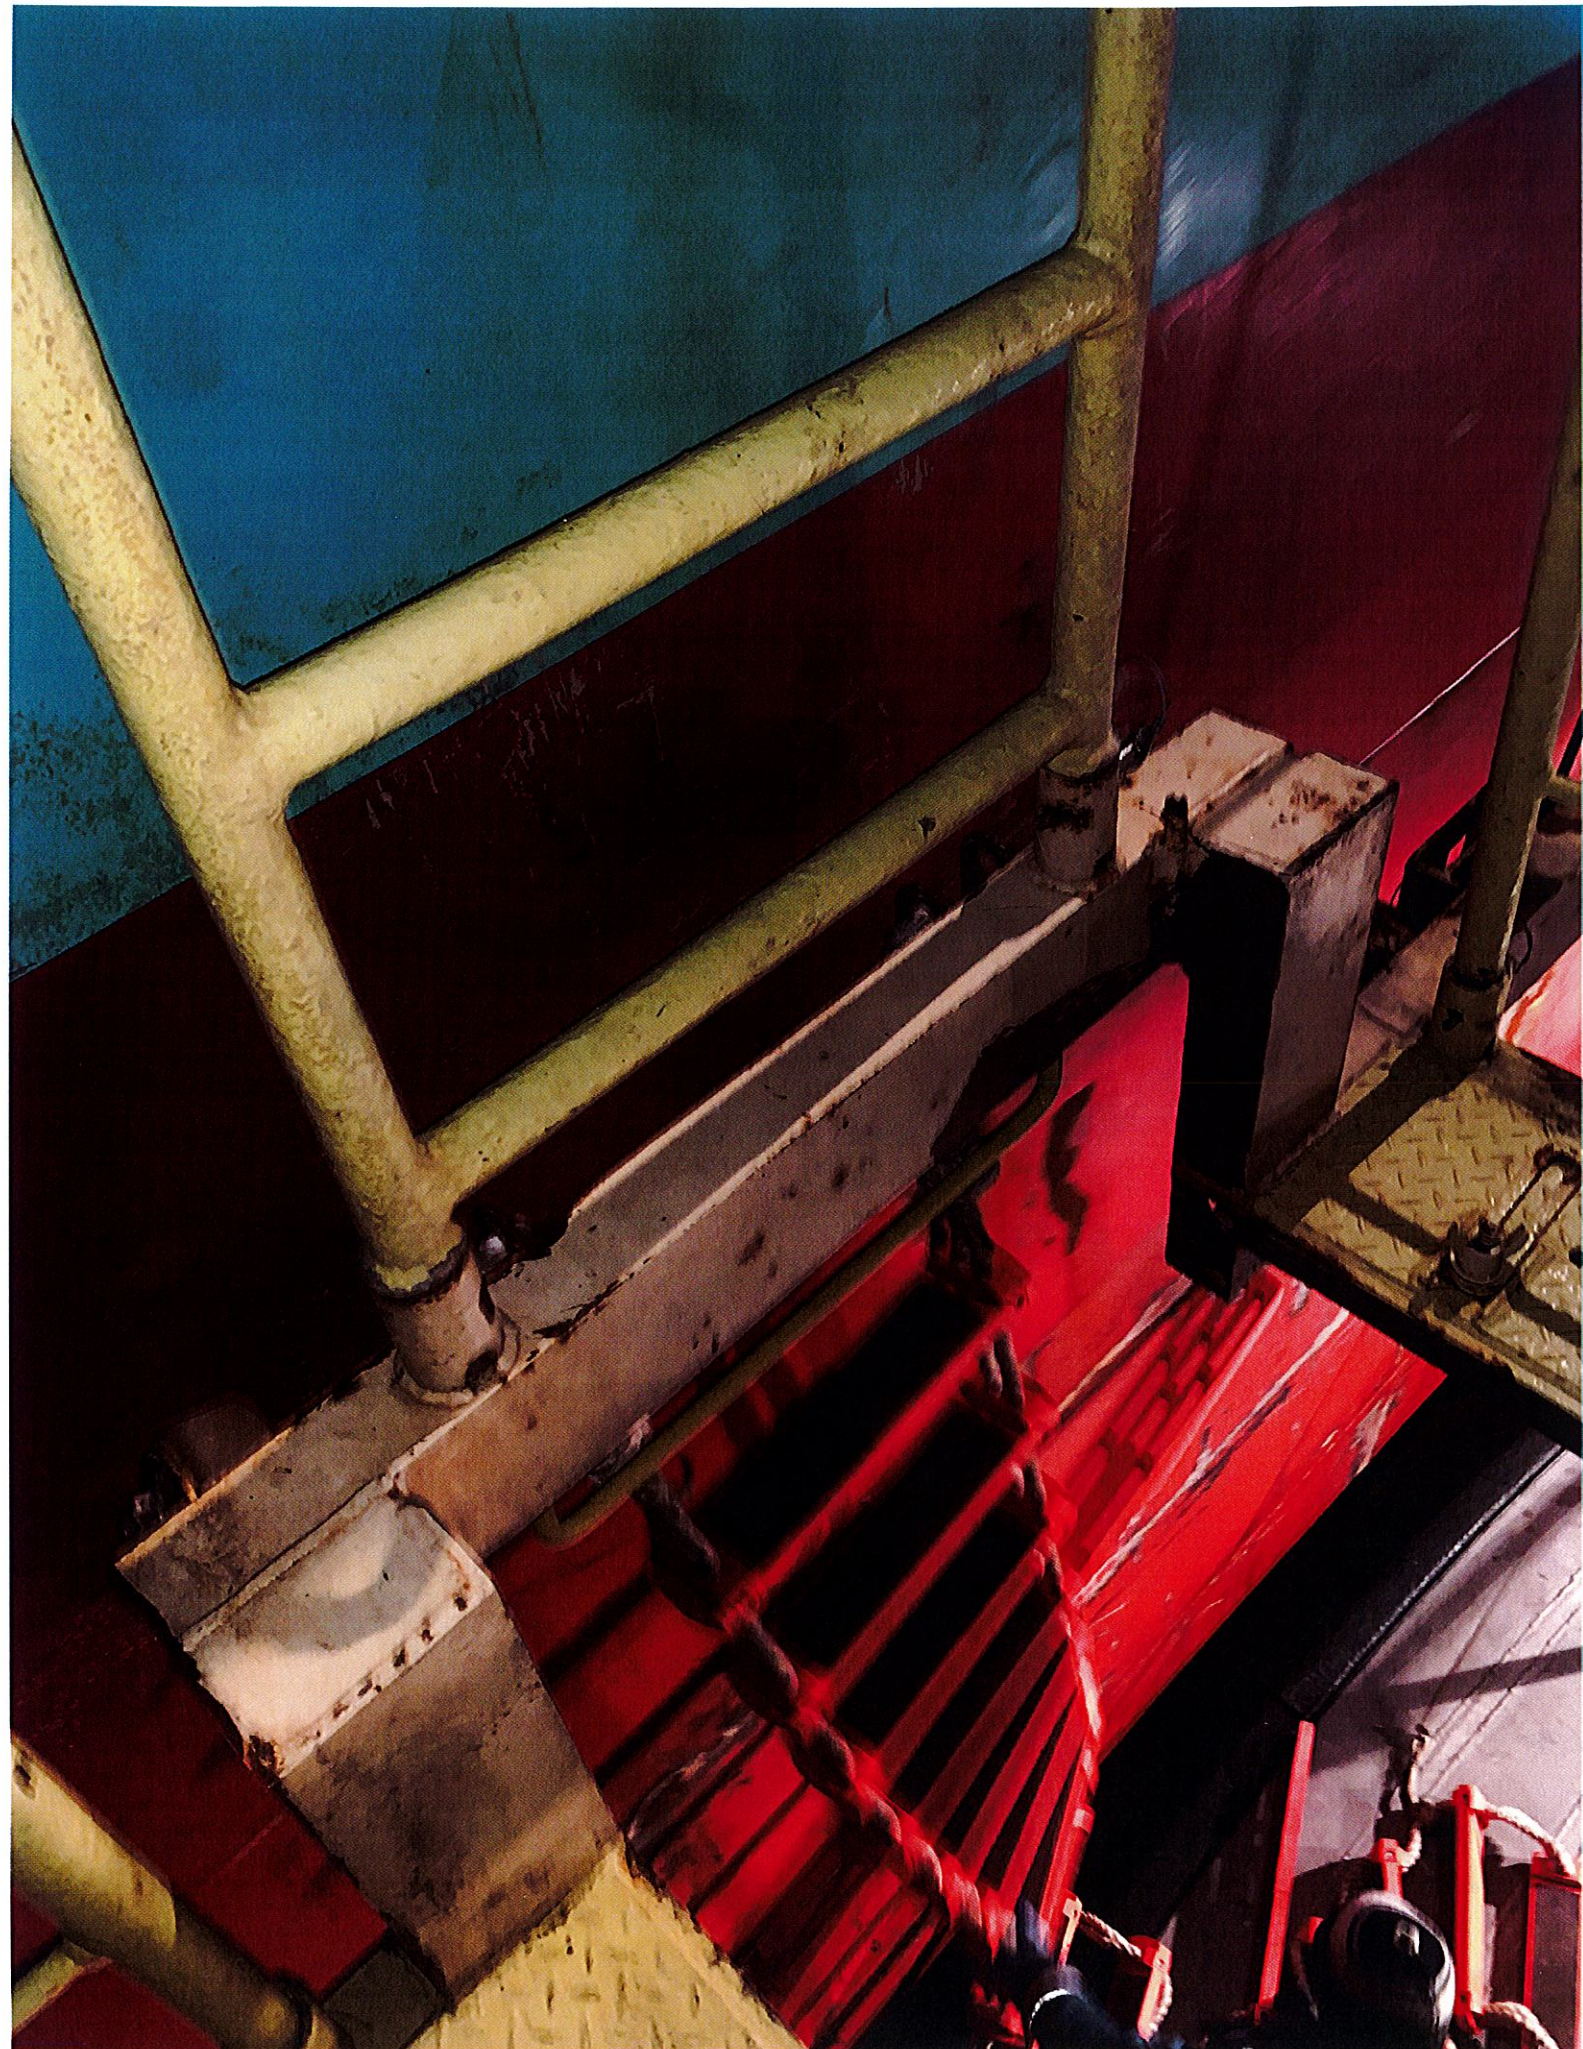
Ladder not resting on hull. Ladder fixed to underside of rail. Not to "height of handrail"

Ladder not rigged "through the trap door." Ladder fixed to underside of lower rail and not to "height of handrail." Ladder not flat against hull.

Difficult to transition from platform to ladder as first step is lower than platform and inboard of door

Gangway not fixed to hull. Possible wrong type of ladder for this type of configuration.
