PILOT BOARDING DEFICIENCY REPORT

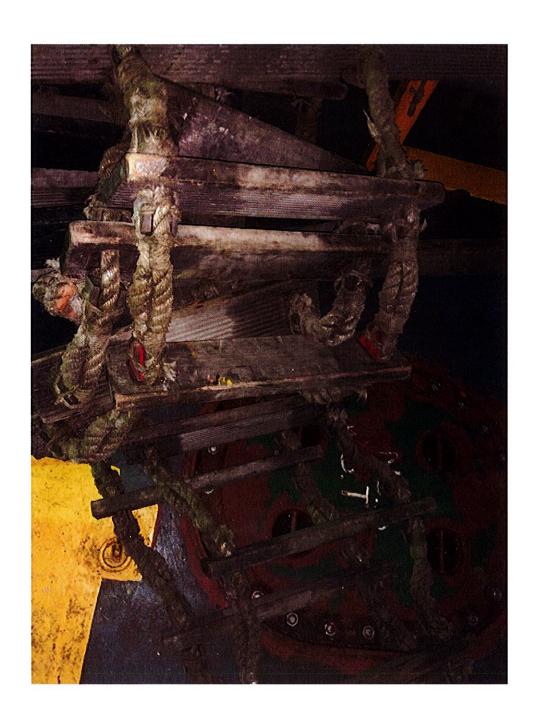
DATE:	2/17/2020 _{TIME:} 1430	
VESSEL: NY Trader 2		
MASTER:		
PILOT:	Andrew Parkis	
CONDITIONS: Clear/Calm		a a constant of the constant o
APPLICABLE LADDER ARRANGEMENTS (check all that apply):		
	PILOT LADDER ONLY COMBINATION LADDER SIDE PORT OTHER	
DEFICIENCIES (check all that apply and provide brief comment)		
	GENERAL ARRANGEMENT (ie: Insufficient lighting, no of	ficer, unsafe deck access, etc.)
		an and a second an
	■ PILOT LADDER (ie: Poor condition/wear, not resting on hull, poor rigging, etc.)	
	Poor Condition, Climb exceeded 9m	
	COMBINATION LADDER (ie: Poor condition/wear, not se	cured, platform too low, etc.)
	MAN ROPES (ie: Poor condition/wear, incorrect diameter	er, poor rigging, etc.)
_		
	□ DOCKSIDE (ie: Gangway condition/pitch, netting, poor rigging, etc.)	
ADDITIONAL REMARKS: Ladder needs to be replaced before next boarding		
Signatu	re:	A.J. PARKETS
	MASTER (if available)	PILOT
