PILOT BOARDING DEFICIENCY REPORT

DATE: 5/5/2020 TIME: 1430

VESSEL: Palena

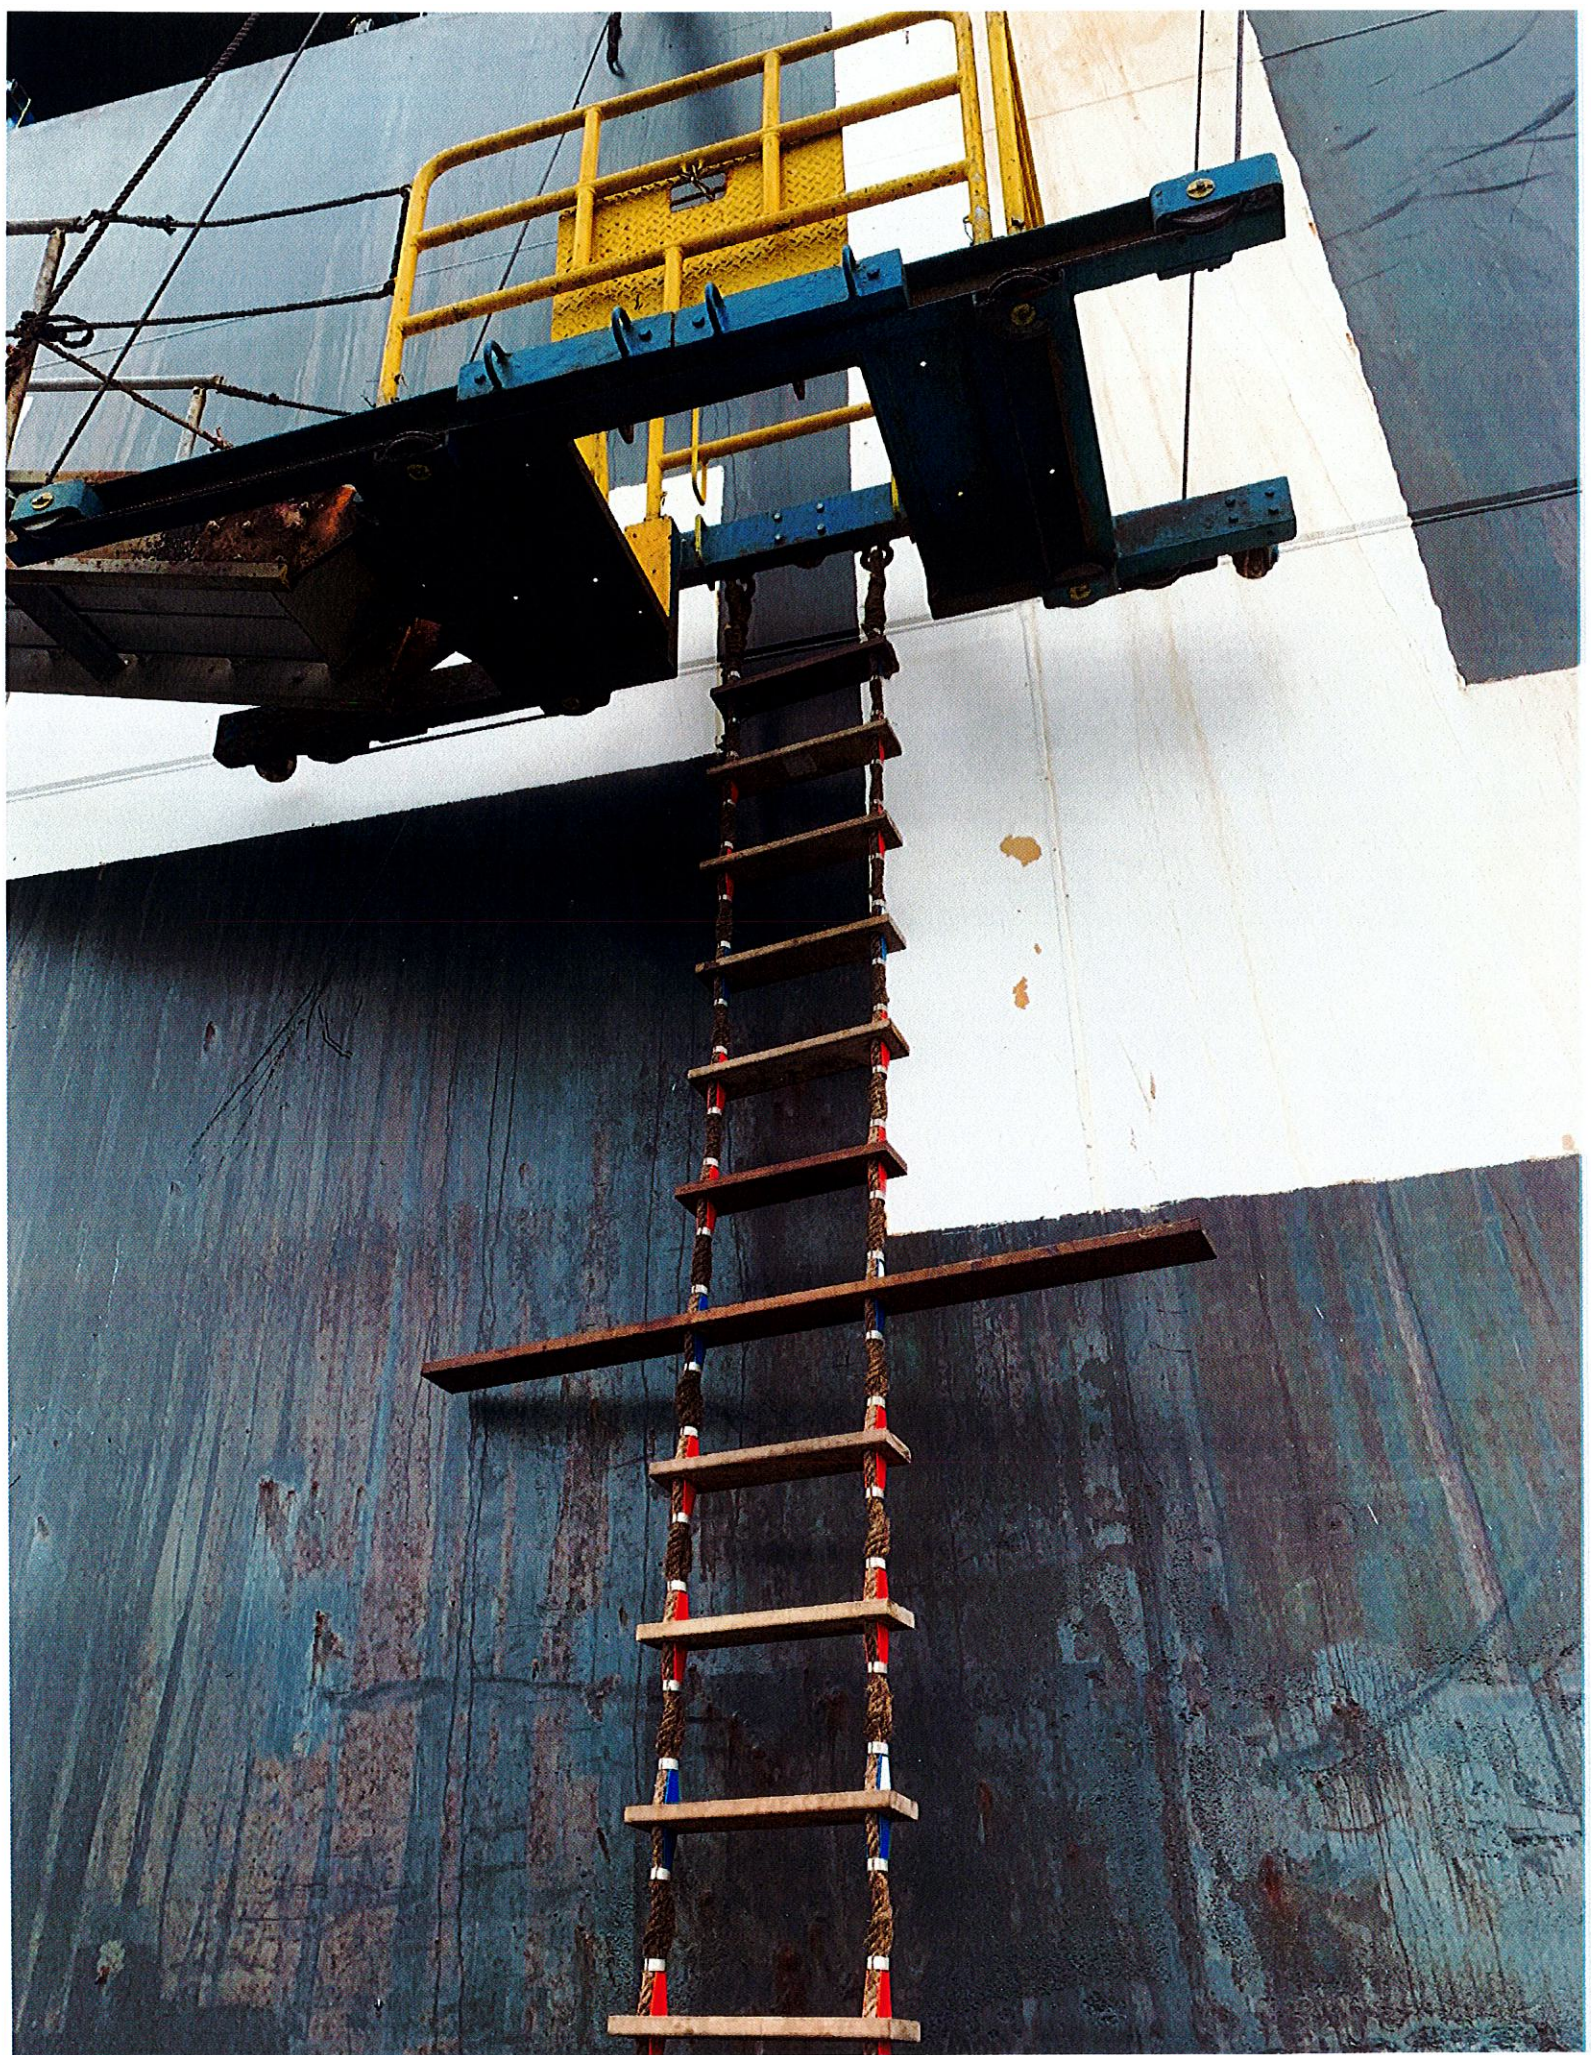
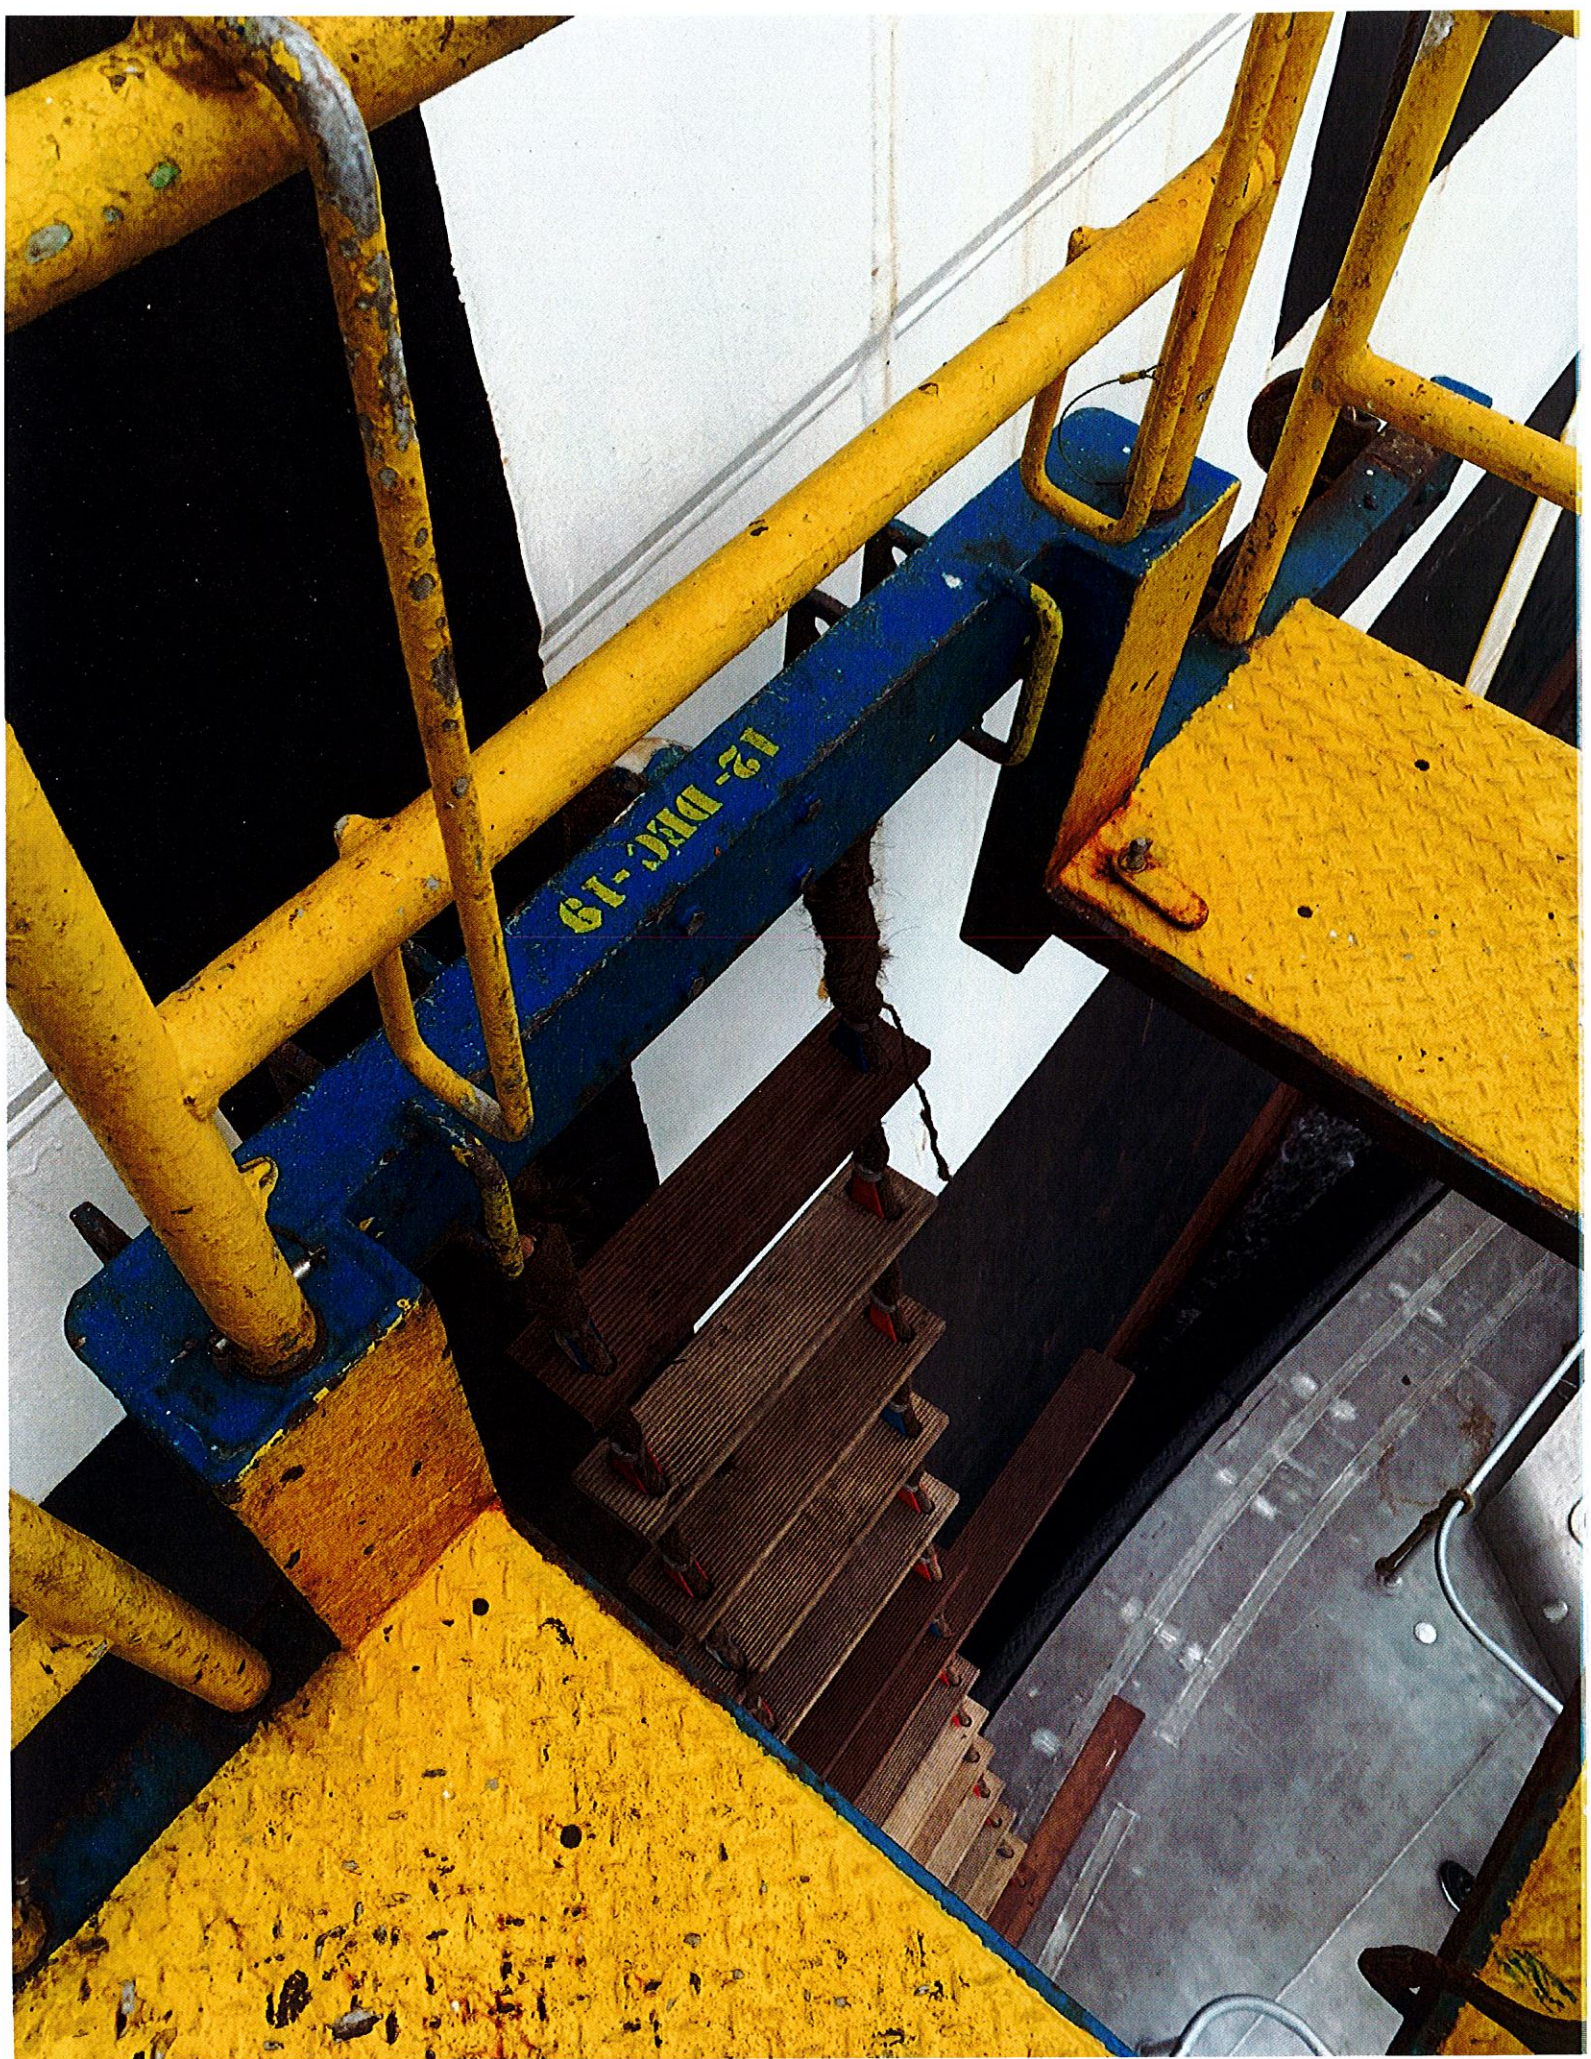
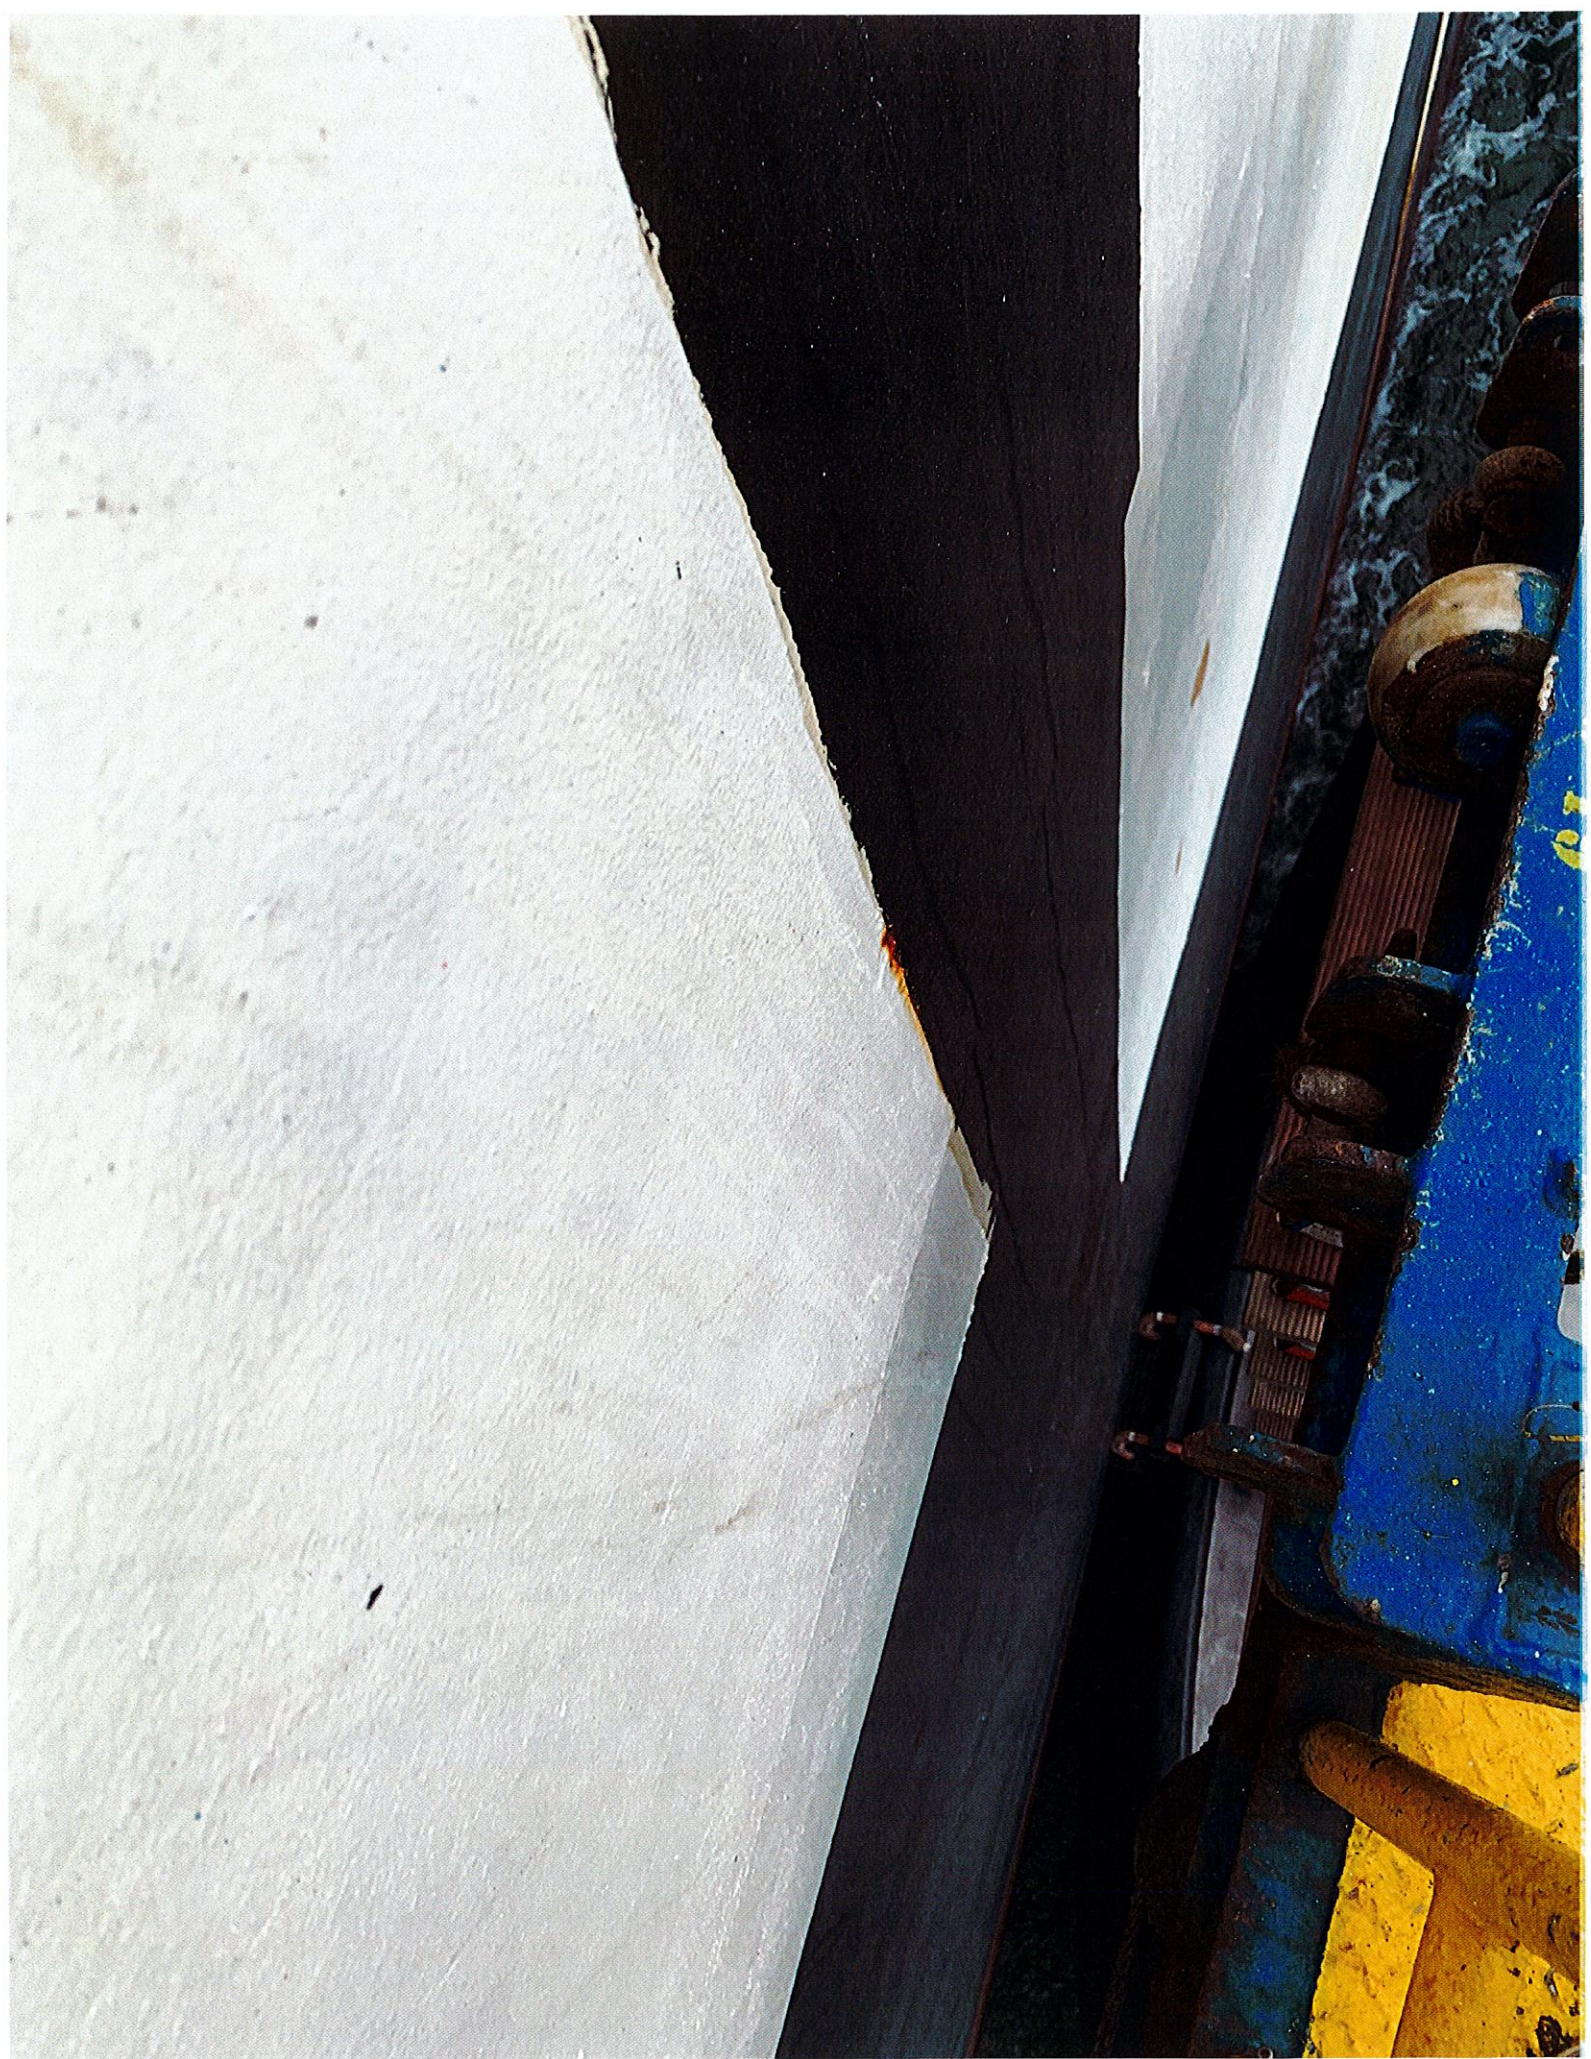
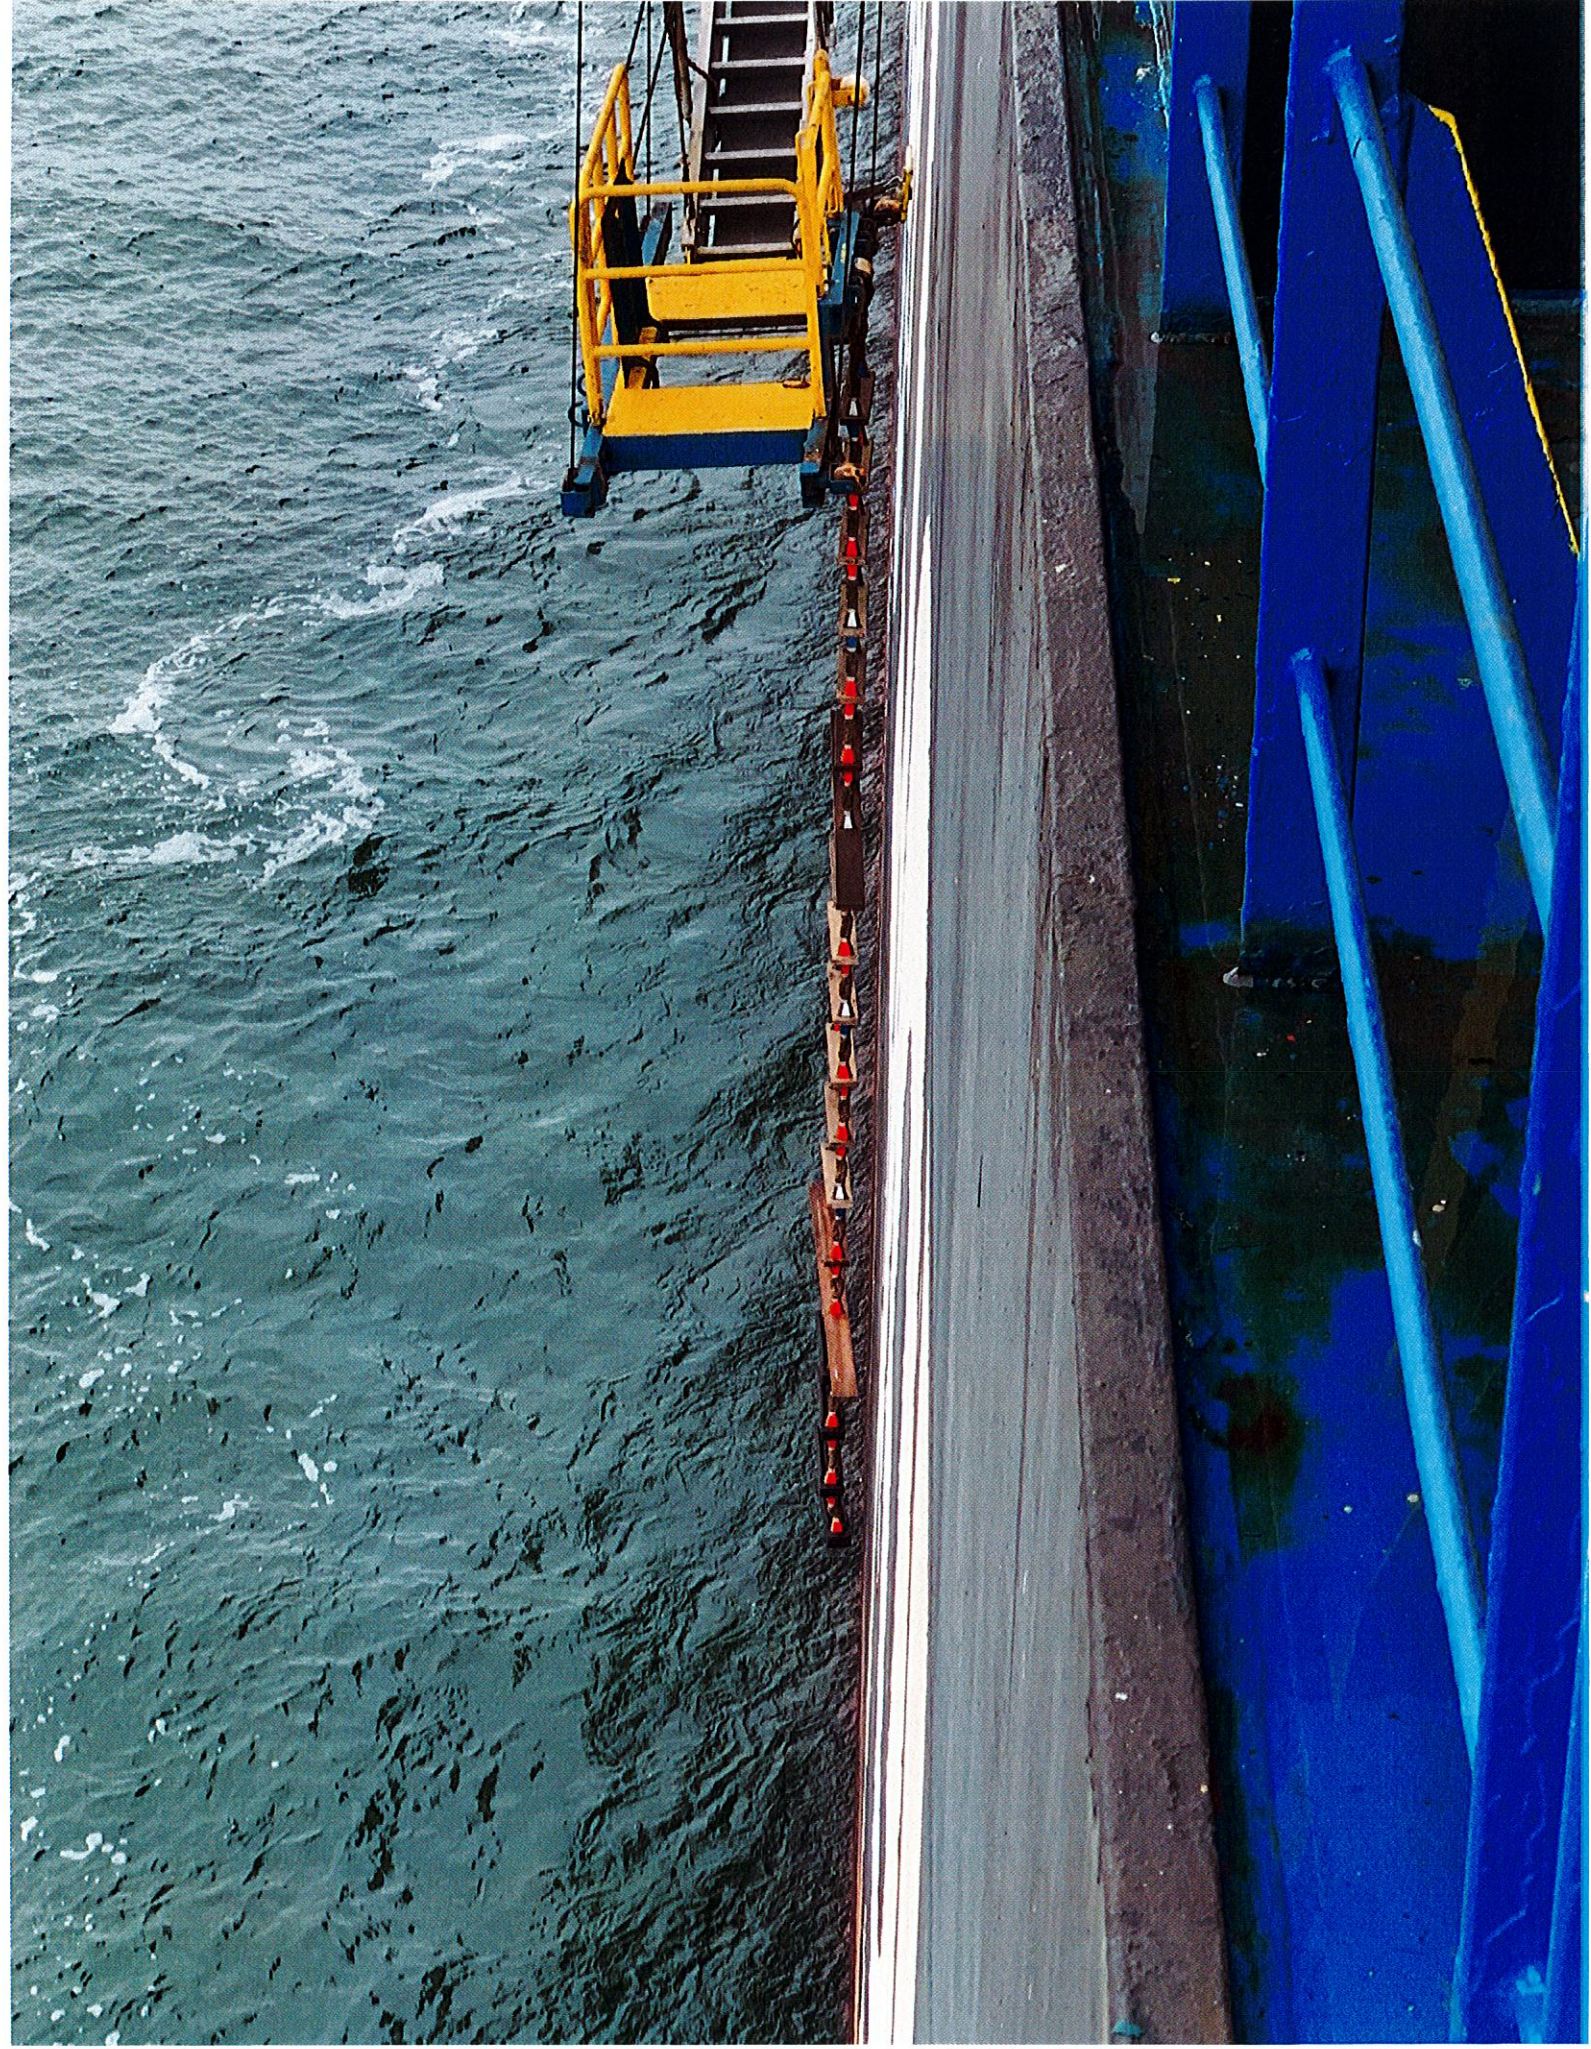
Ladder not resting on hull. Ladder fixed to underside of rail. Not to "height of handrail"

Ship constructed in 2006. Ladder not rigged "through the trap door" fixed to underside of lower rail and not to "height of handrail" ladder not flat

Against hull. Capt. stated he already notified company. Not scheduled for dry dock until Dec 2021
