# PILOT BOARDING DEFICIENCY REPORT

DATE: 6/18/2020 TIME: 0900

VESSEL: Star River

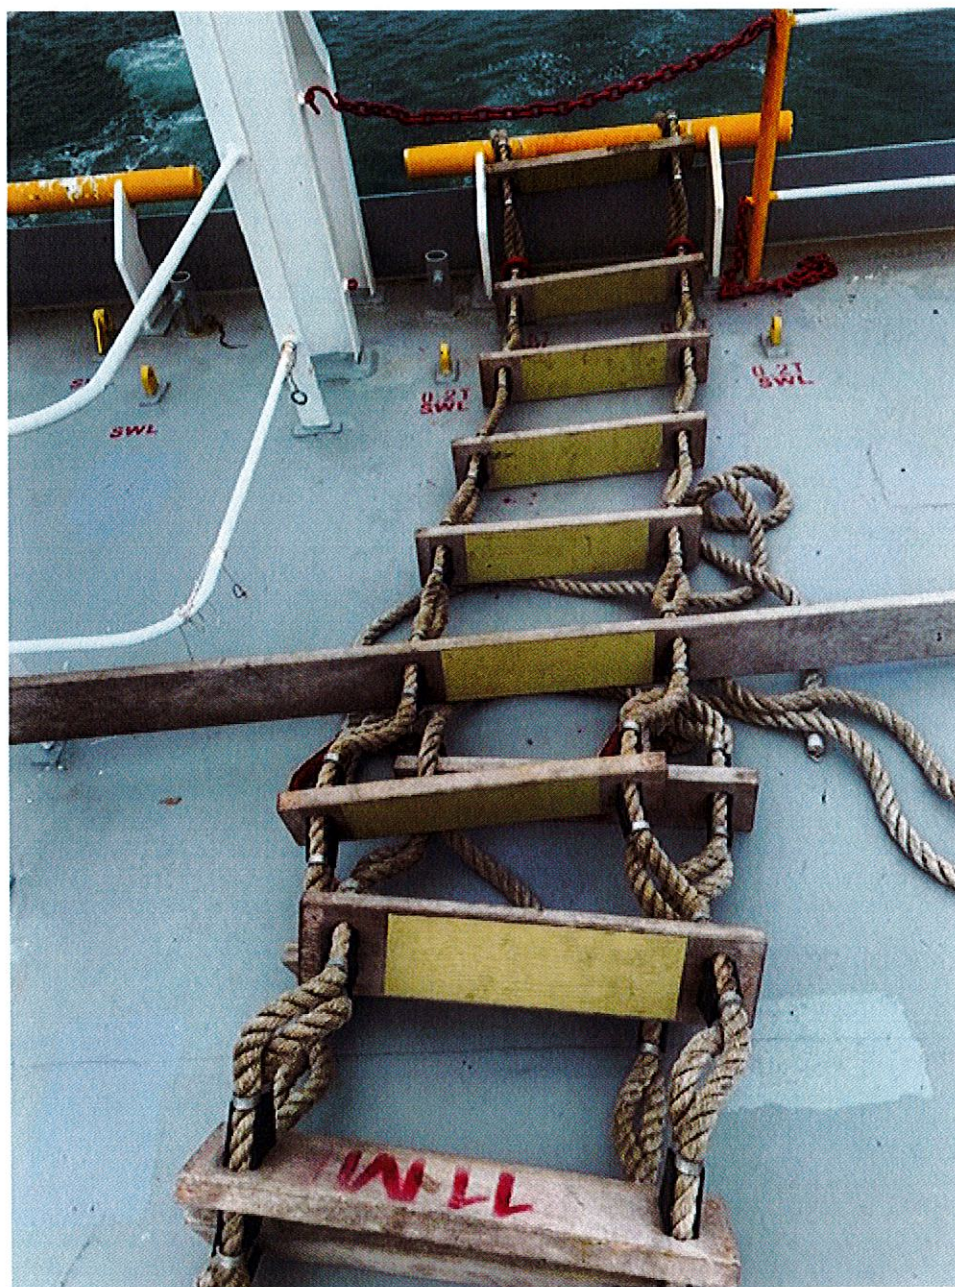
Both Port/Stbd ladders appear to have yellow paint on each step.

Each step on both side ladders have yellow paint on them. Non-compliance according to ISO 799-1

Capt said manufacturers painted them. See photos and Ladder certificates.
