PILOT BOARDING DEFICIENCY REPORT

DATE: 3/28/2020 TIME: 0345

VESSEL: Wide Bravo

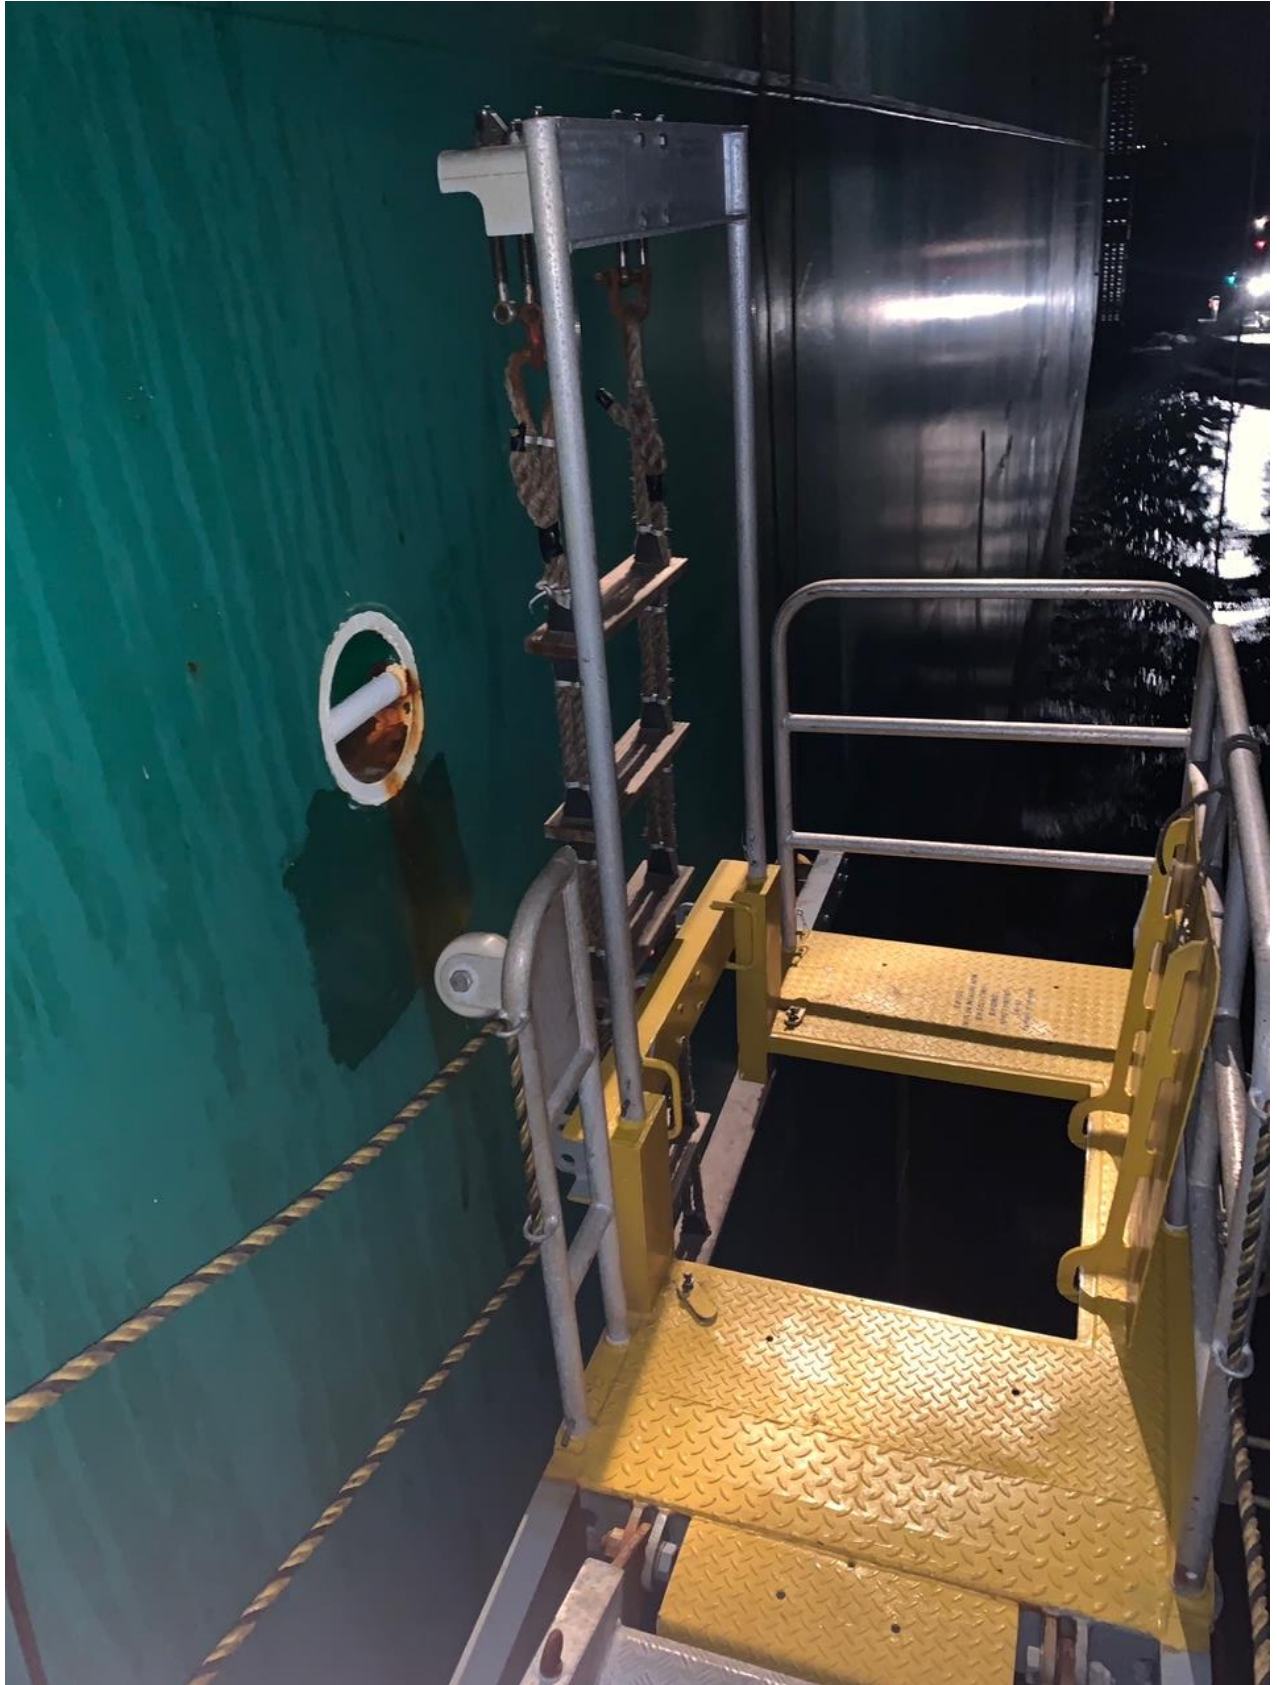
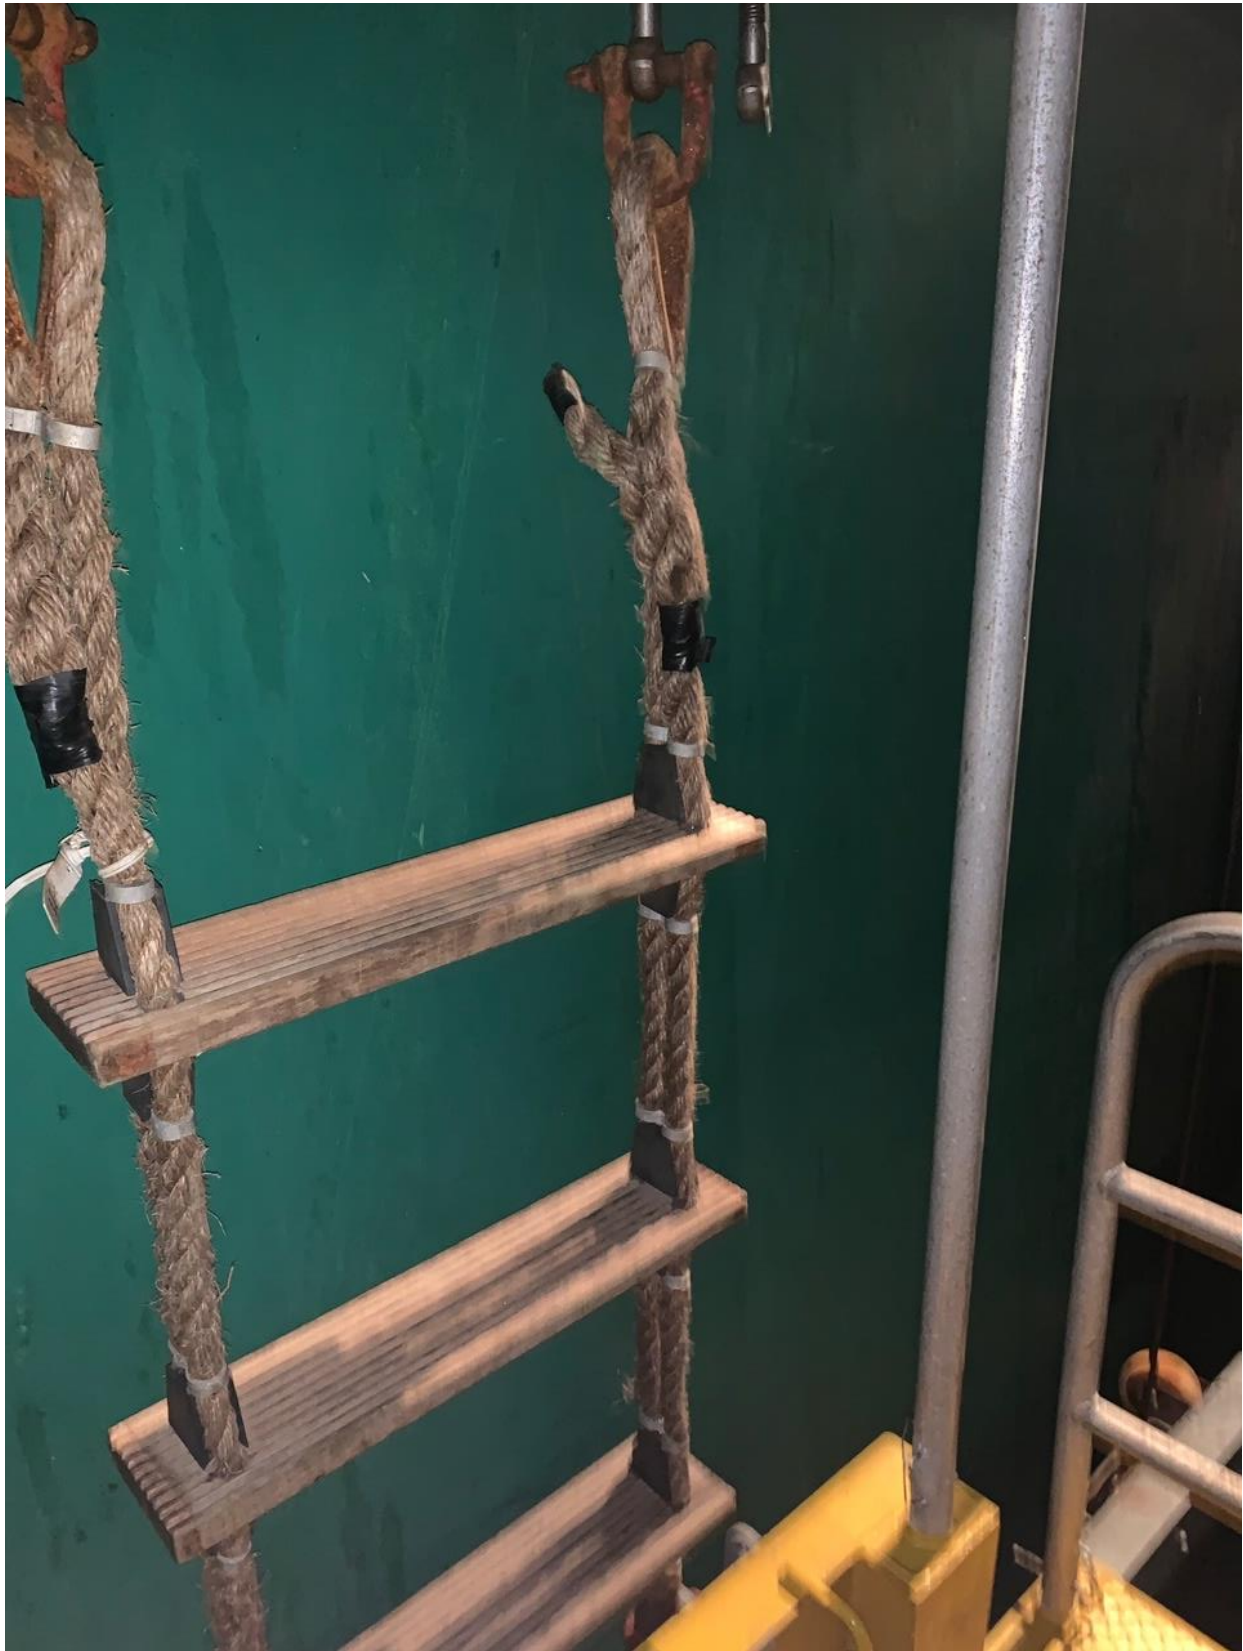
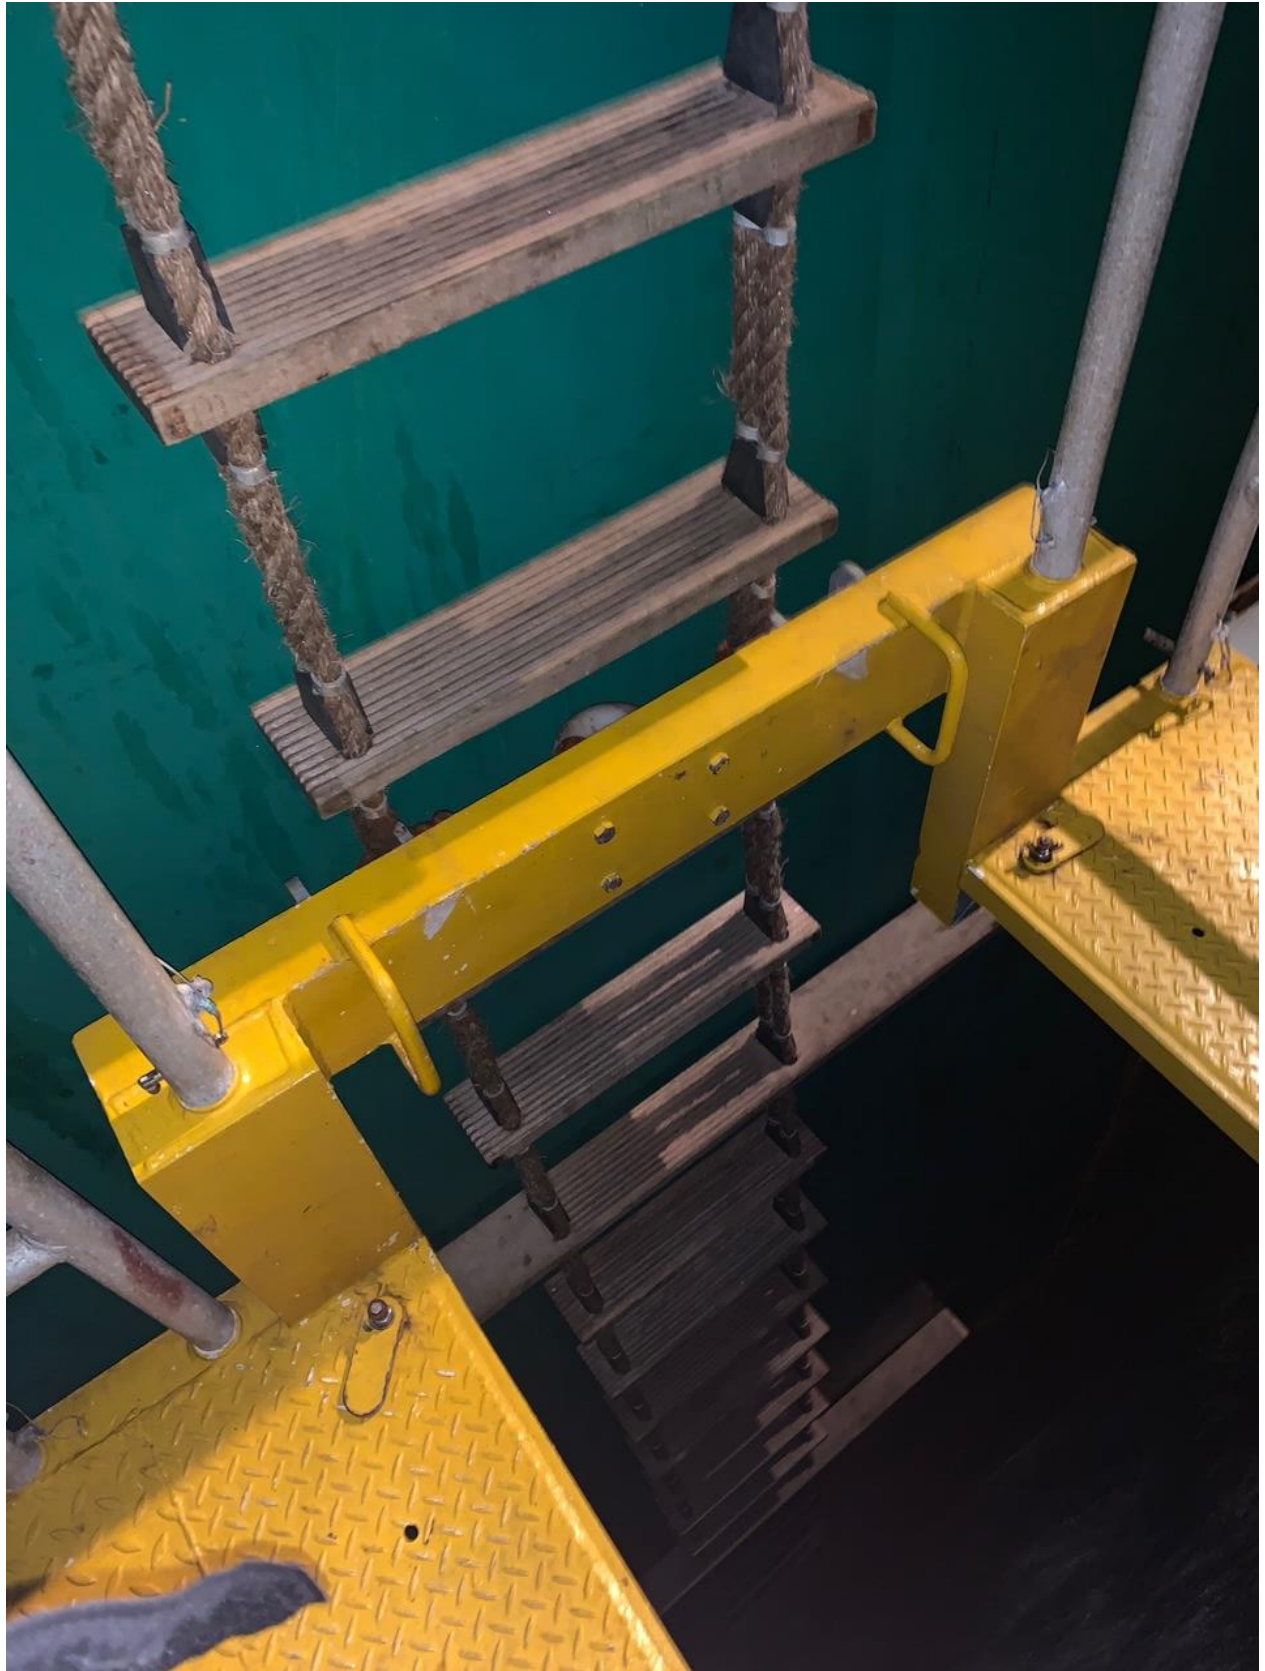
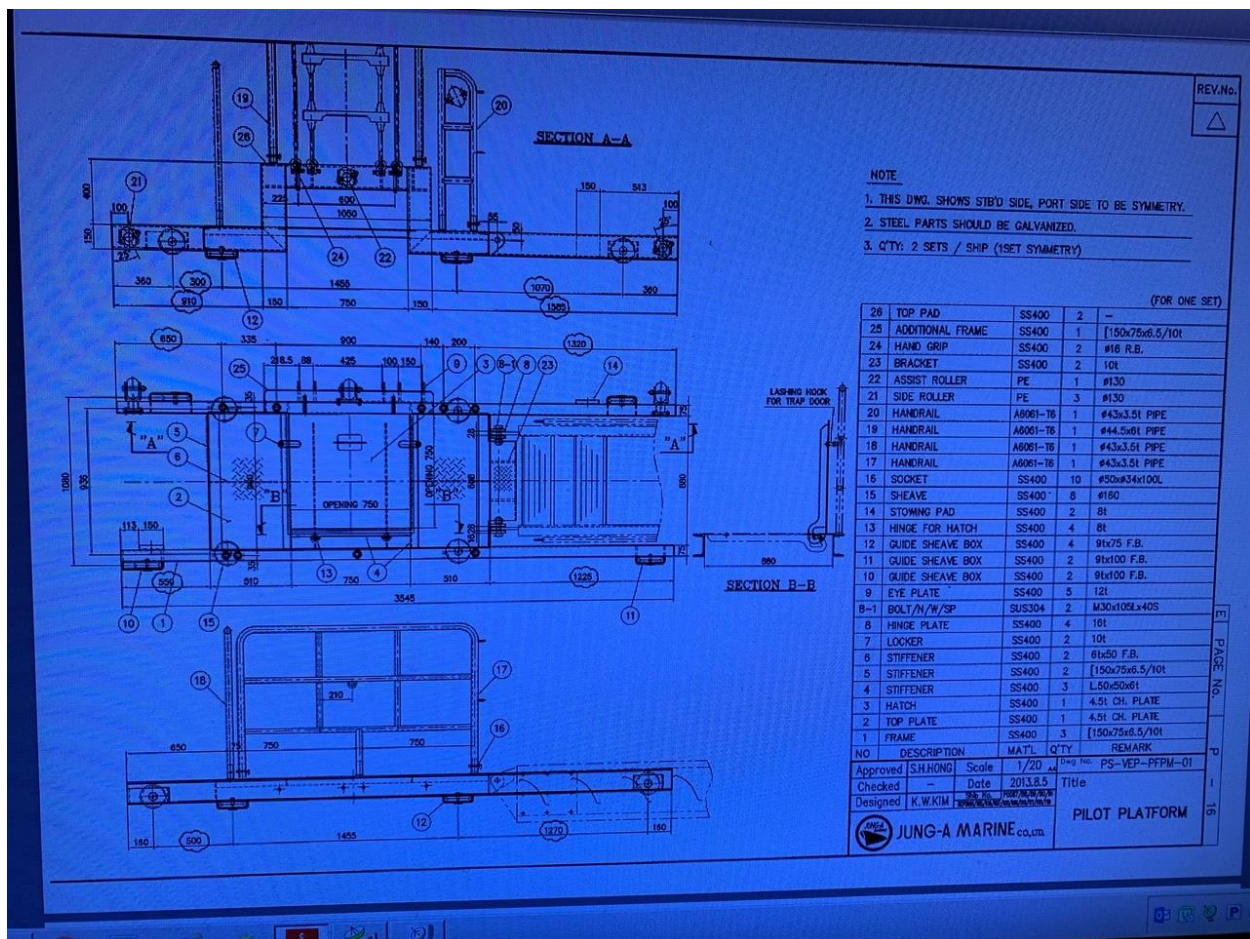
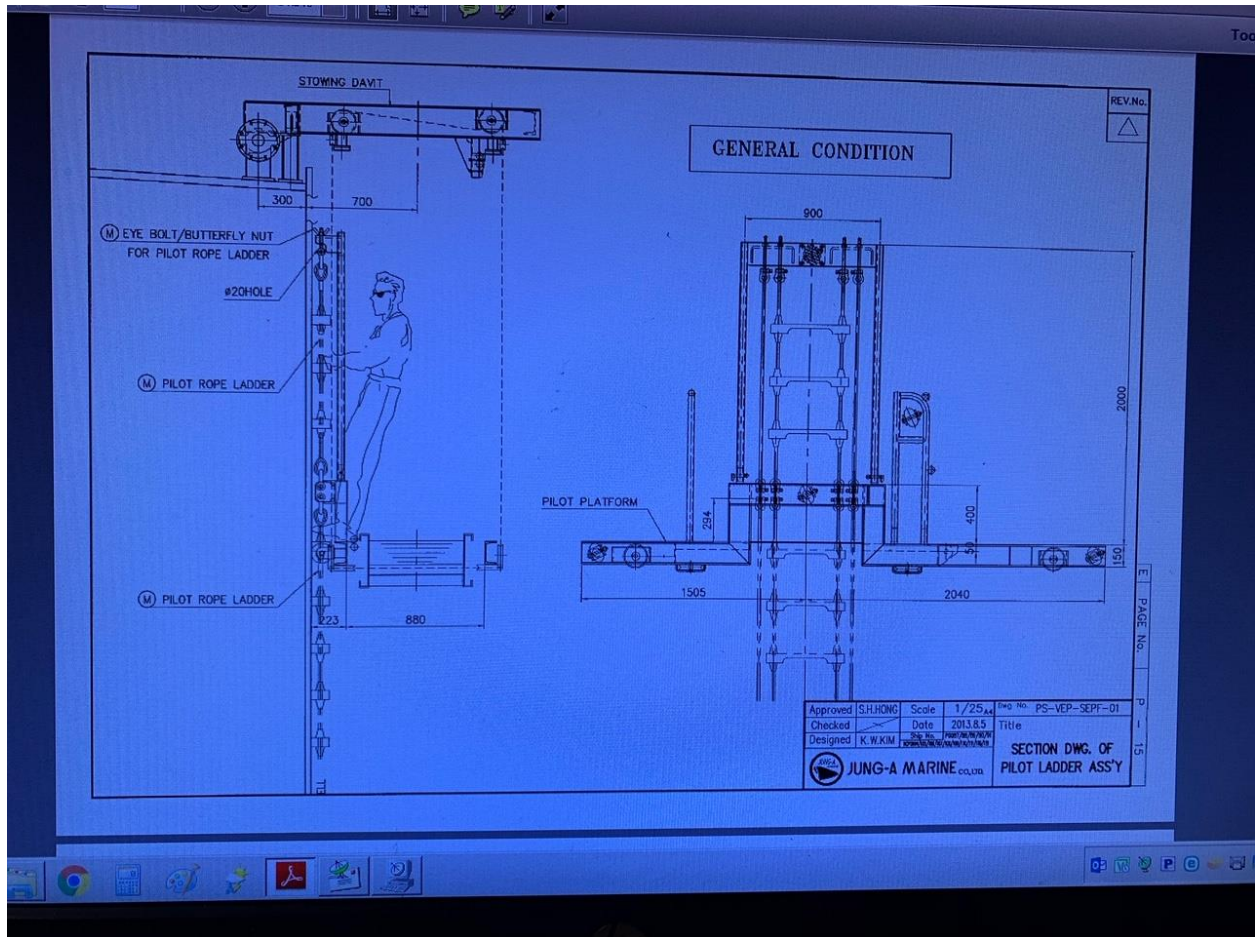
Ladder not resting on hull. Ladder not "rigged through" trap door.

Ship constructed in 2014. Climb on ladder is obstructed by yellow bar where the ladder runs behind therefore the ladder is not

"Rigged through" the trap door. Refused to use. Ship unable to rig any other combination config.
