PILOT BOARDING DEFICIENCY REPORT

DATE: 11/8/2020 TIME: 1900

VESSEL: Agios Dimitrios

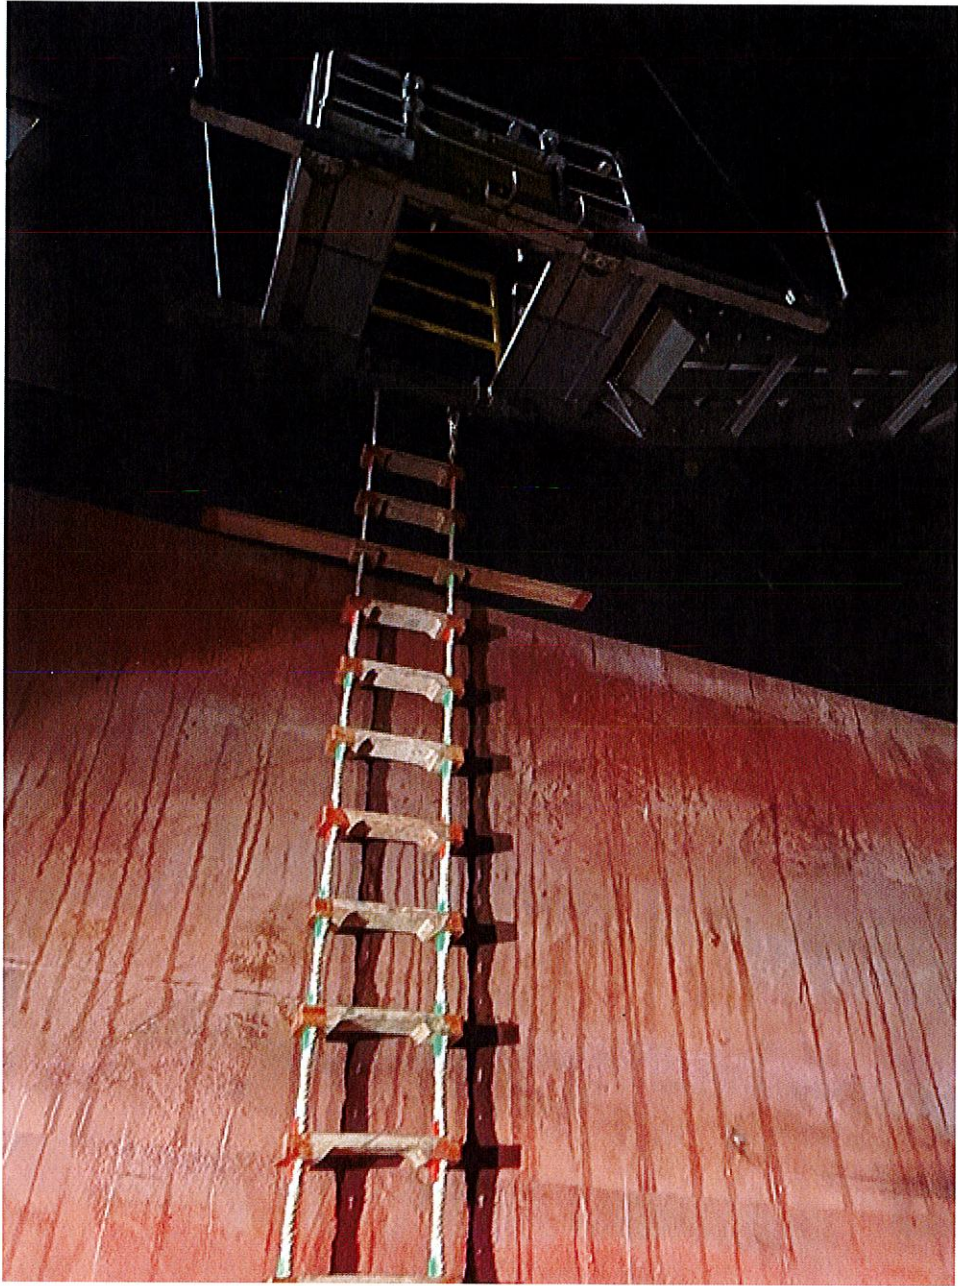
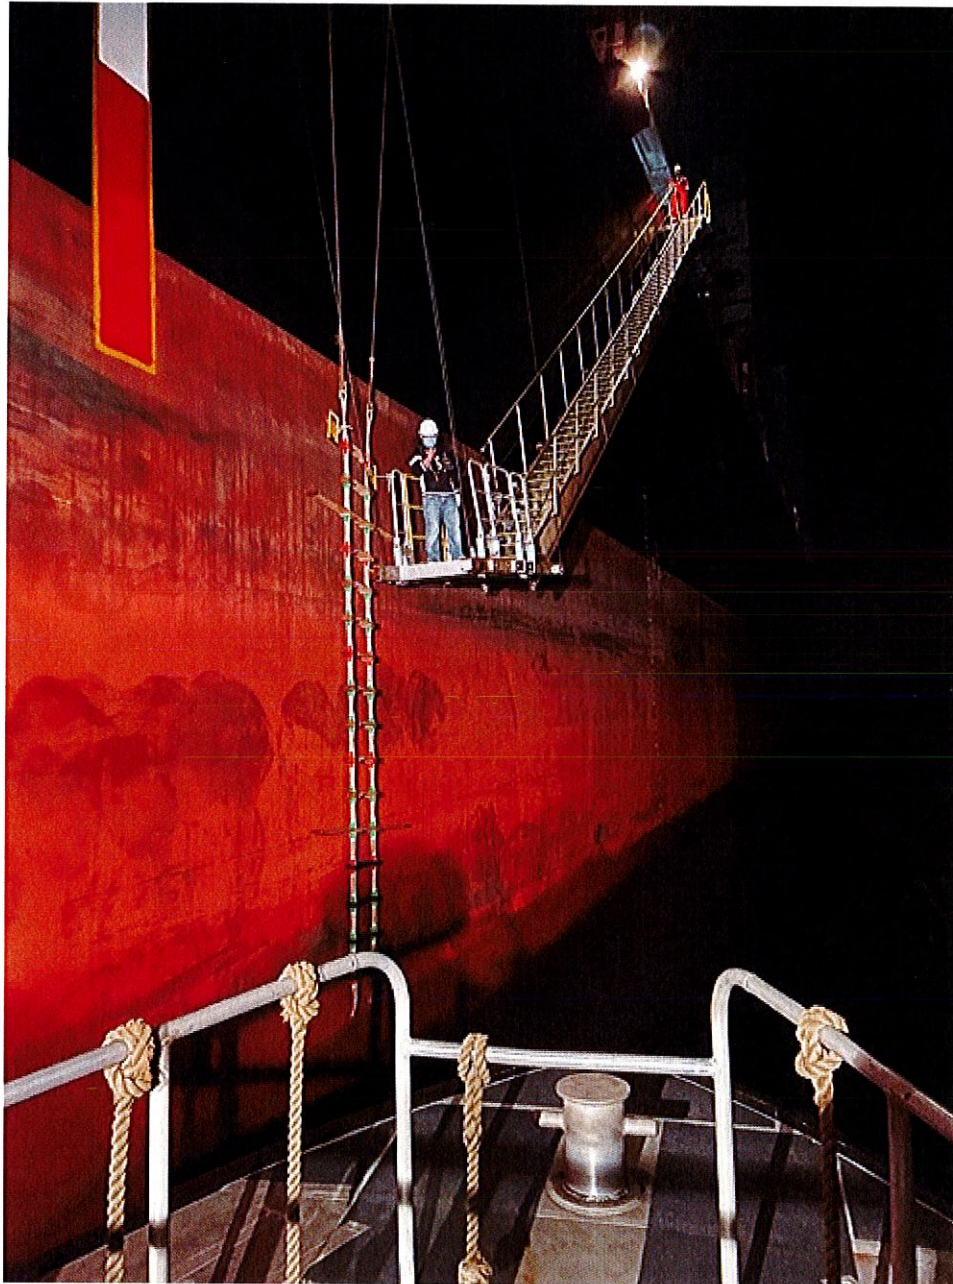
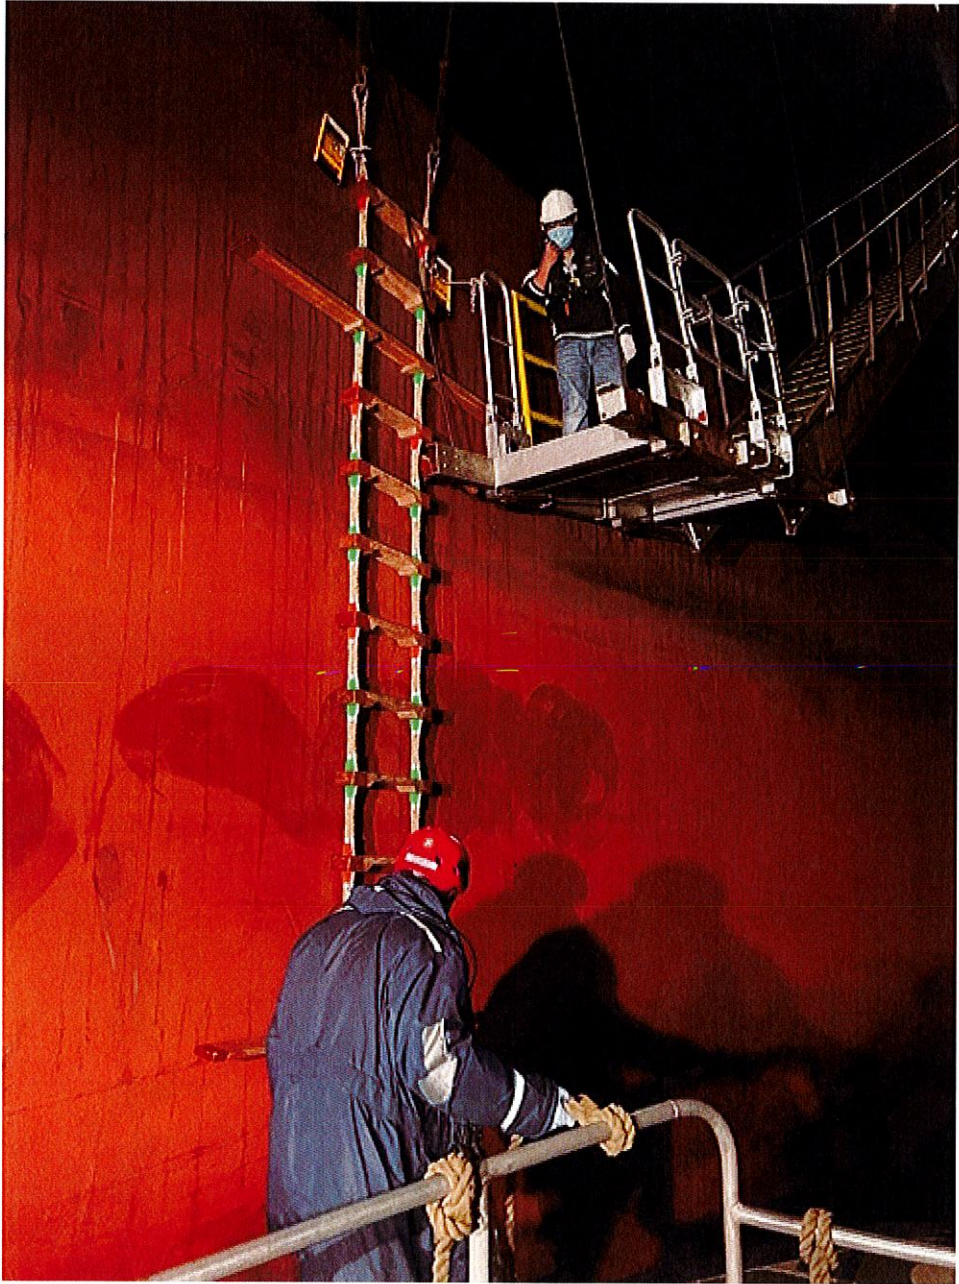
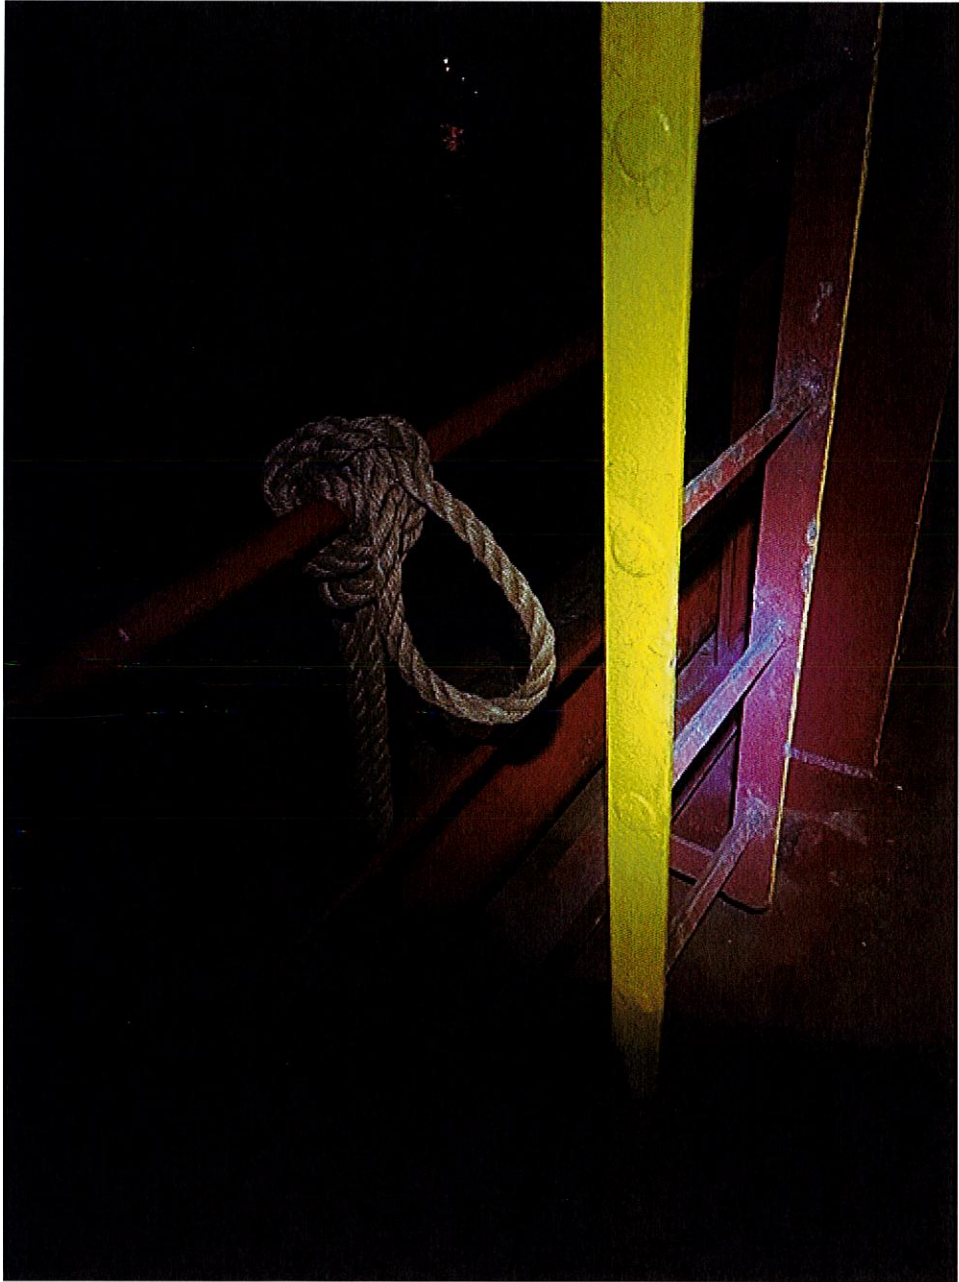
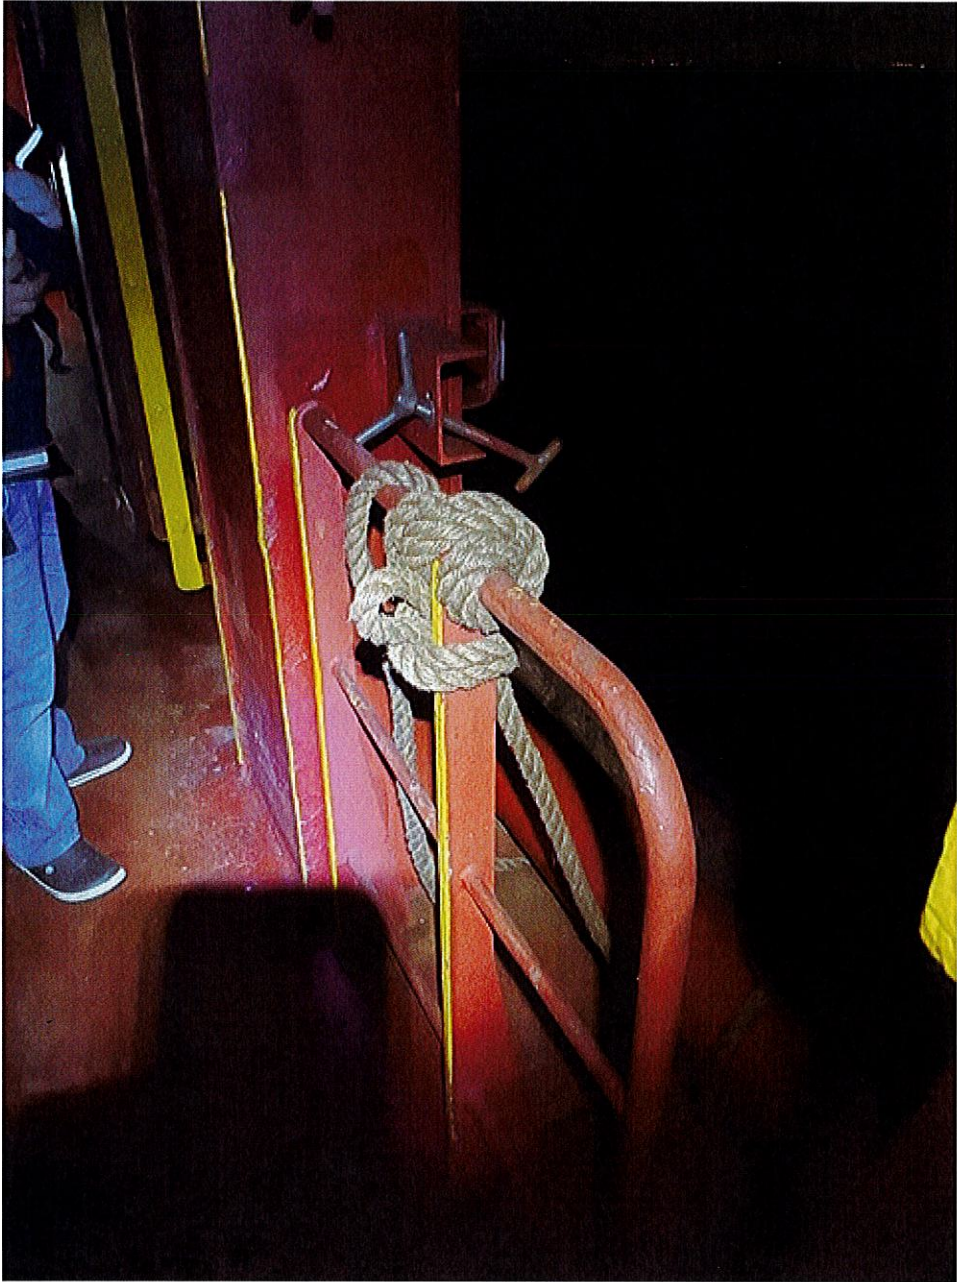
After reconfigured, ladder was secured on main deck to railing, large step from ladder to g'way

Trap door configuration not compliant to current standards.

Ladder not passing through trap door. Ladder not secured to height of handrail. Ladder not resting

Against hull. Ladder and g'way not secured to hull. Denied boarding. Crew reconfigured to

"Traditional" combo. Gap from ladder to g'way was large. Ladder secured to ship handrail.
