# PILOT BOARDING DEFICIENCY REPORT

DATE: 9/12/2020 TIME: 1400

VESSEL: MOL Emissary

PILOT: M. P. Haley

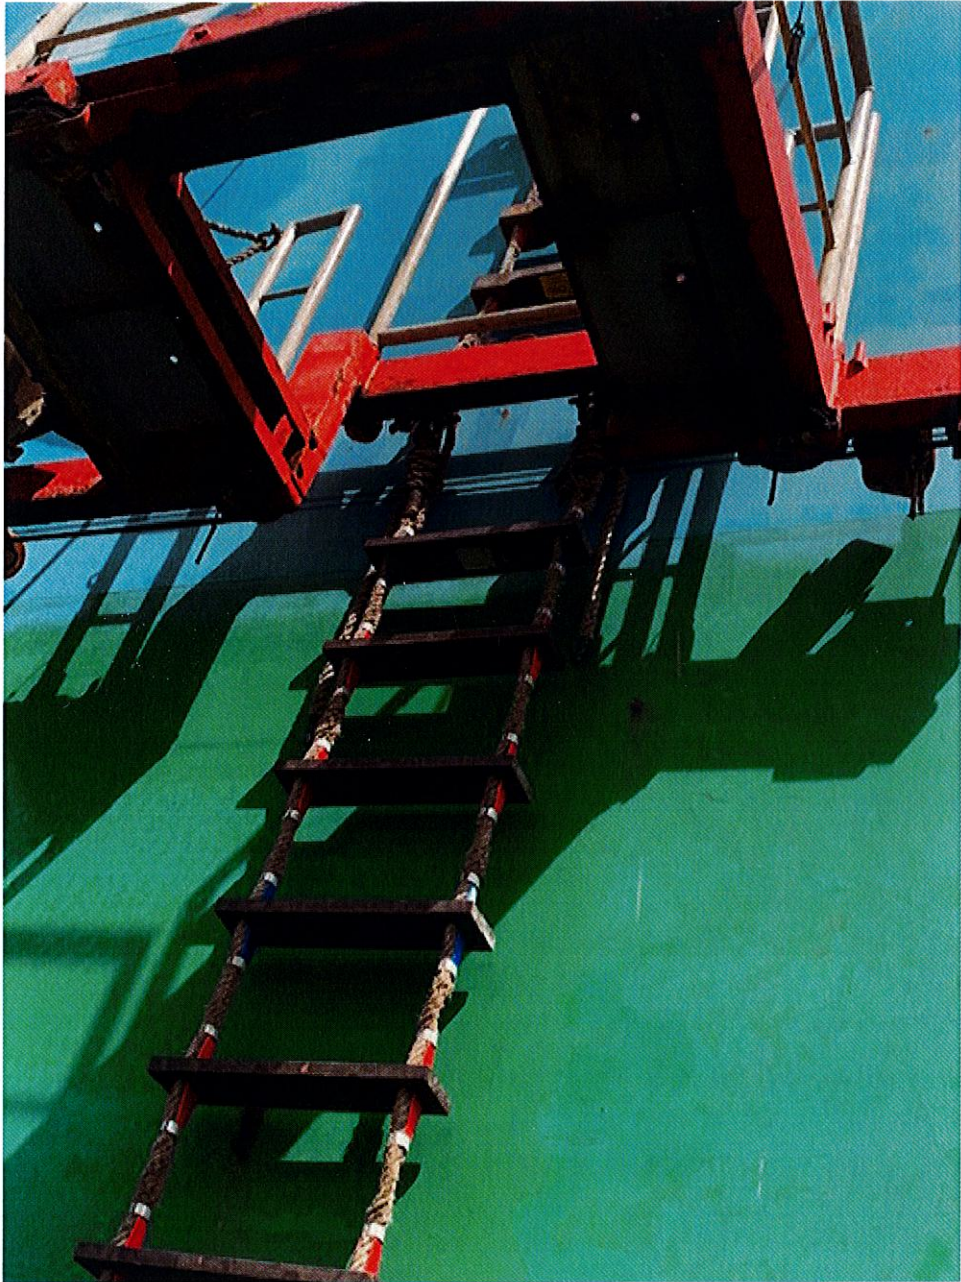
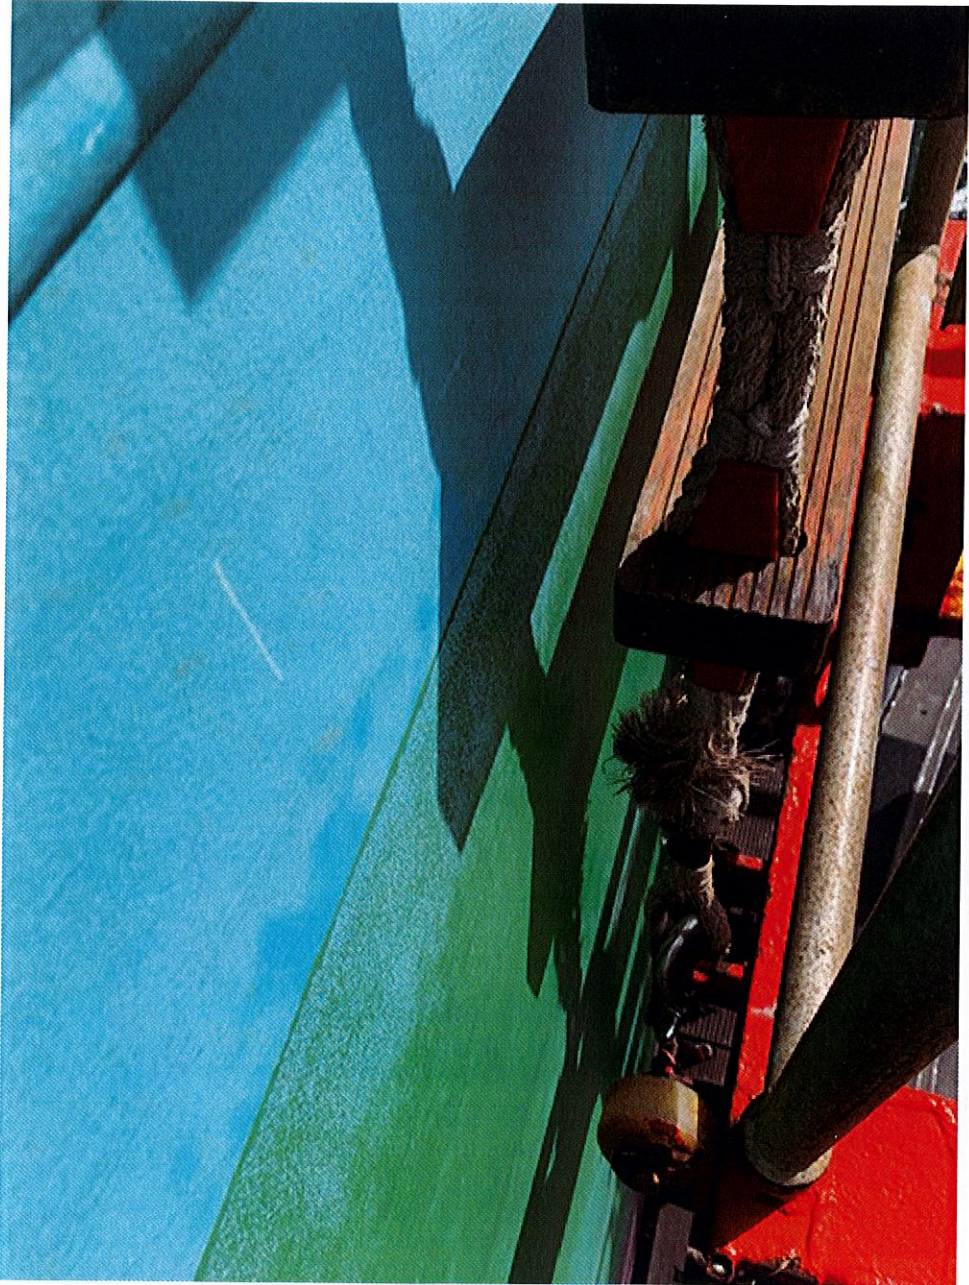
Non compliant Trap door configuration

Ladder not secured to height of handrail. Upper portion of ladder is a separate ladder. See pics.

Ladder not through the trapdoor. Gangway not secured to hull. This configuration is however better

Than some. Company has plans to reconfigure arrangement.

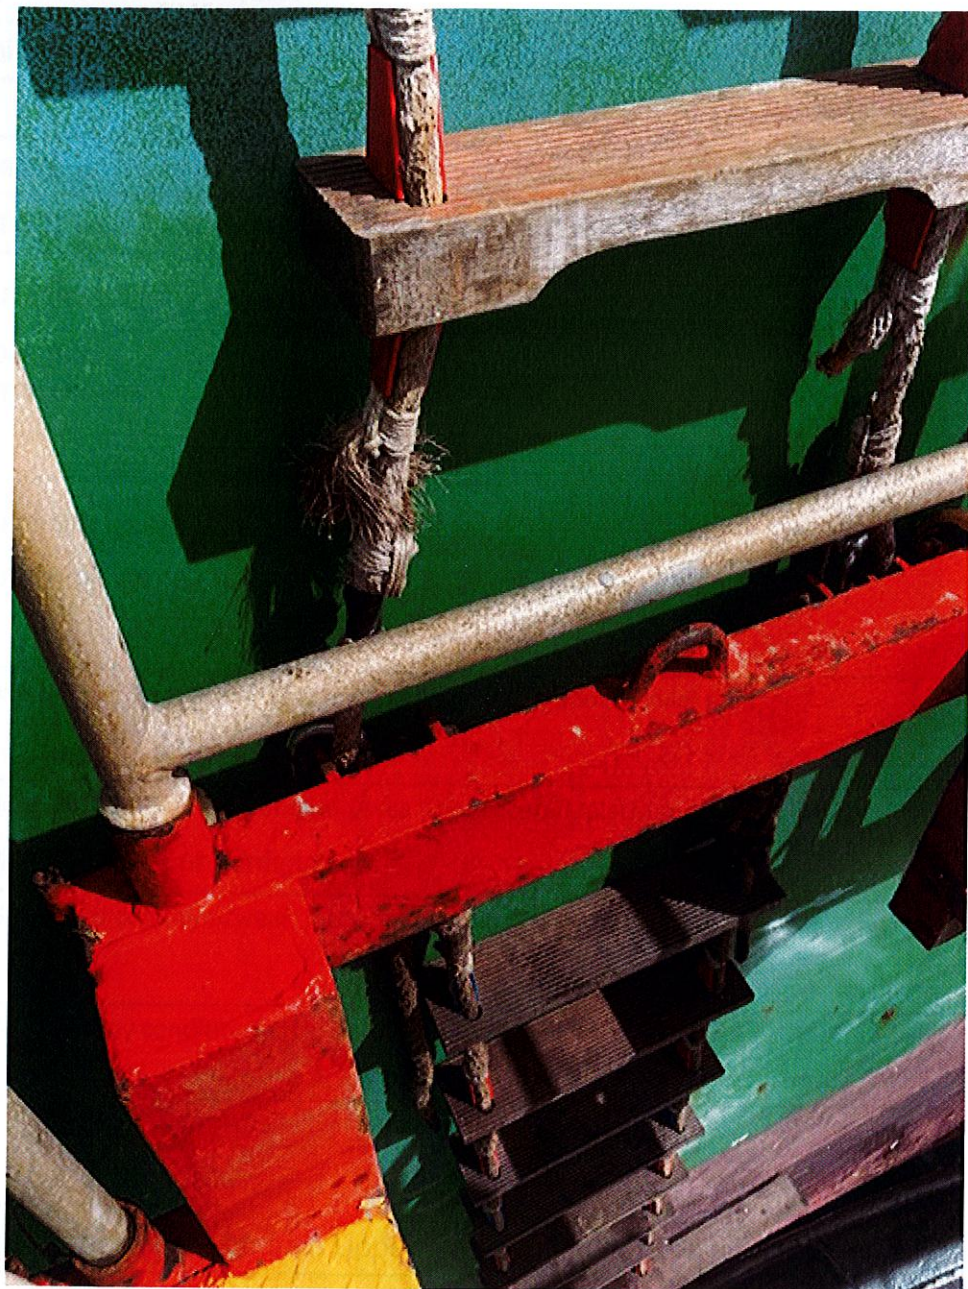
## PILOT BOARDING DECK READY REPAIR

All the Pilot Boarding Deck is secured to hull. This configuration is hazardous.
