PILOT BOARDING DEFICIENCY REPORT

DATE: 19 OCT 2020 TIME: 1800

VESSEL: Thelma Victory - Berth 14 Port Newark - Hudson Tank Terminal

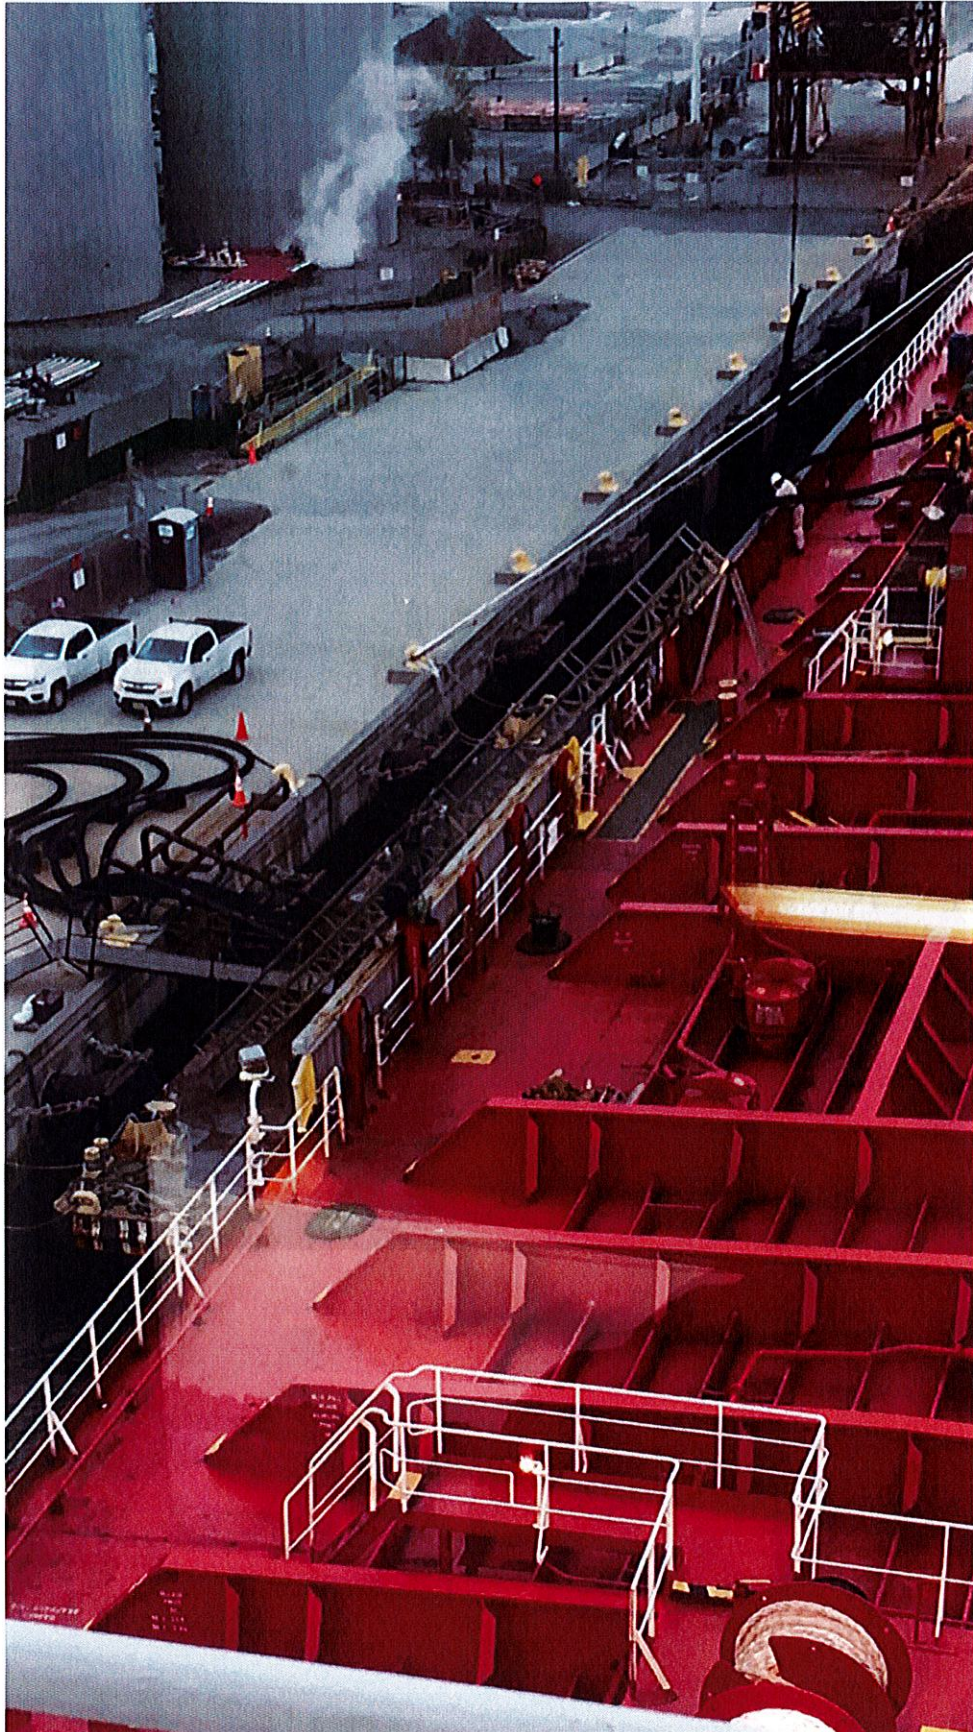
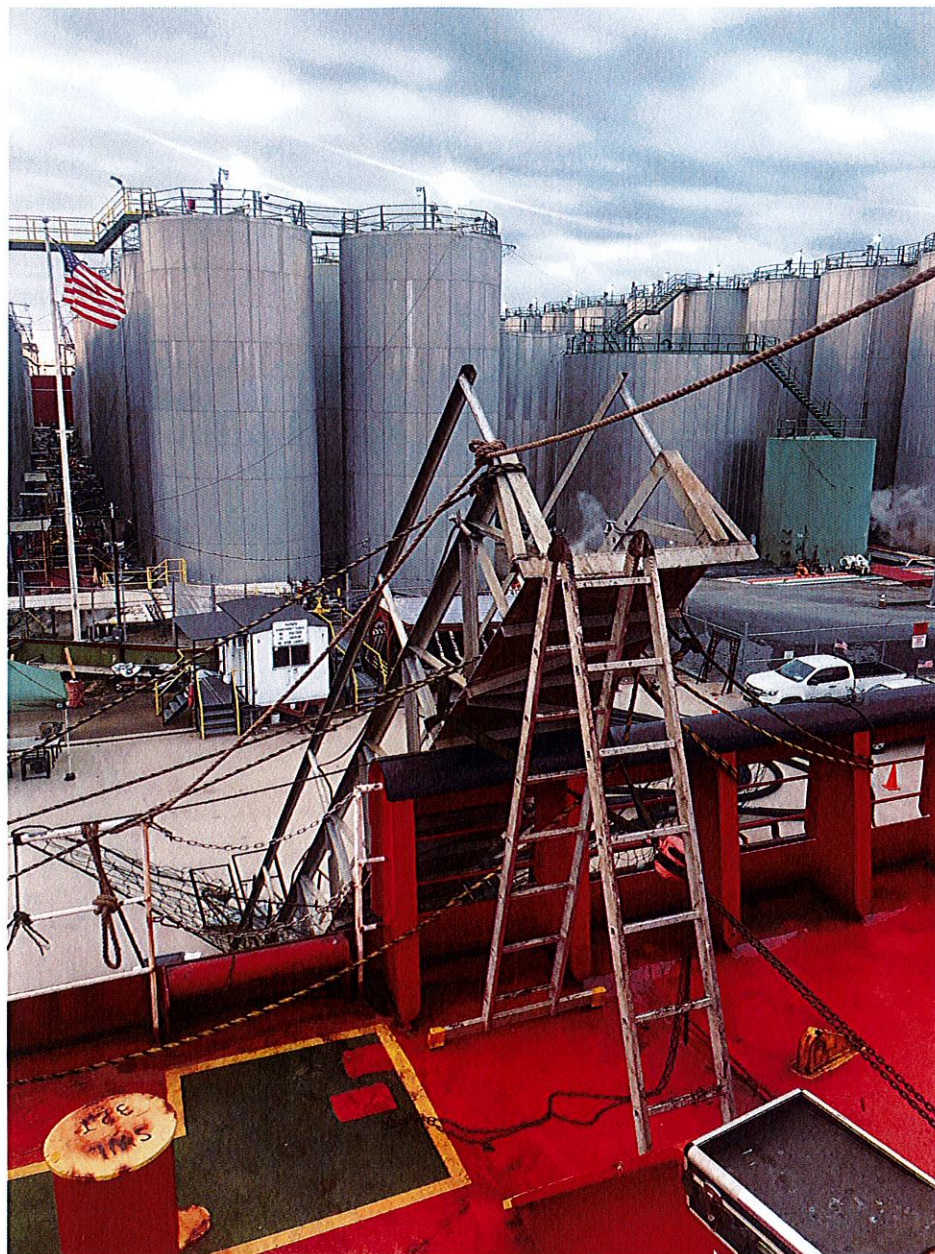
Gangway slippery with palm oil, excessive pitch, dangerous transition from gangway to aluminum ladder.

An AB was on deck to steady the ladder once I was off the gangway; top of gangway was approx. 8' above deck. Very dangerous.
