# PILOT BOARDING DEFICIENCY REPORT

DATE: 9/8/21 TIME: 2300

VESSEL: AS Petra

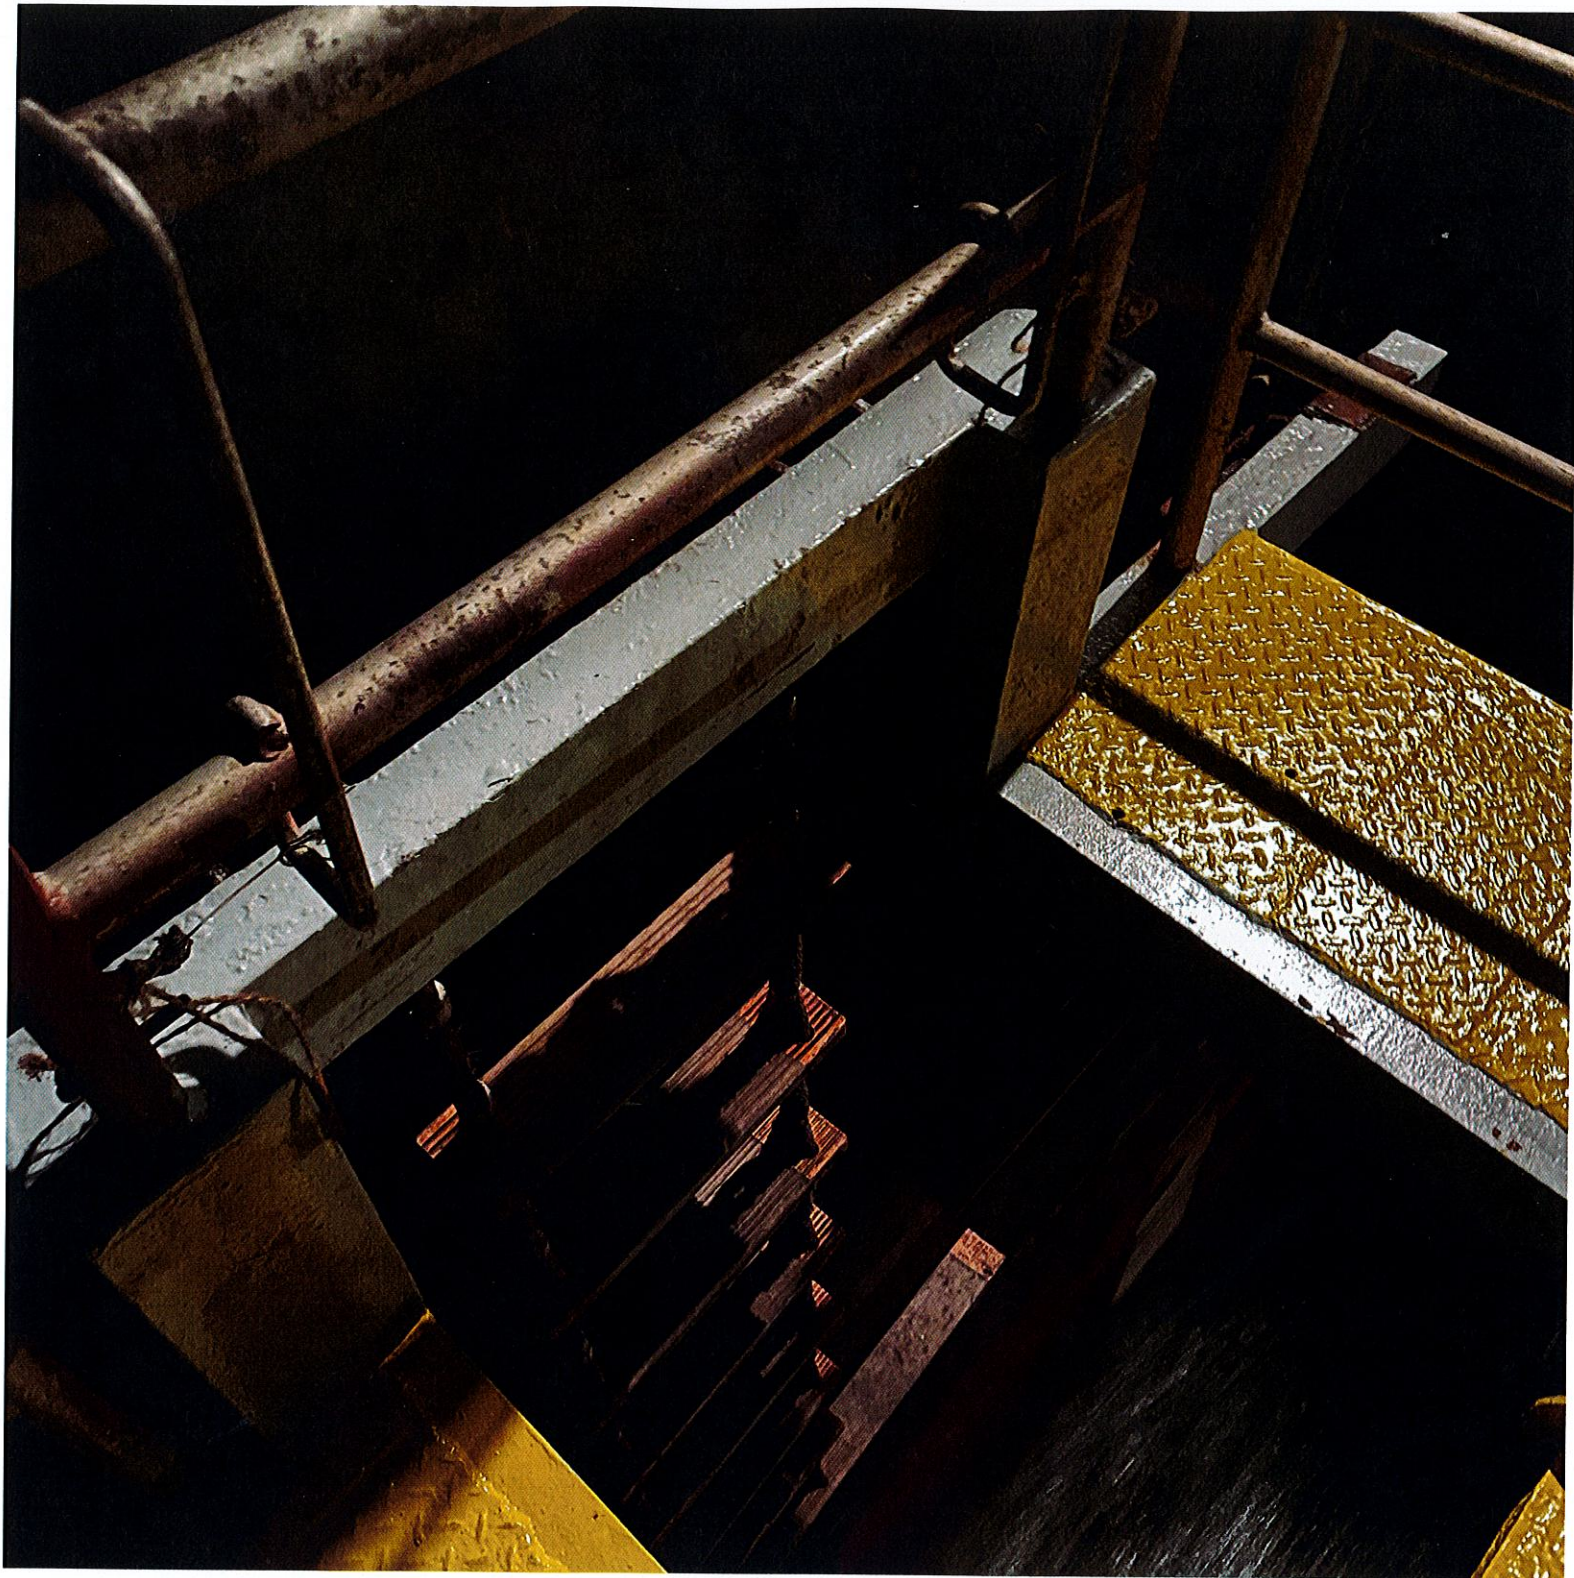
- ☒ COMBINATION LADDER (ie: Poor condition/wear, not secured, platform too low, etc.)

Rope ladder does not continue beyond the platform. Painting of railings non compliant.
