# PILOT BOARDING DEFICIENCY REPORT

DATE: 30 Oct 2021 TIME: 1345

VESSEL: Argolikos

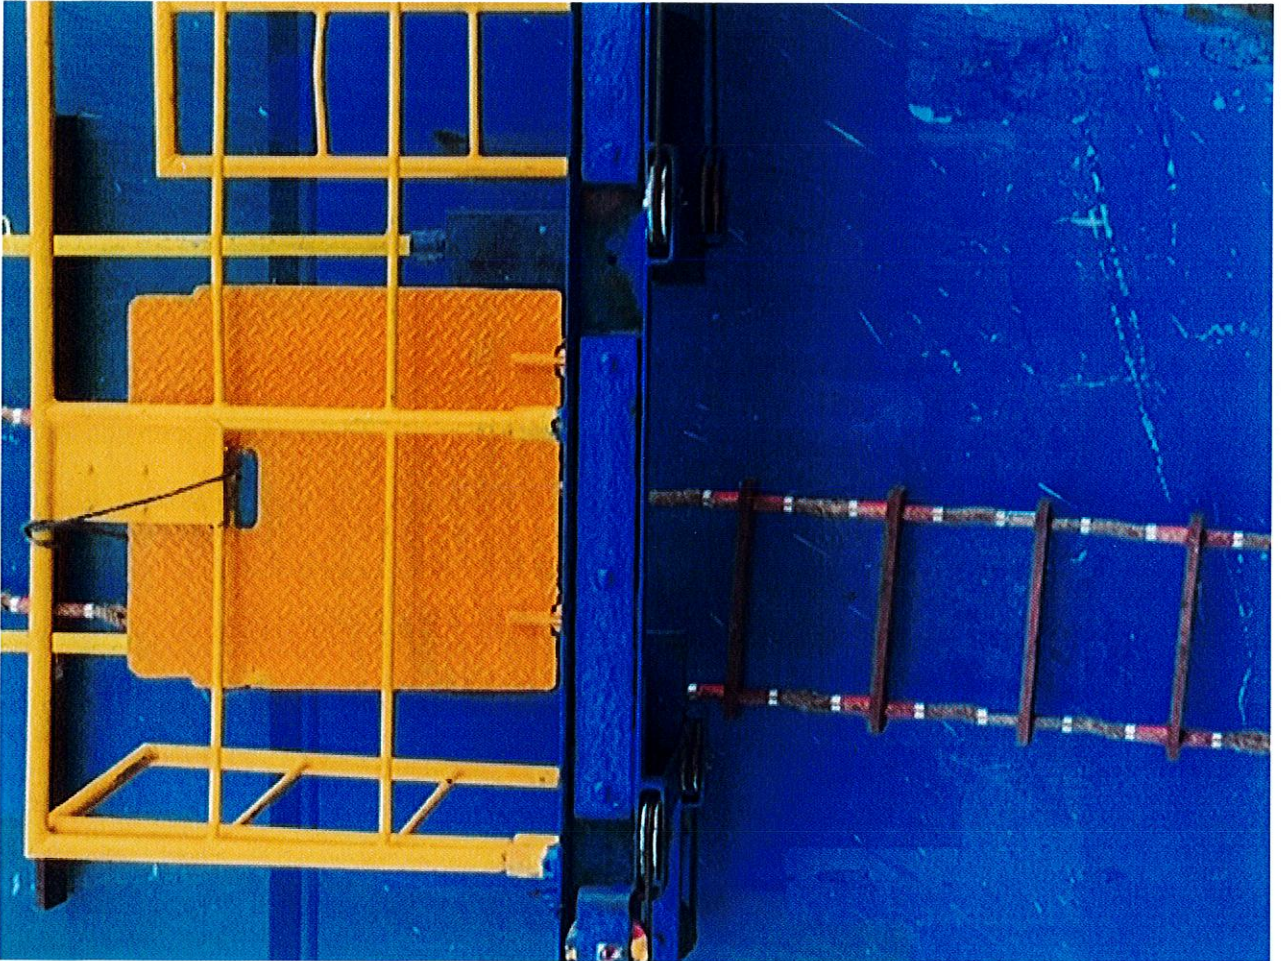
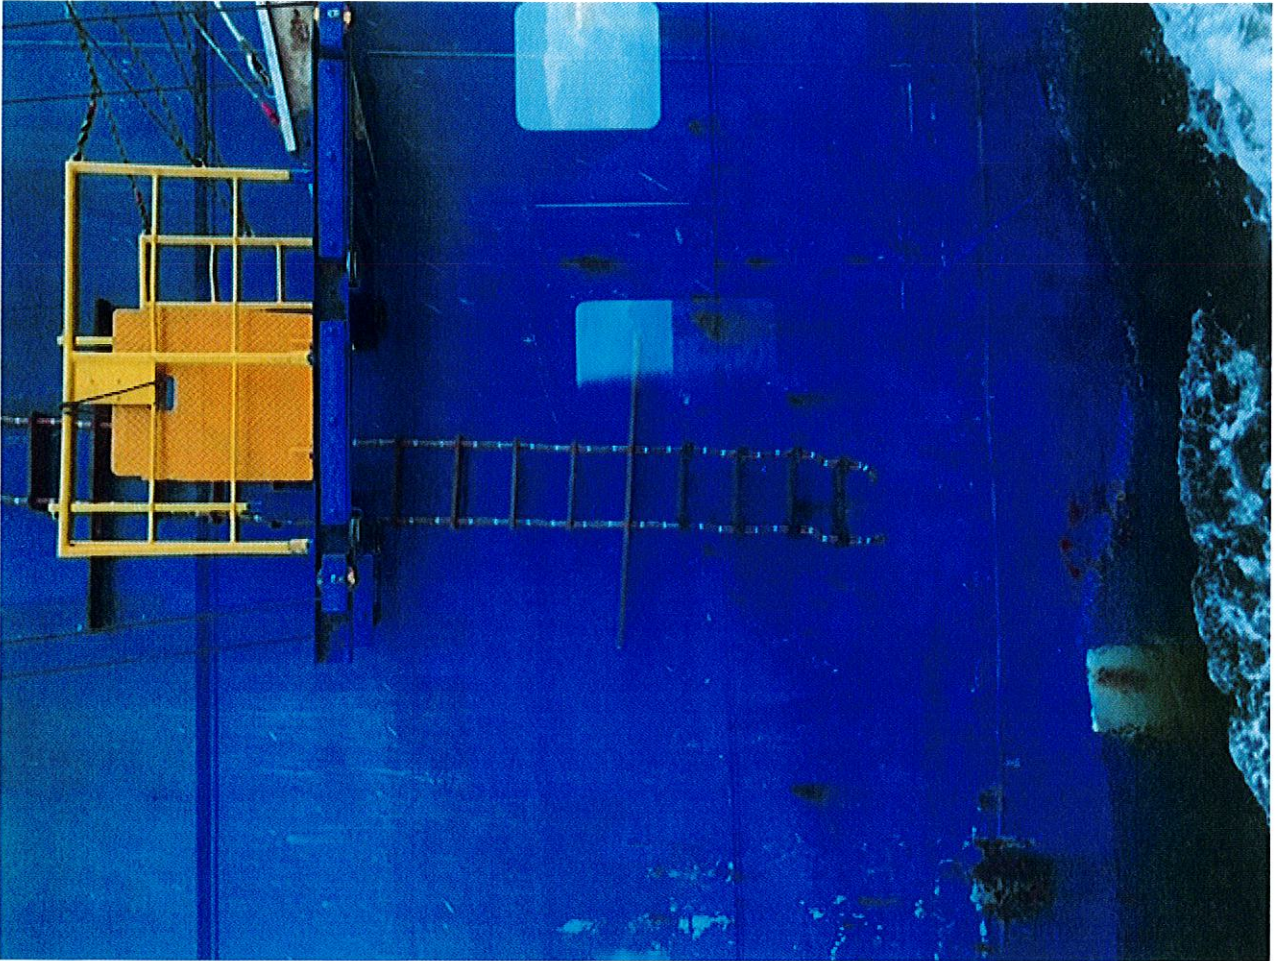
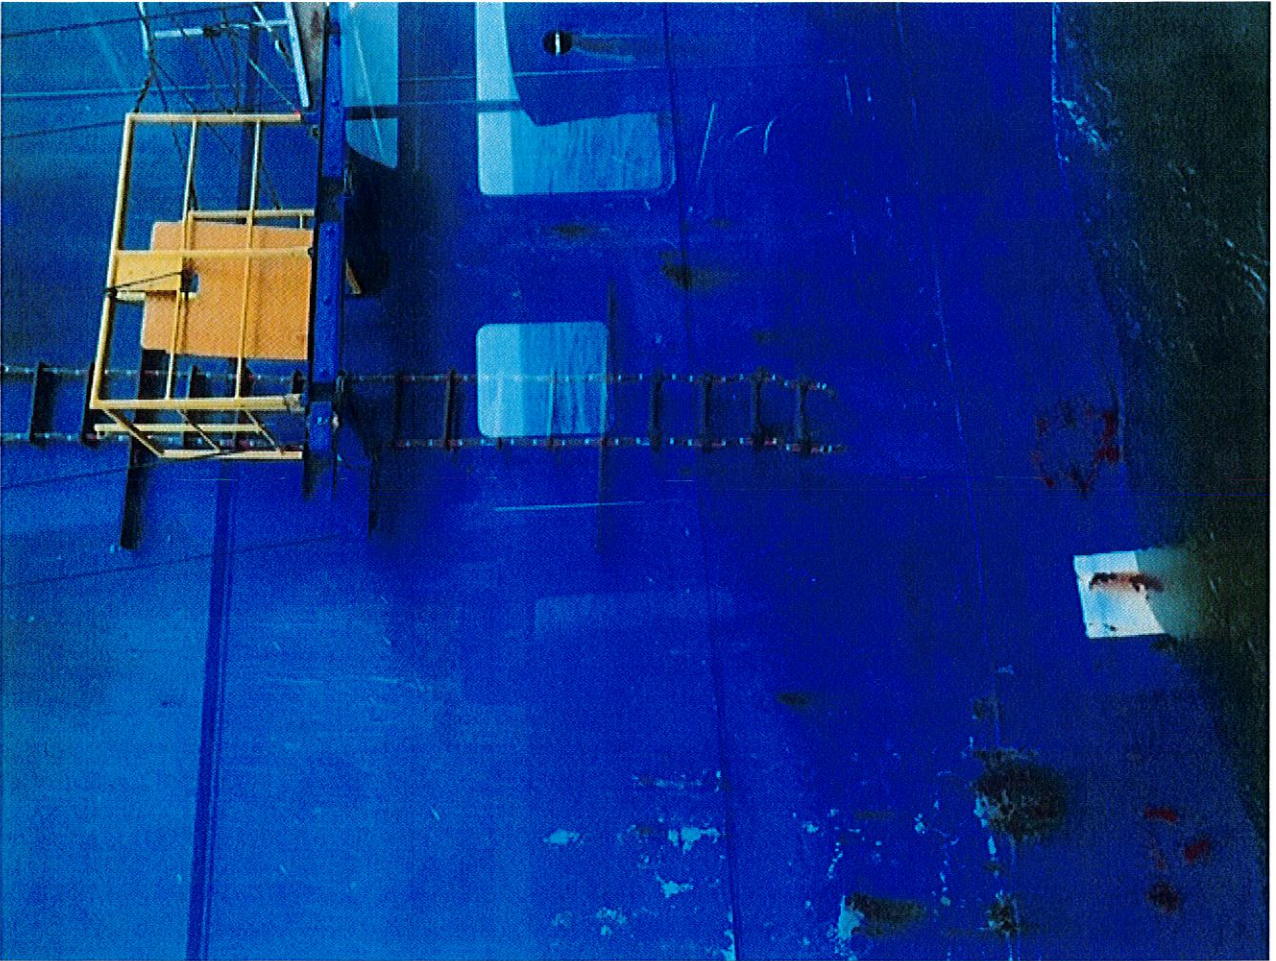
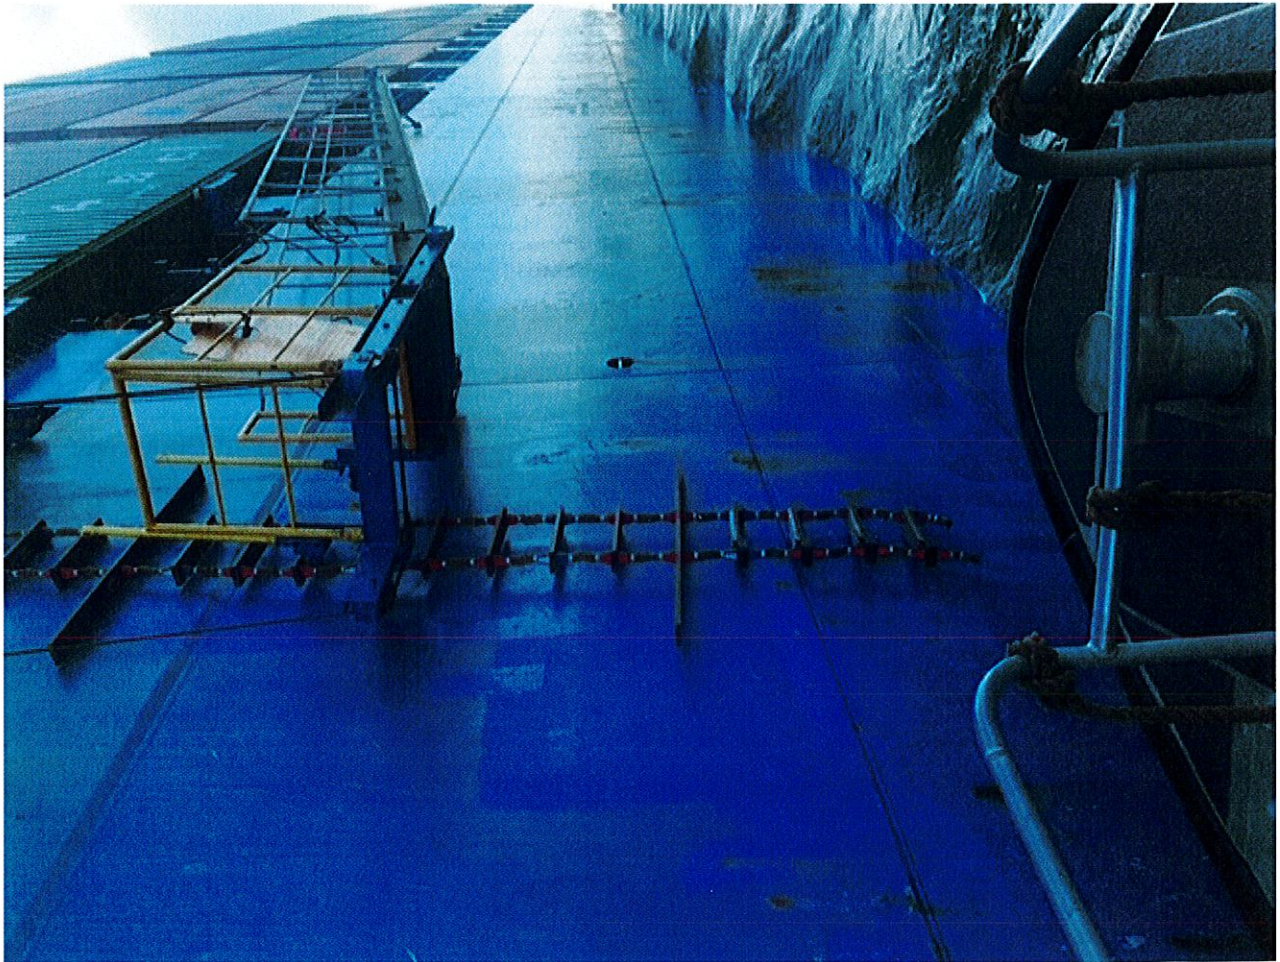
Framework to trap door overlapped rope ladder. Ladder not centered.

The left side rope of the ladder was in a metal bracket from the frame of the trapdoor. This caused the hardware to overlap with the rope ladder, allowing access to the right half of the rope pilot ladder. The captain was informed on the radio of the poor rigging.
