PILOT BOARDING DEFICIENCY REPORT

DATE: 4/16/2021 TIME: 2300

VESSEL: Challenge Passage

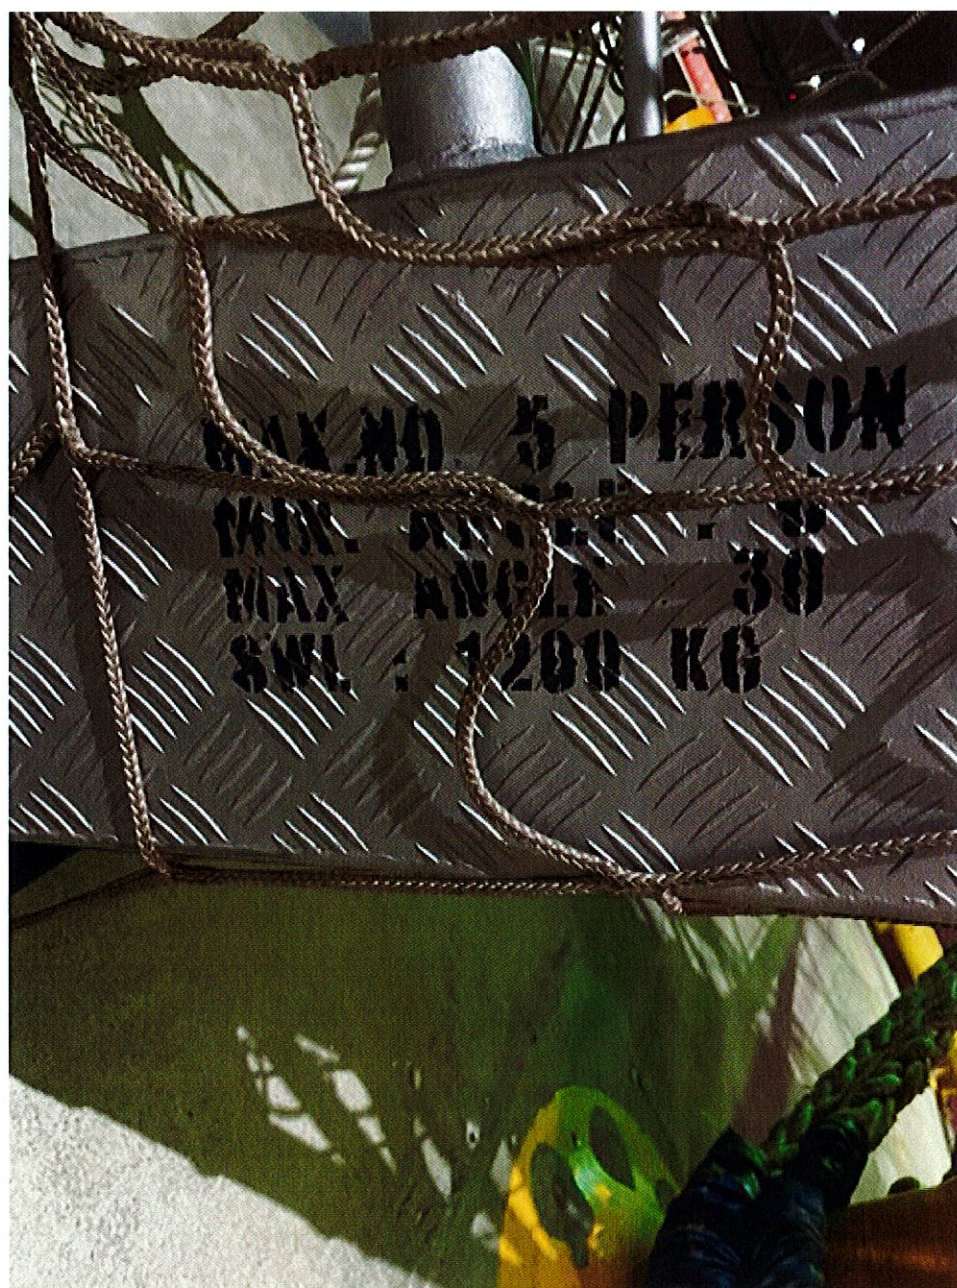
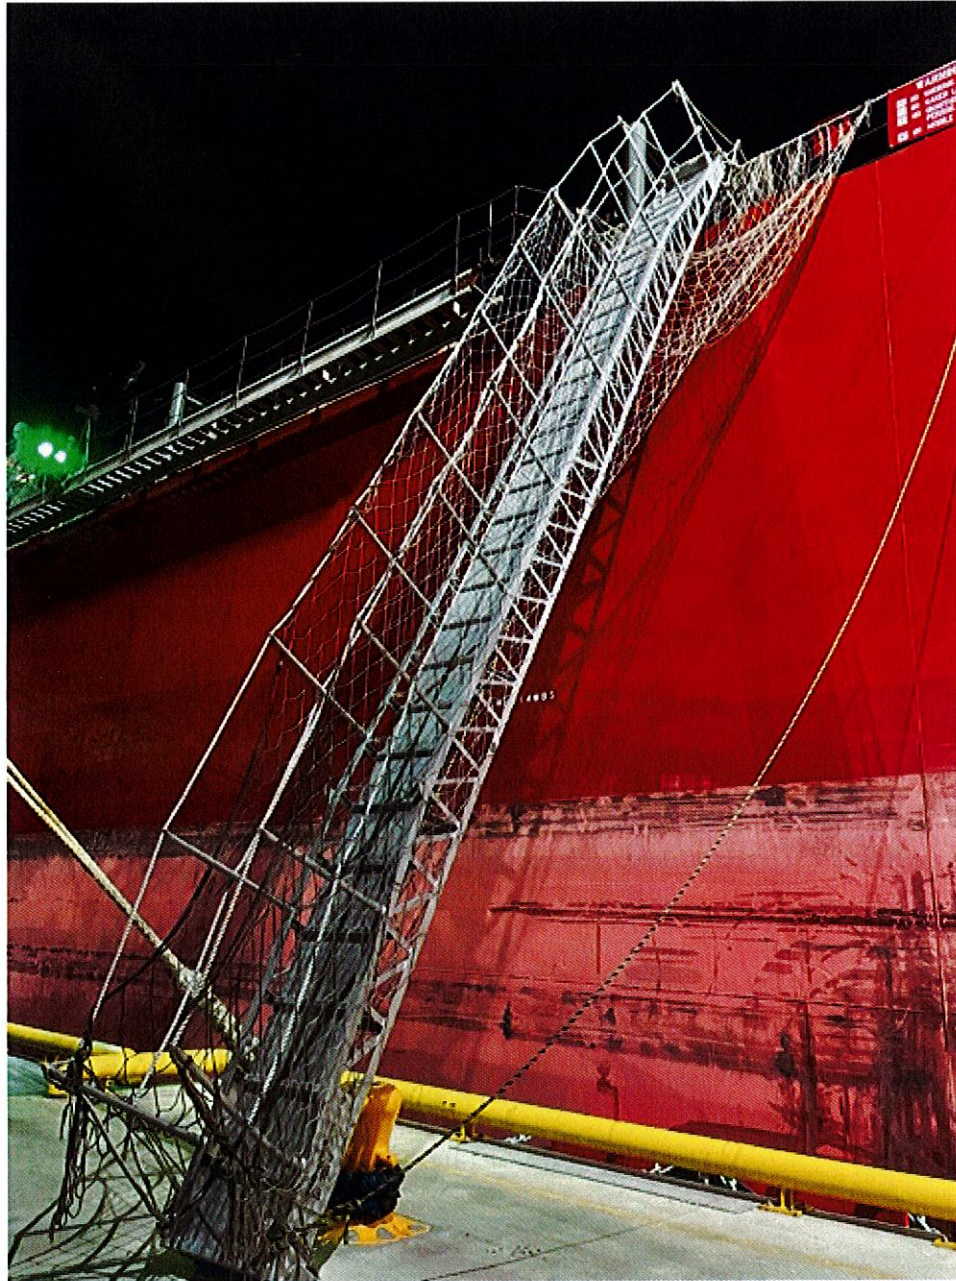
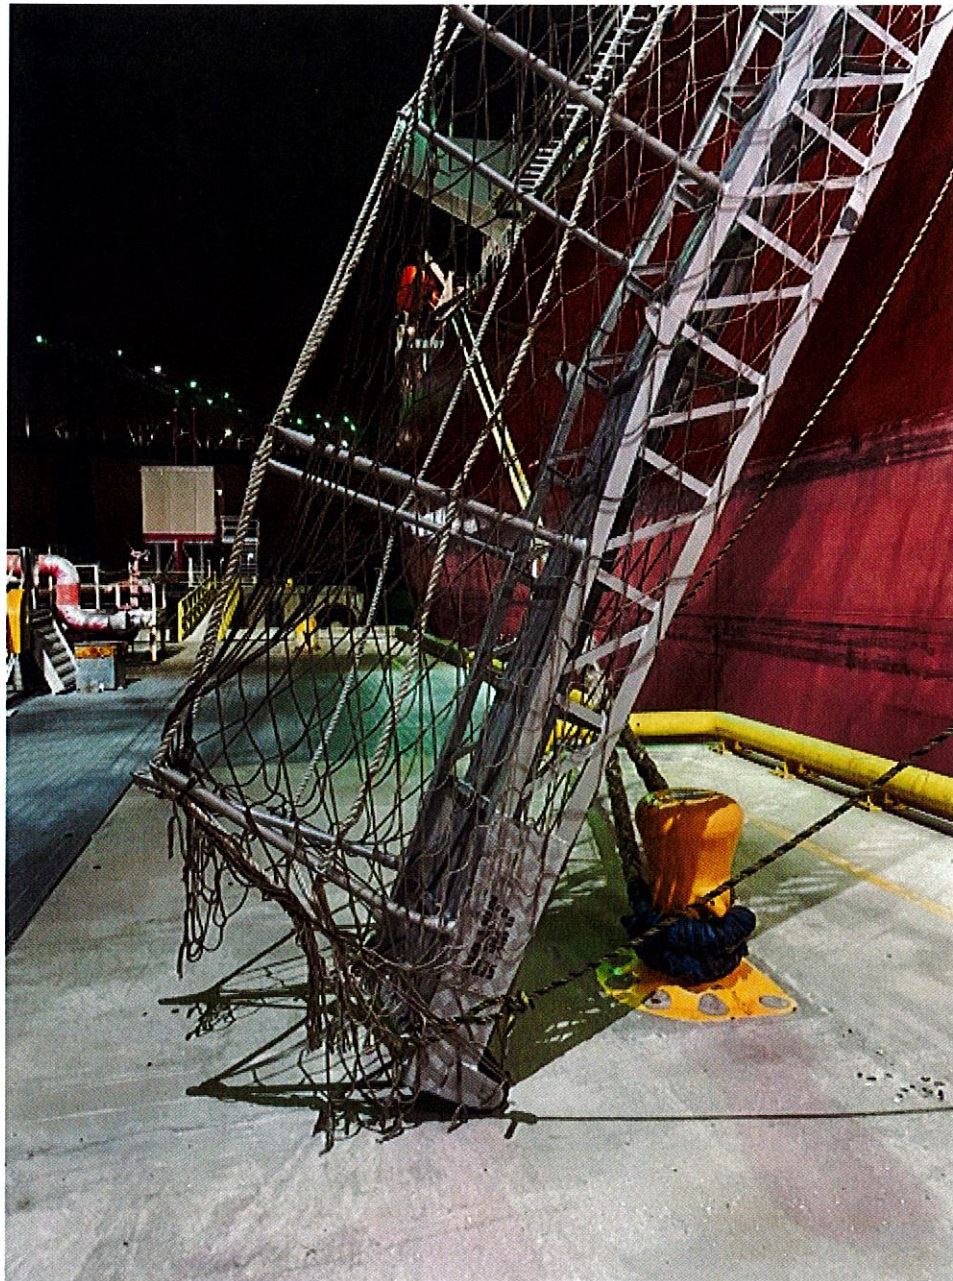
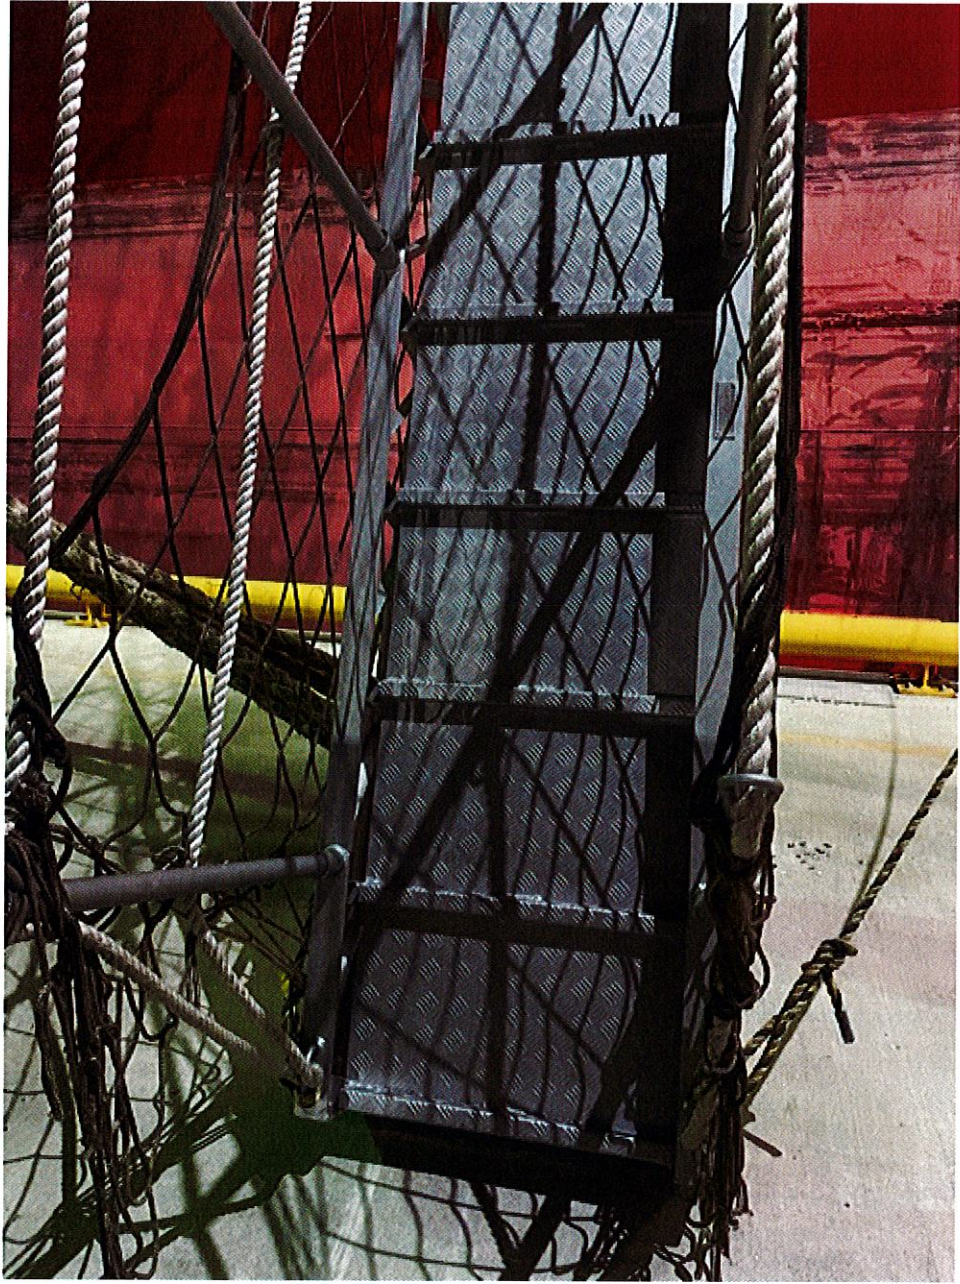
Gangway pitch very steep.

Very steep portable gangway going to dock. Exceeding the maximum 30° design angle. "Steps"

Are insufficient for use with that much angle especially being wet from rain. See Pictures.
