## PILOT BOARDING DEFICIENCY REPORT

DATE: 3/17/2021 TIME: 1800
VESSEL: Hafnia Phoenix
MASTER:
PILOT: M. P. Haley
CONDITIONS: Light NE'ly wind.
APPLICABLE LADDER ARRANGEMENTS (check all that apply):
<ul> <li>□ PILOT LADDER ONLY</li> <li>■ COMBINATION LADDER</li> <li>□ SIDE PORT</li> <li>□ OTHER</li> </ul>
DEFICIENCIES (check all that apply and provide brief comment)
■ GENERAL ARRANGEMENT (ie: Insufficient lighting, no officer, unsafe deck access, etc.)
No officer
PILOT LADDER (ie: Poor condition/wear, not resting on hull, poor rigging, etc.)
Ladder improperly secured to deck
COMBINATION LADDER (ie: Poor condition/wear, not secured, platform too low, etc.)
MAN ROPES (ie: Poor condition/wear, incorrect diameter, poor rigging, etc.)
DOCKSIDE (ie: Gangway condition/pitch, netting, poor rigging, etc.)
ADDITIONAL REMARKS: Ladder not secured to strong point on deck. Only to platform holding the ladder reel (see pictures) ladder crooked during climb (not

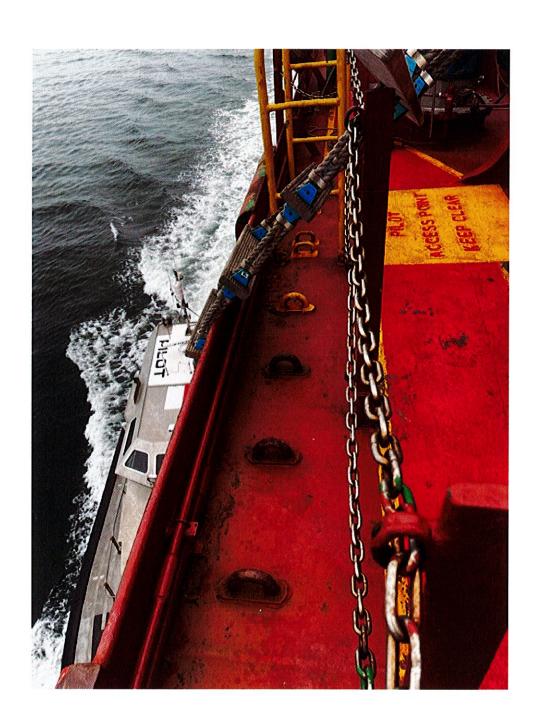
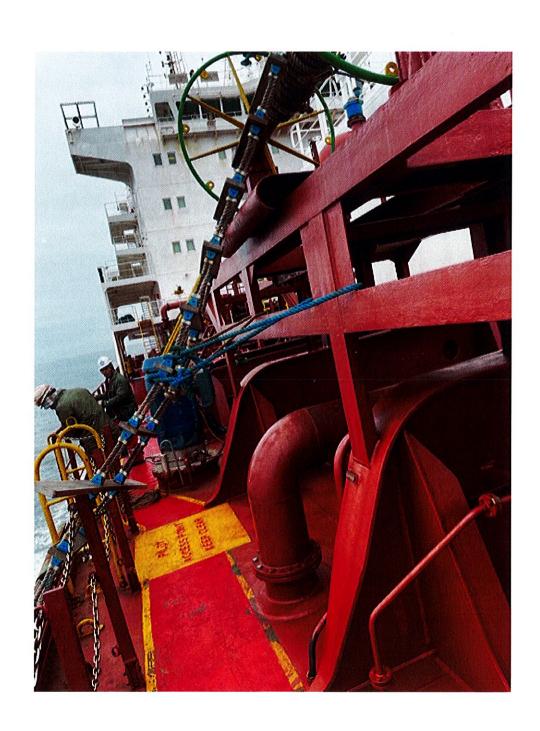
Pictured) no qualified officer on deck to inspect ladder and receive pilot. Only ships cadet.
Crew was able to rectify and secure ladder to deck for next time as there are strong points available.
Signature:
