# PILOT BOARDING DEFICIENCY REPORT

DATE: Feb 14, 2021 TIME: 0330

VESSEL: MOL GLIDE

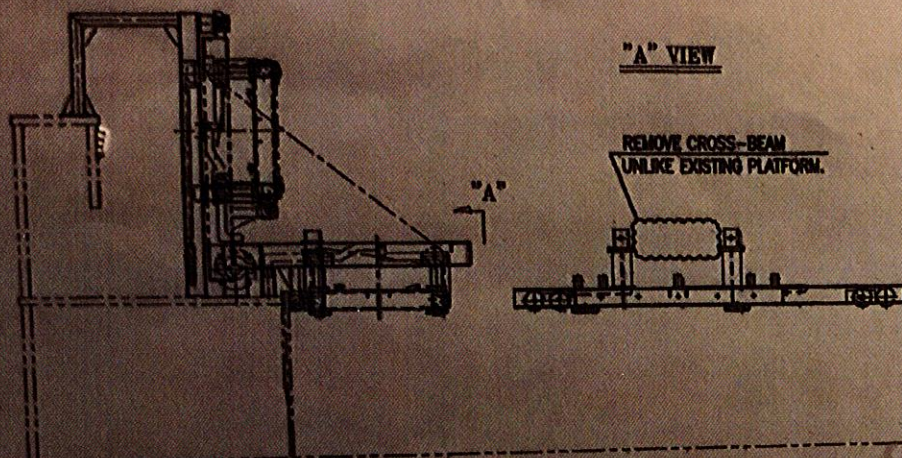
<STORAGE & HORIZONTAL CONDITION>

TRAP DOOR WITH CROSS BAR in the way

ADDITIONAL REMARKS: Capt and OWNERS AWARE TRAP DOOR needs to be corrected. Capt  
gave pilot copy of plans for modifications APPROVED BY  
ABS (CLASSIFICATION society) Capt stated he hopes OWNERS WILL

REMOVE CROSS-BEAM  
UNLIKE EXISTING PLATFORM.

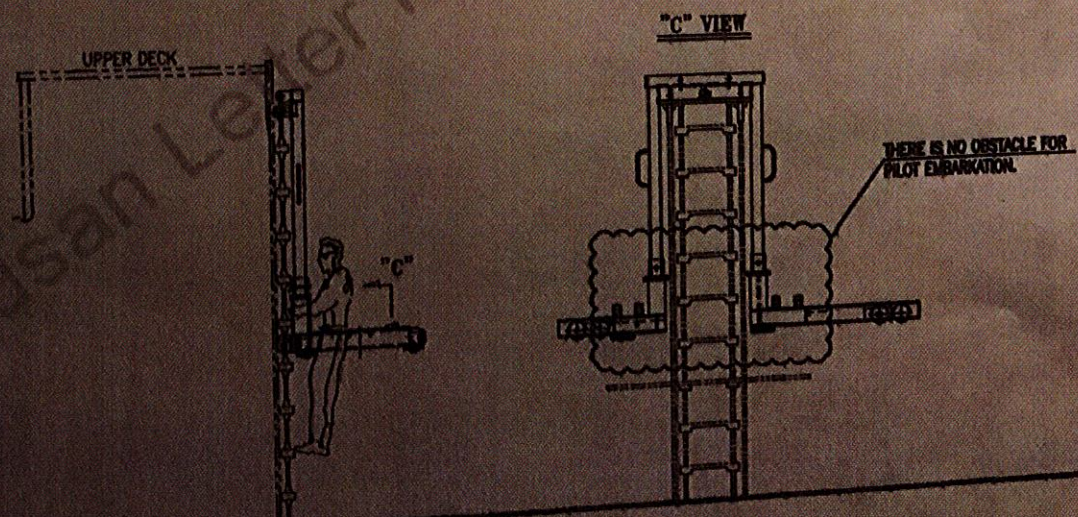
<PILOT EMBARKATION CONDITION>

THERE IS NO OBSTACLE FOR  
PILOT EMBARKATION.
