## PILOT BOARDING DEFICIENCY REPORT

DATE: 2/11/2021 TIME: 1106 disembarking

VESSEL: Maersk Denver

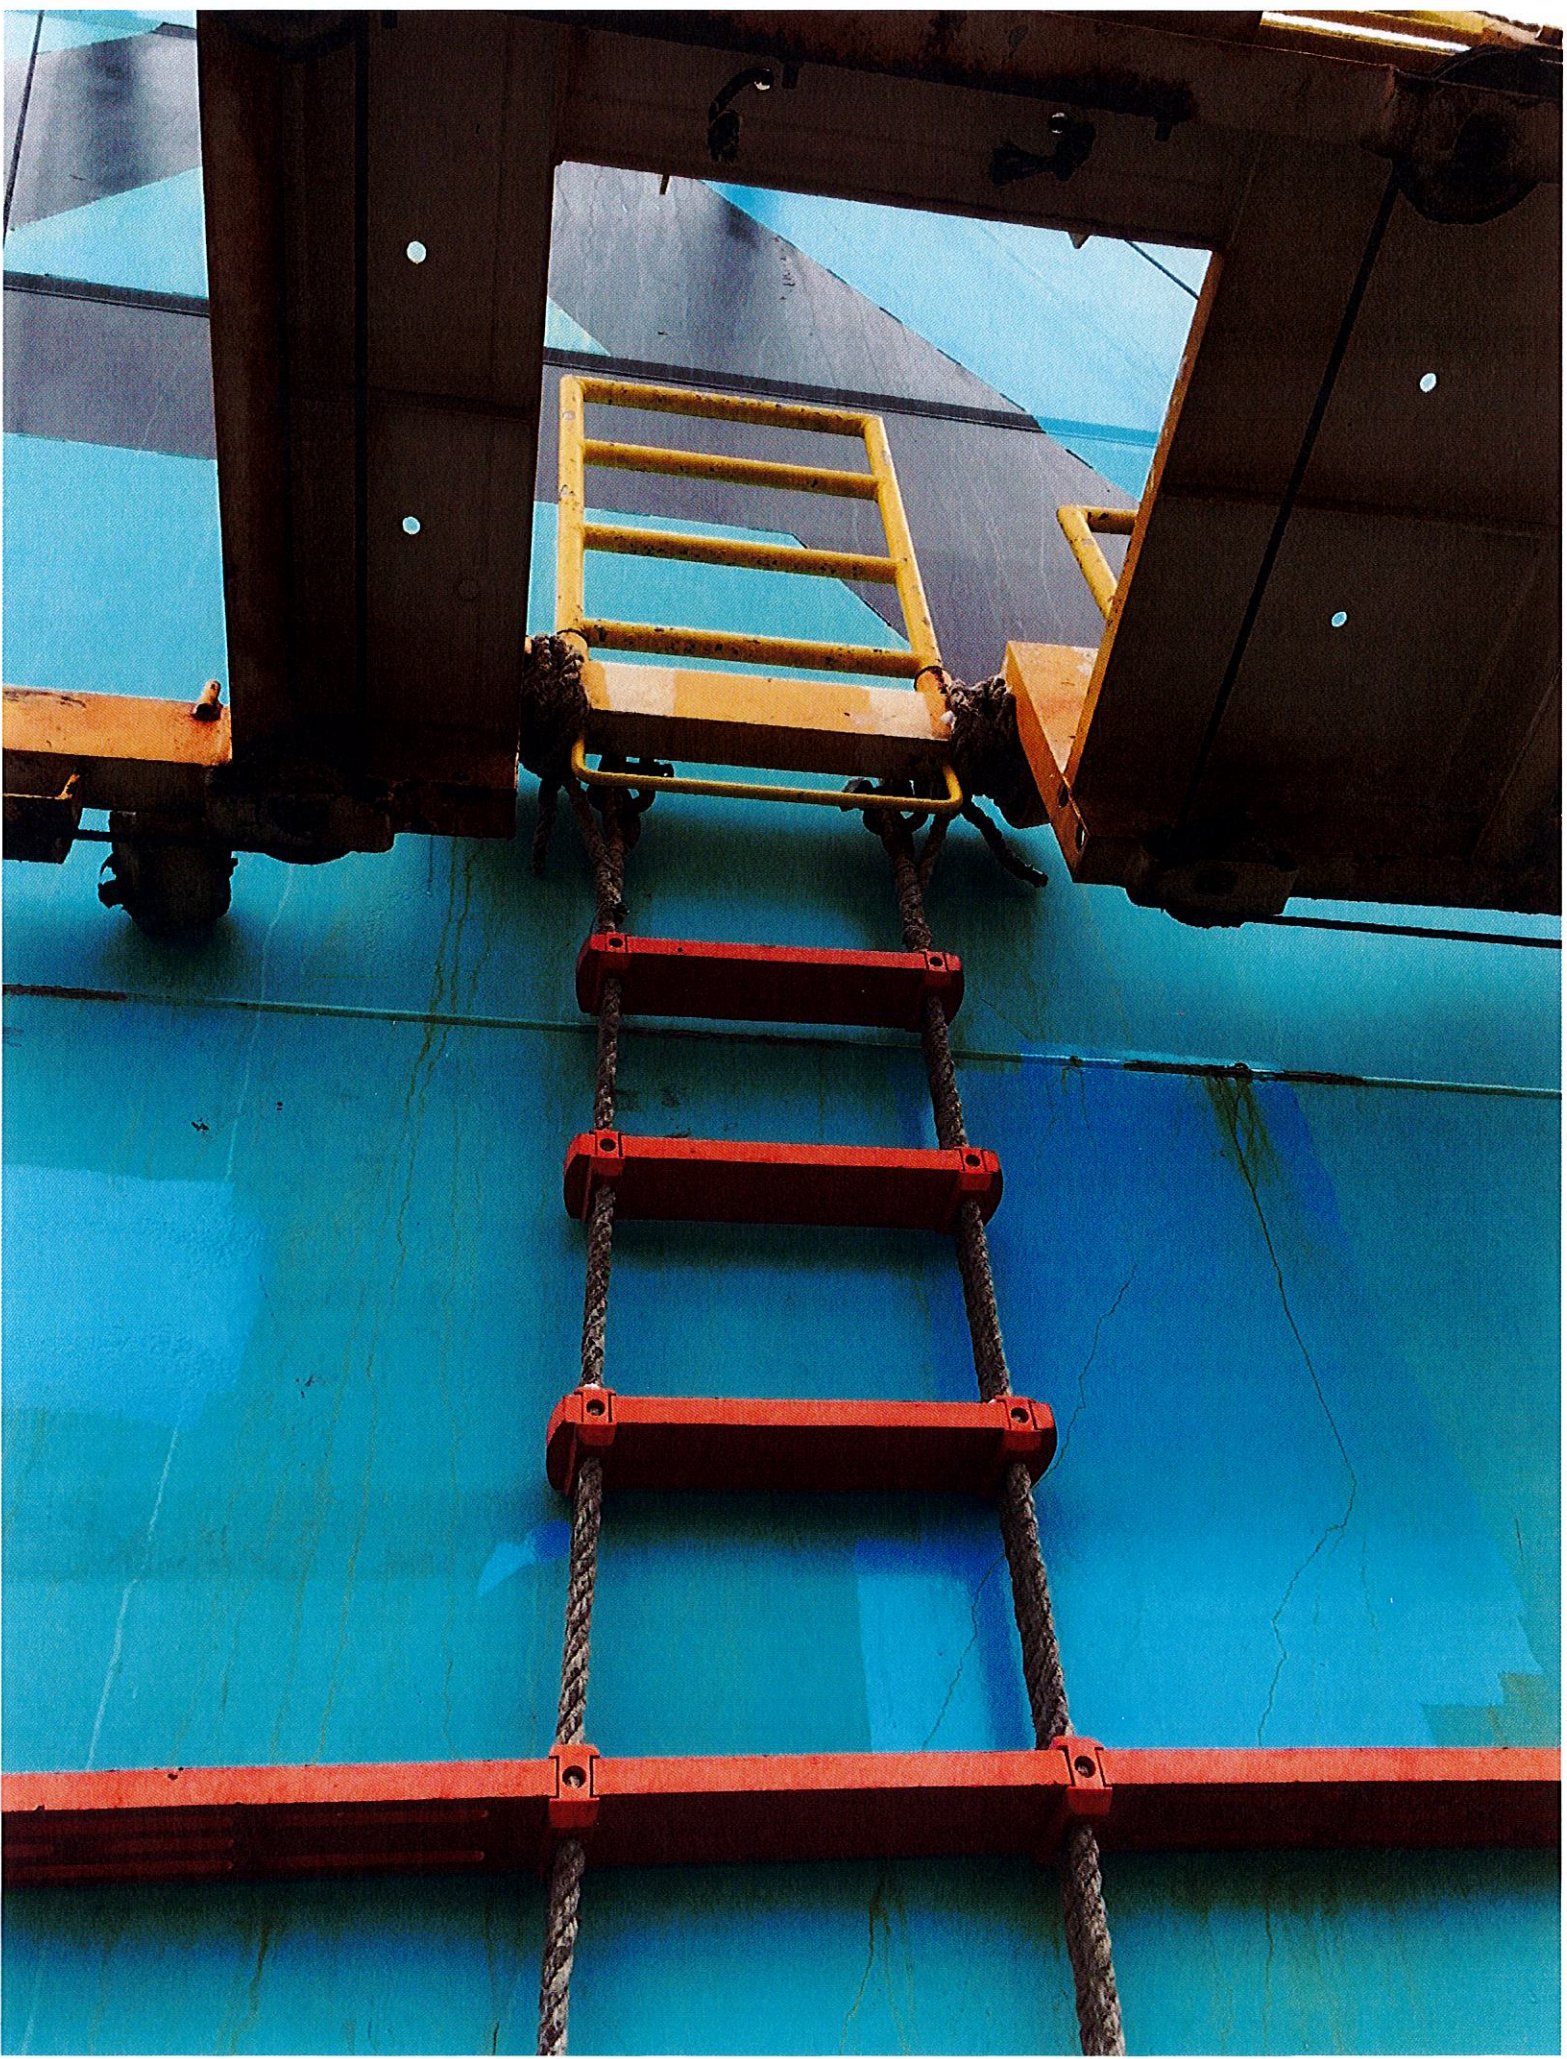
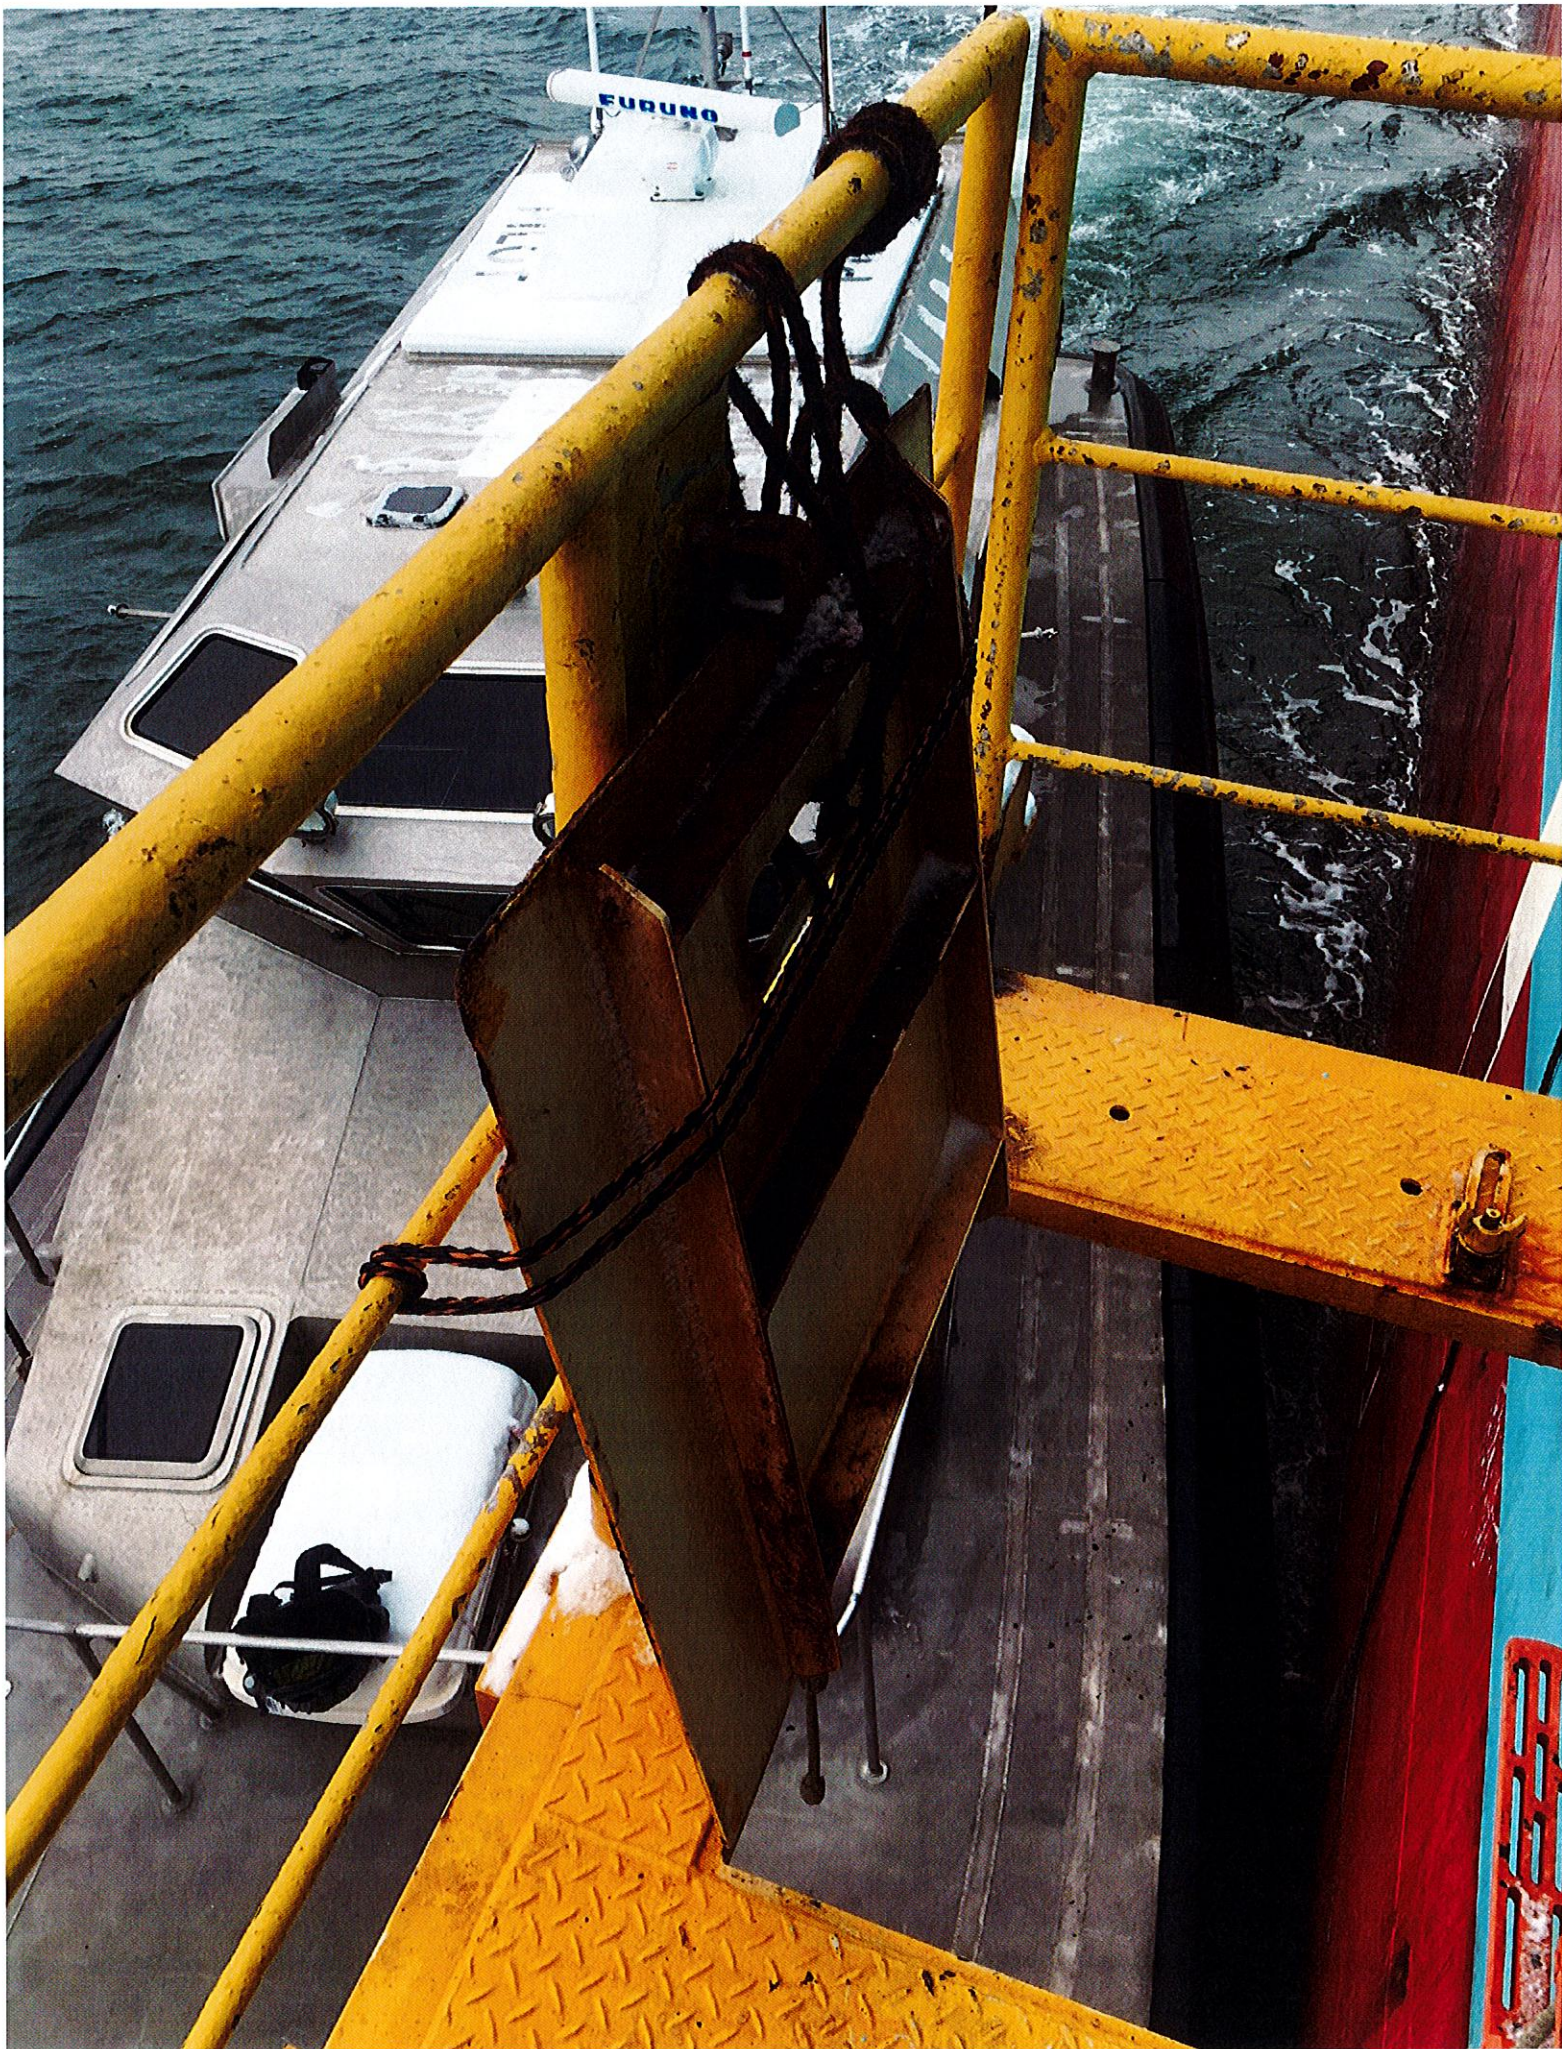
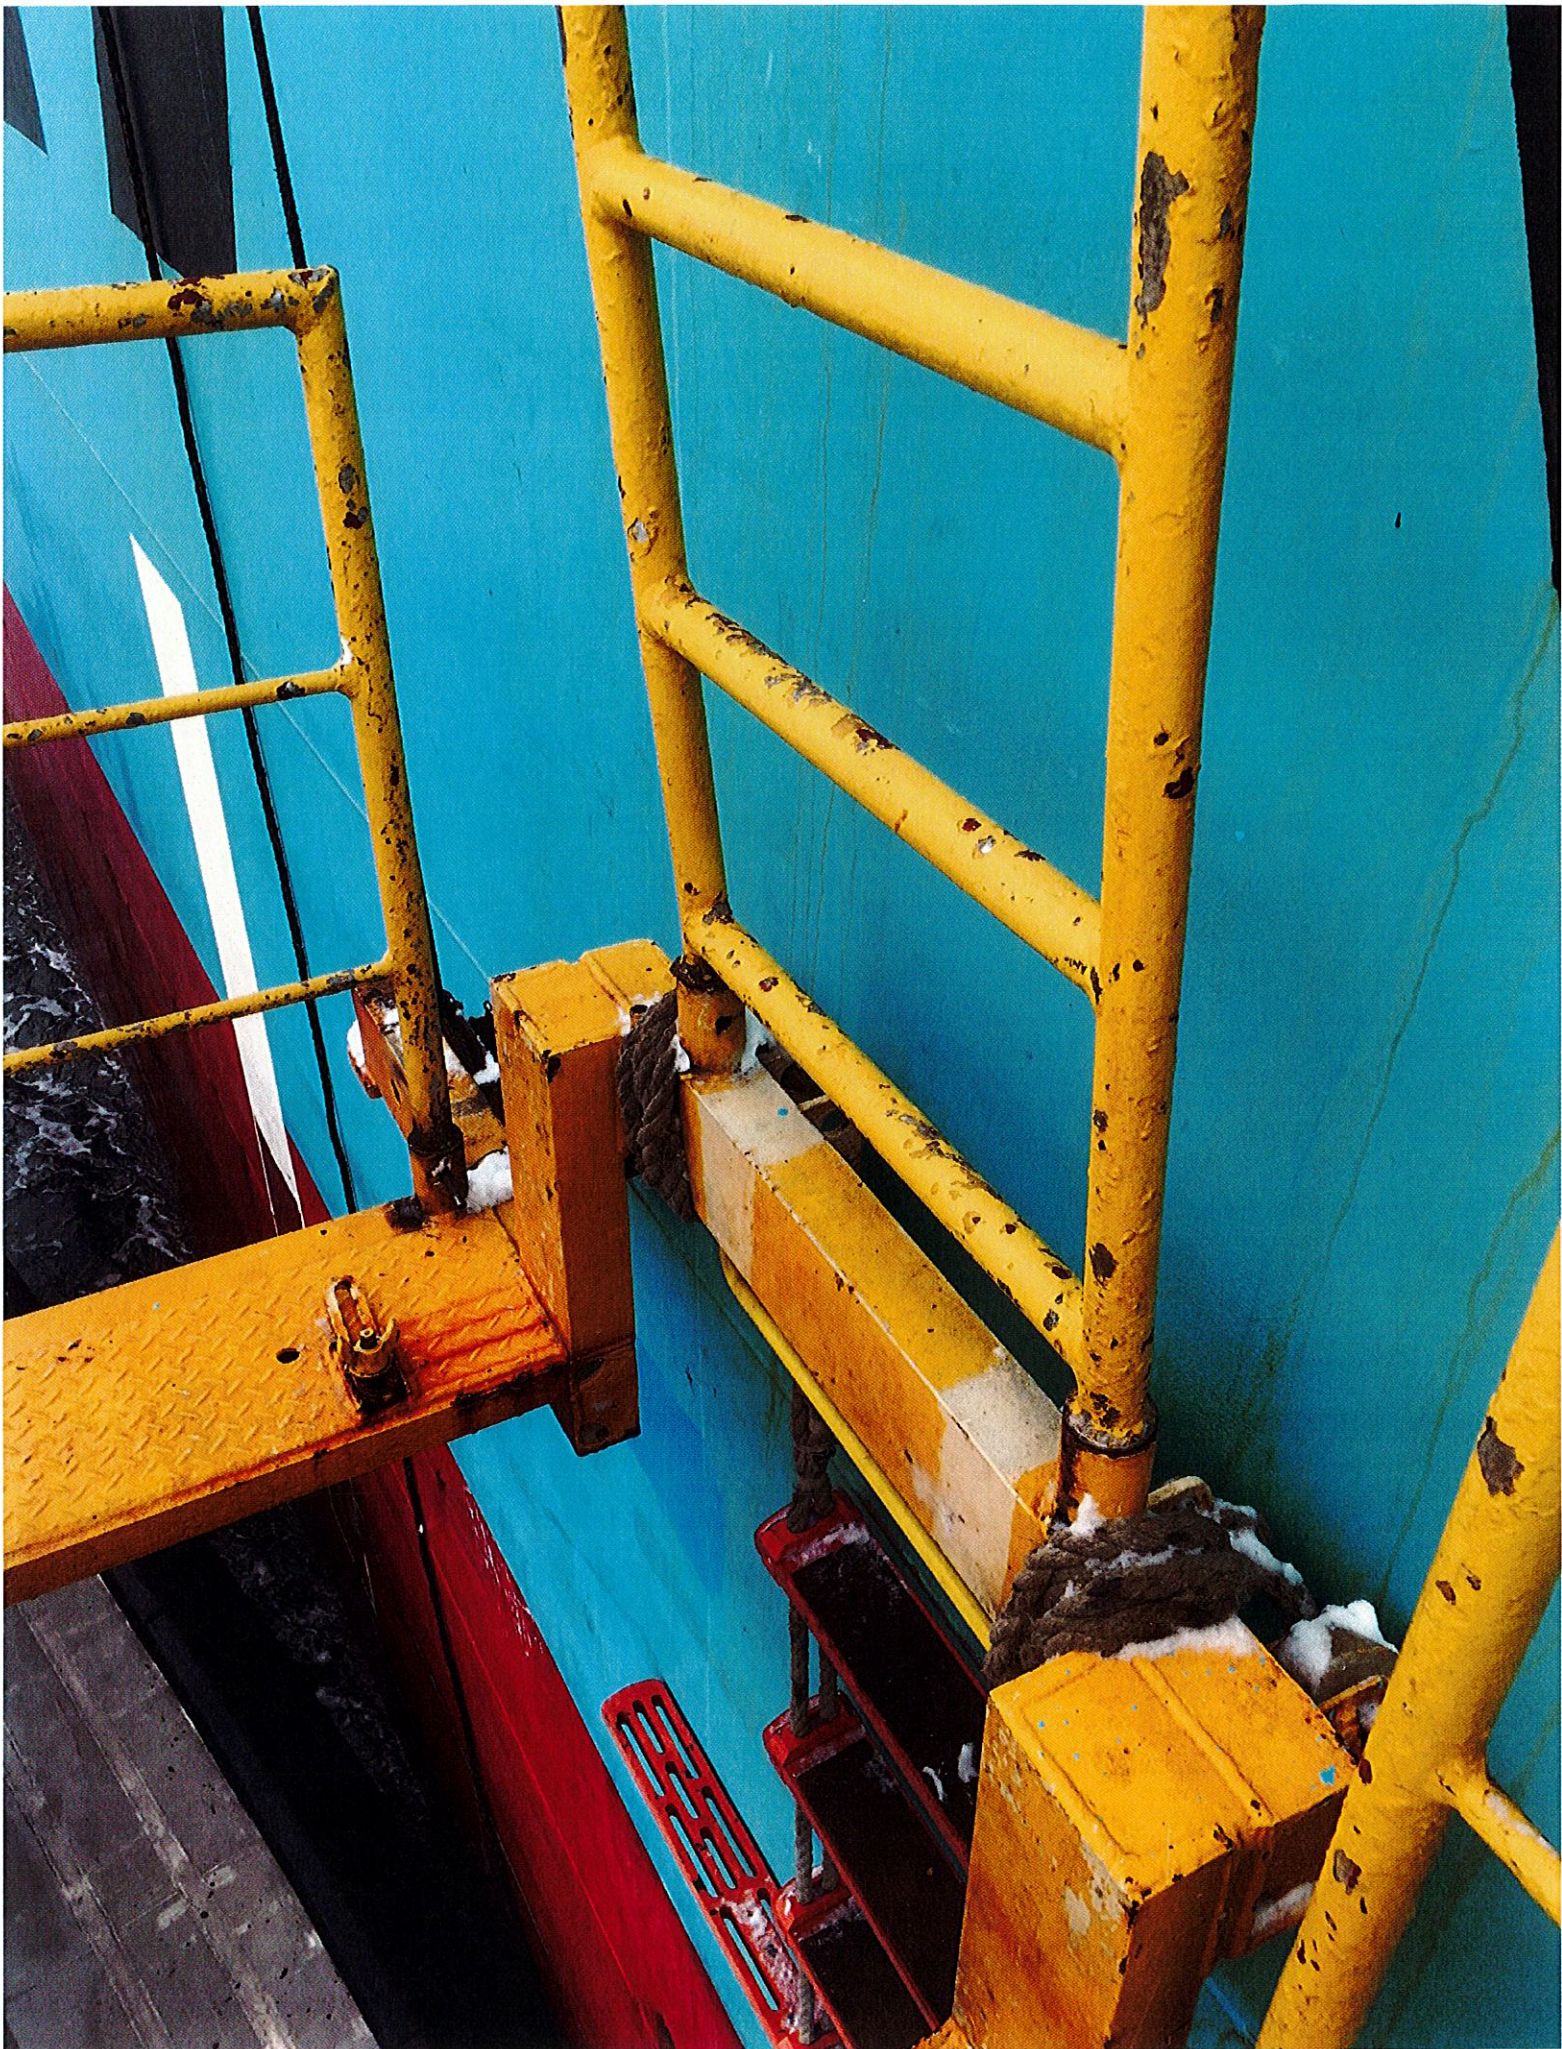
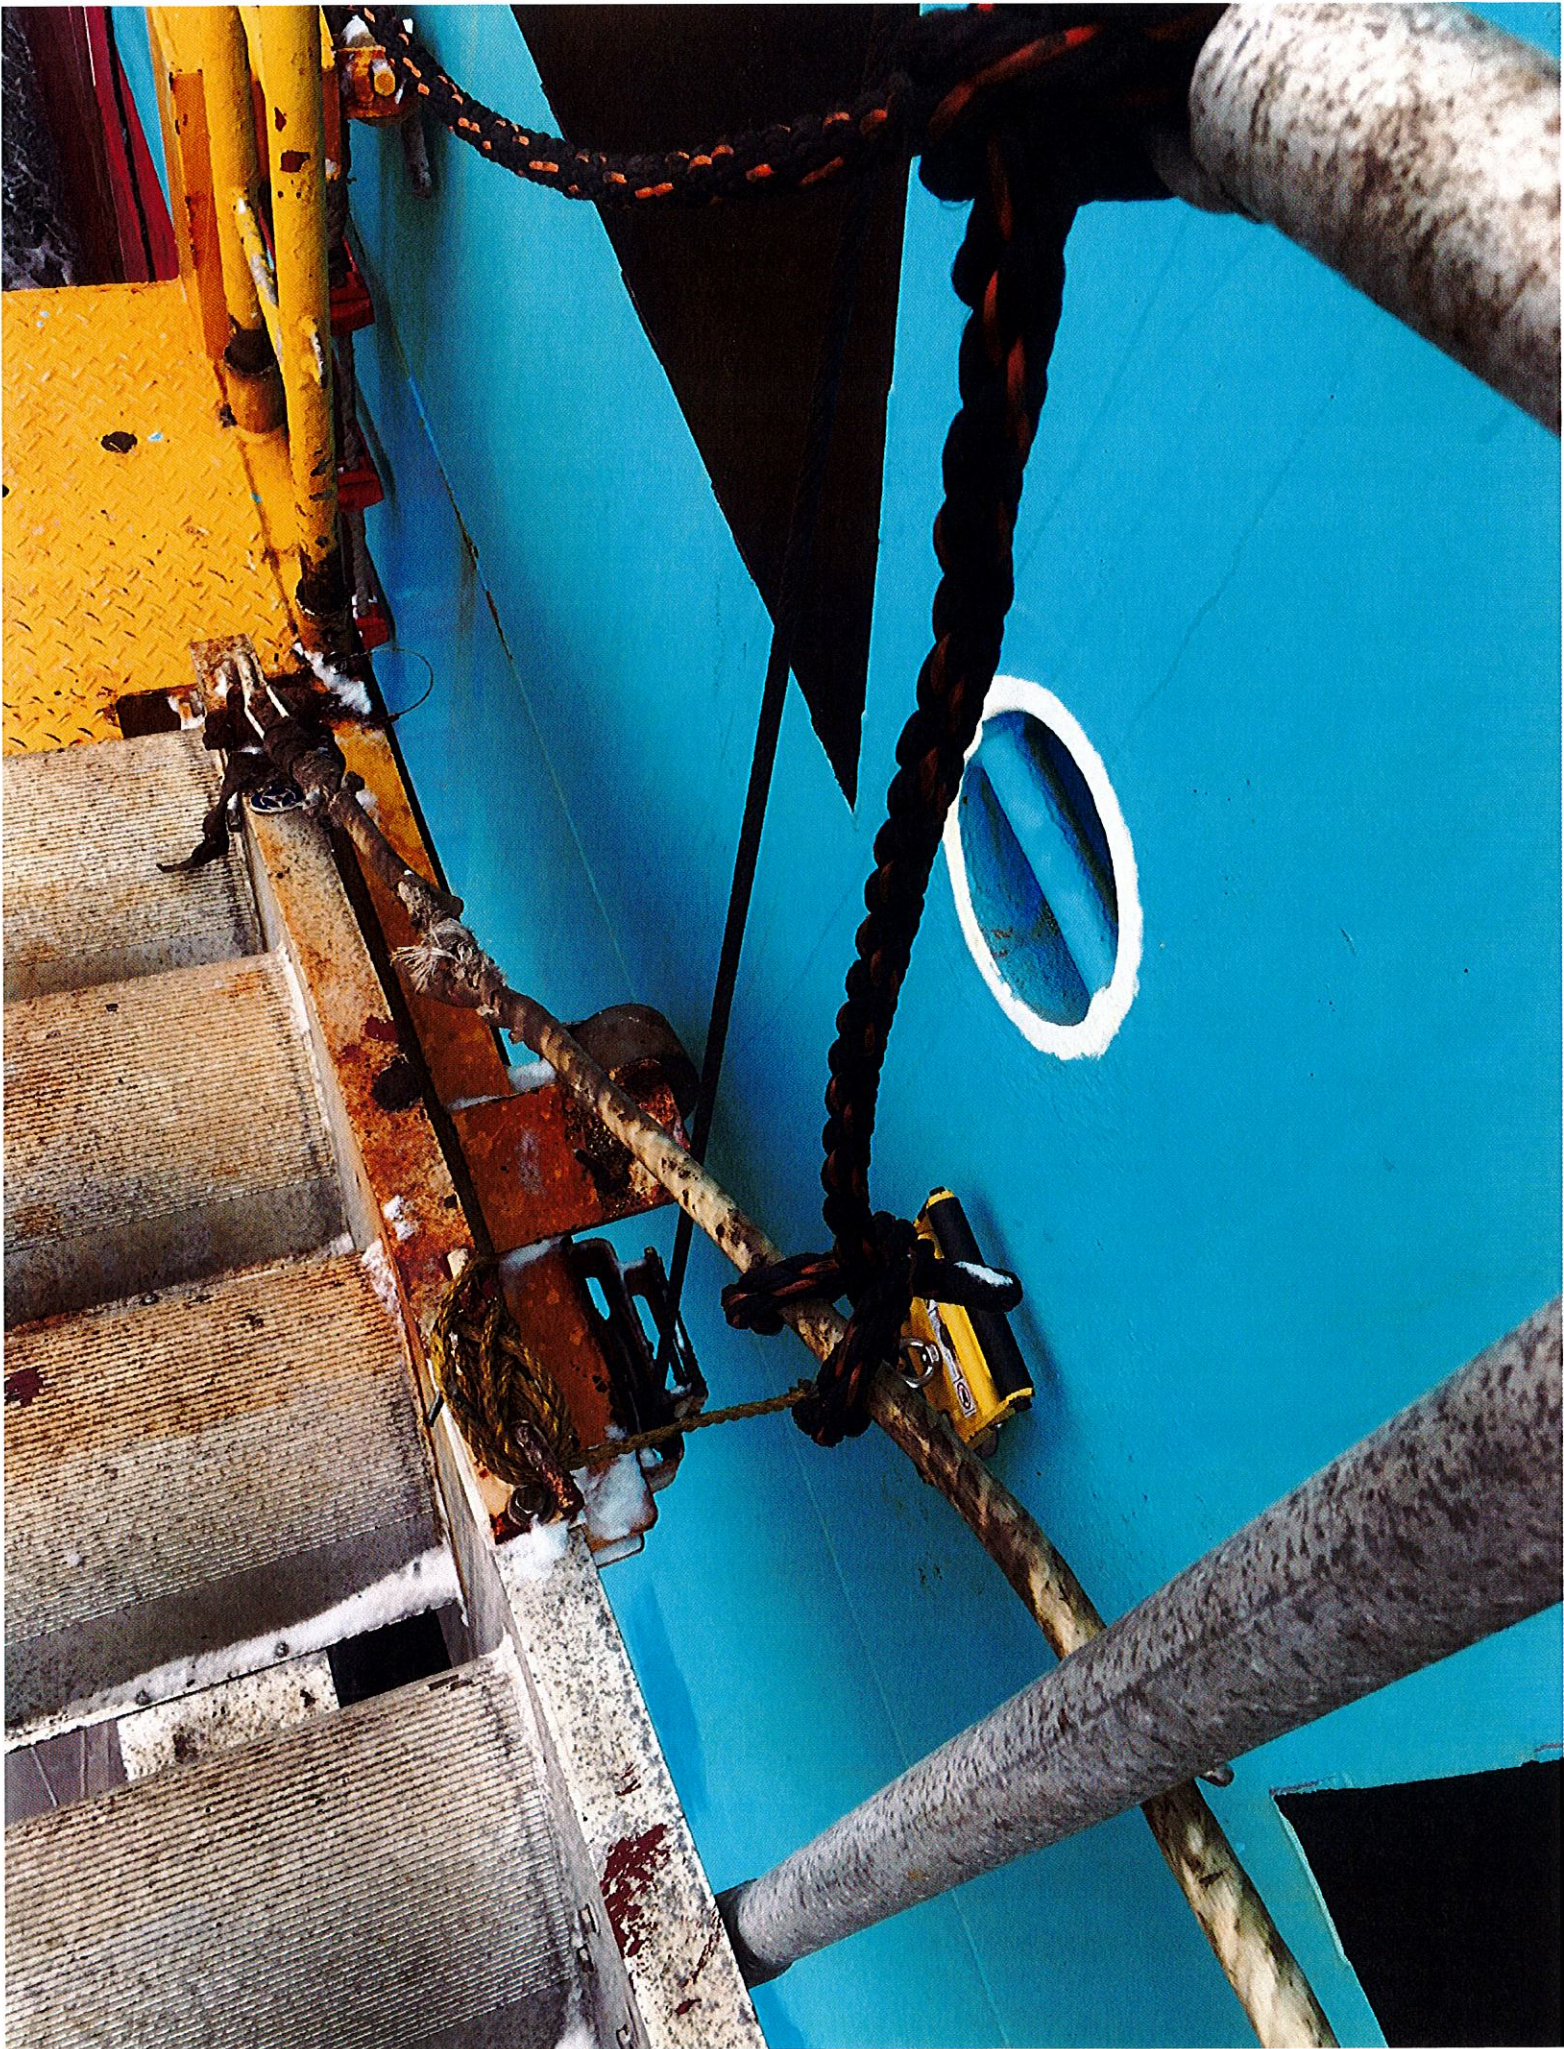
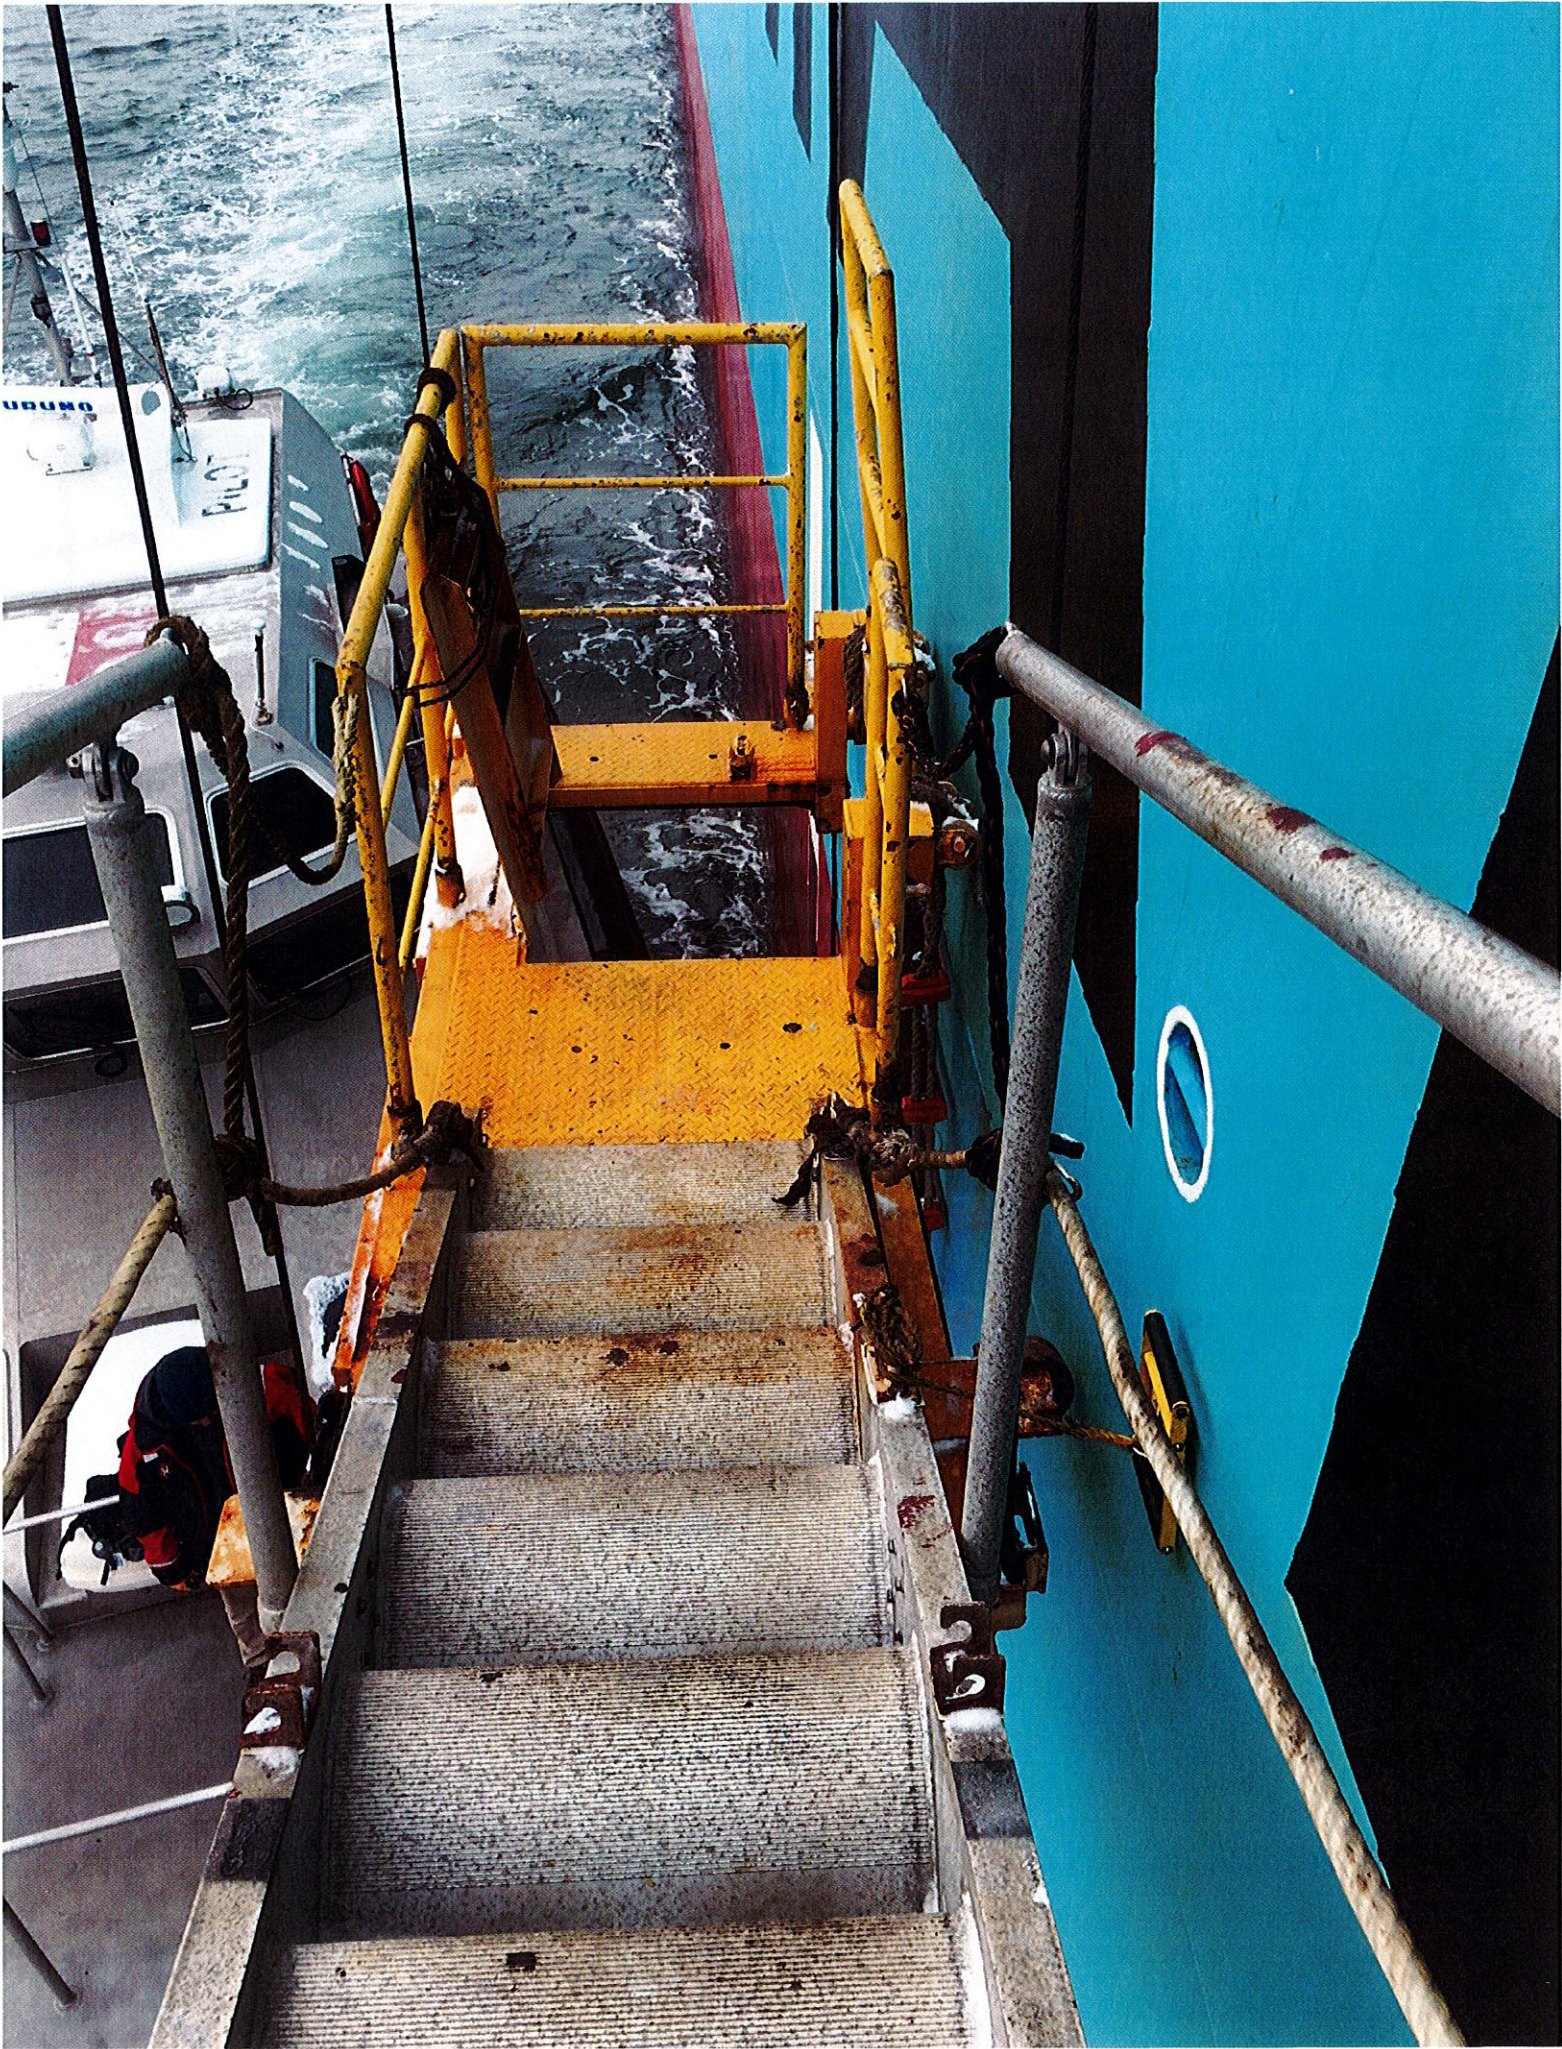
An additional bar/handle was welded on - see picture attached

difficulty to get a good hold of top opening of trap door. Ladder did not pass through. It ended at trap door.

When I inquired about the trap door, the captain assured me that the magnet would be on. He also said that he lists the ship so the ladder rests against the hull. When disembarking, no magnet and I waited until it was put on.
