## PILOT BOARDING DEFICIENCY REPORT

DATE: 7/13/2021 TIME: 0330

VESSEL: Maersk Detroit

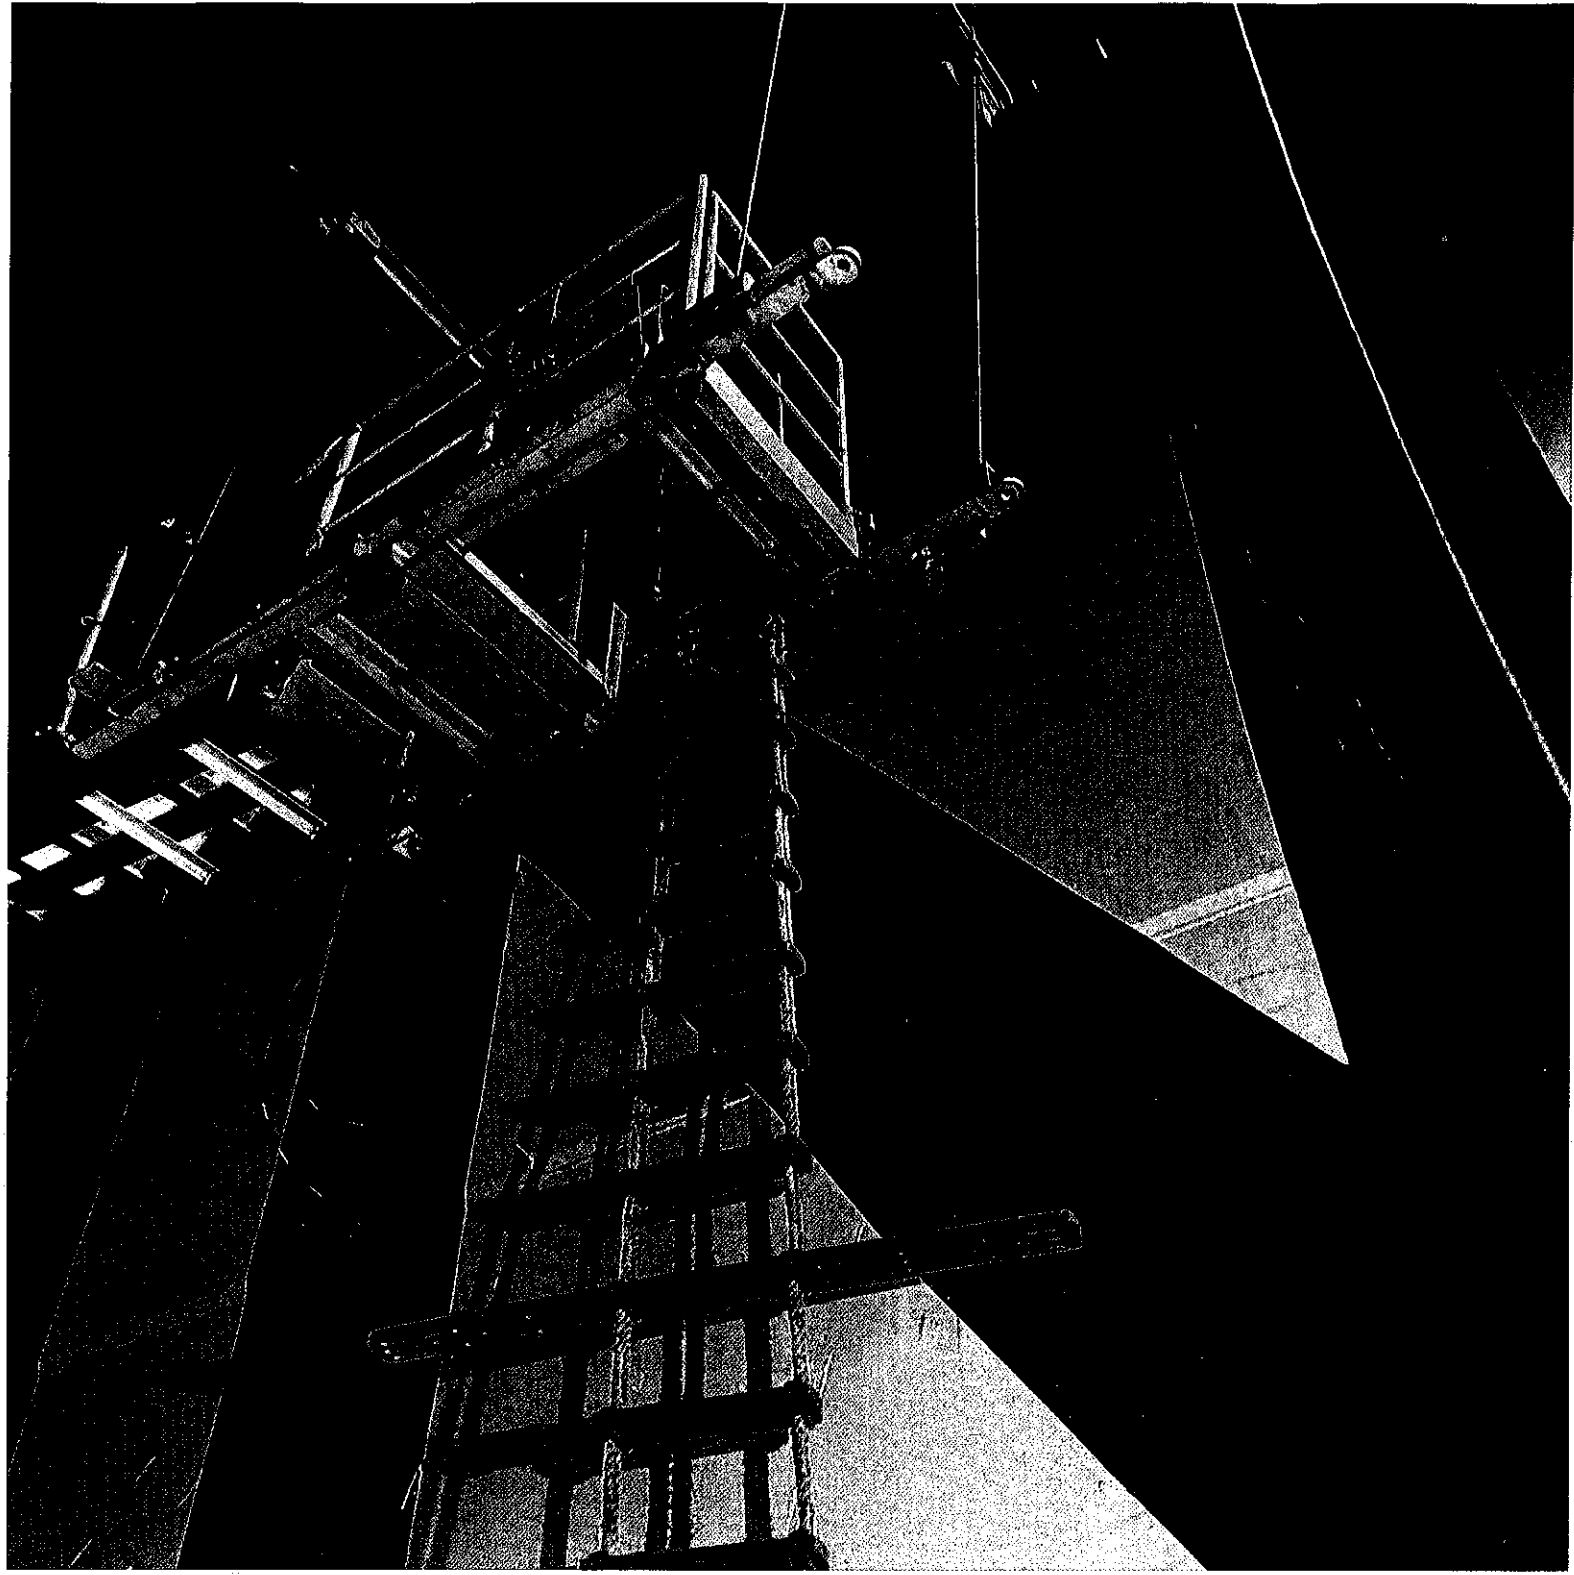
Not resting flat against the hull. Ladder not secured to height of handrail.

Gangway not secured to hull. Ladder not passing through trap door.
