# PILOT BOARDING DEFICIENCY REPORT

DATE: 3/8/2021 TIME: 1600

VESSEL: Maersk Serangoon

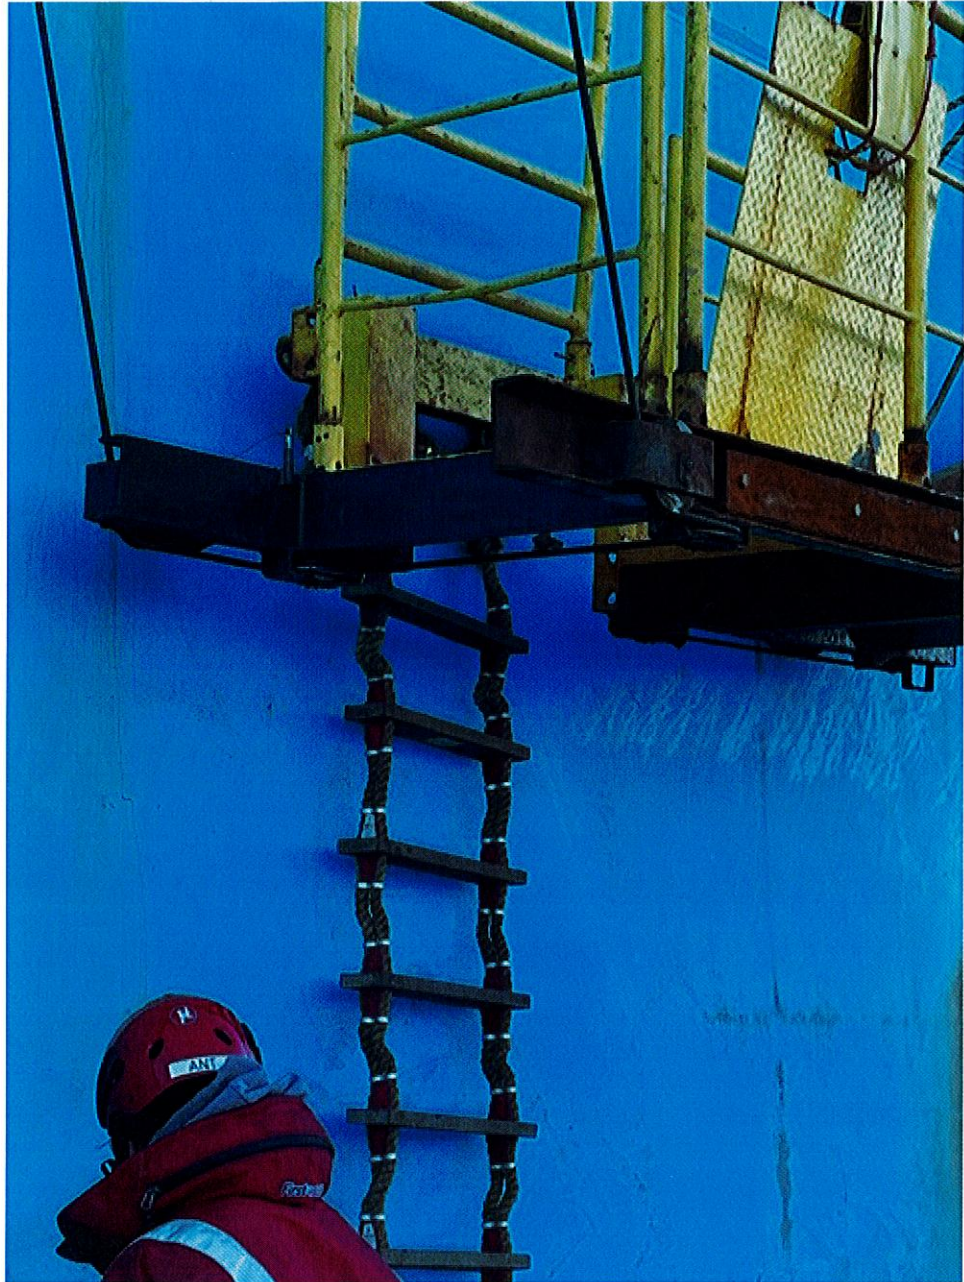
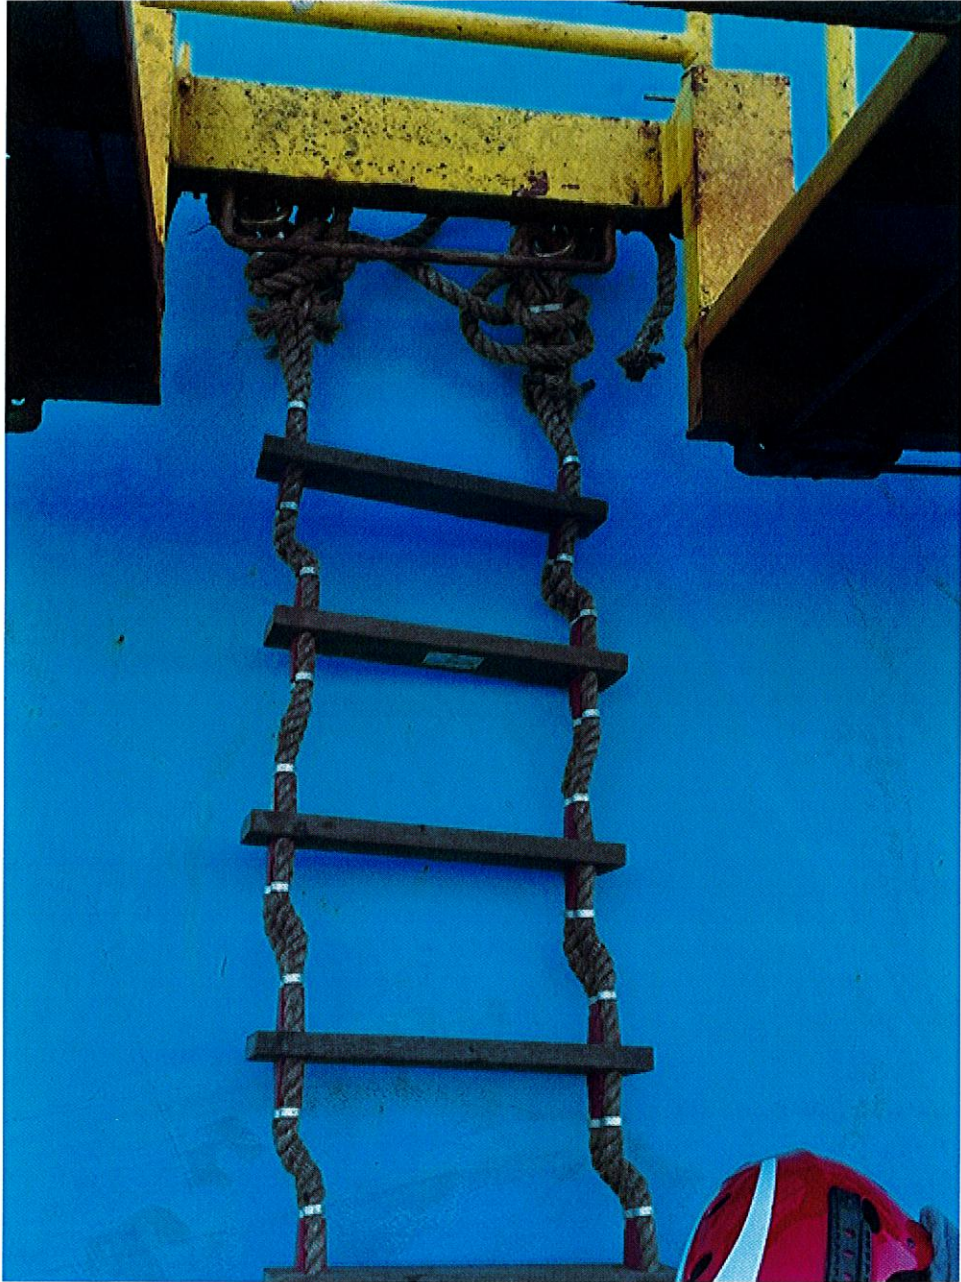
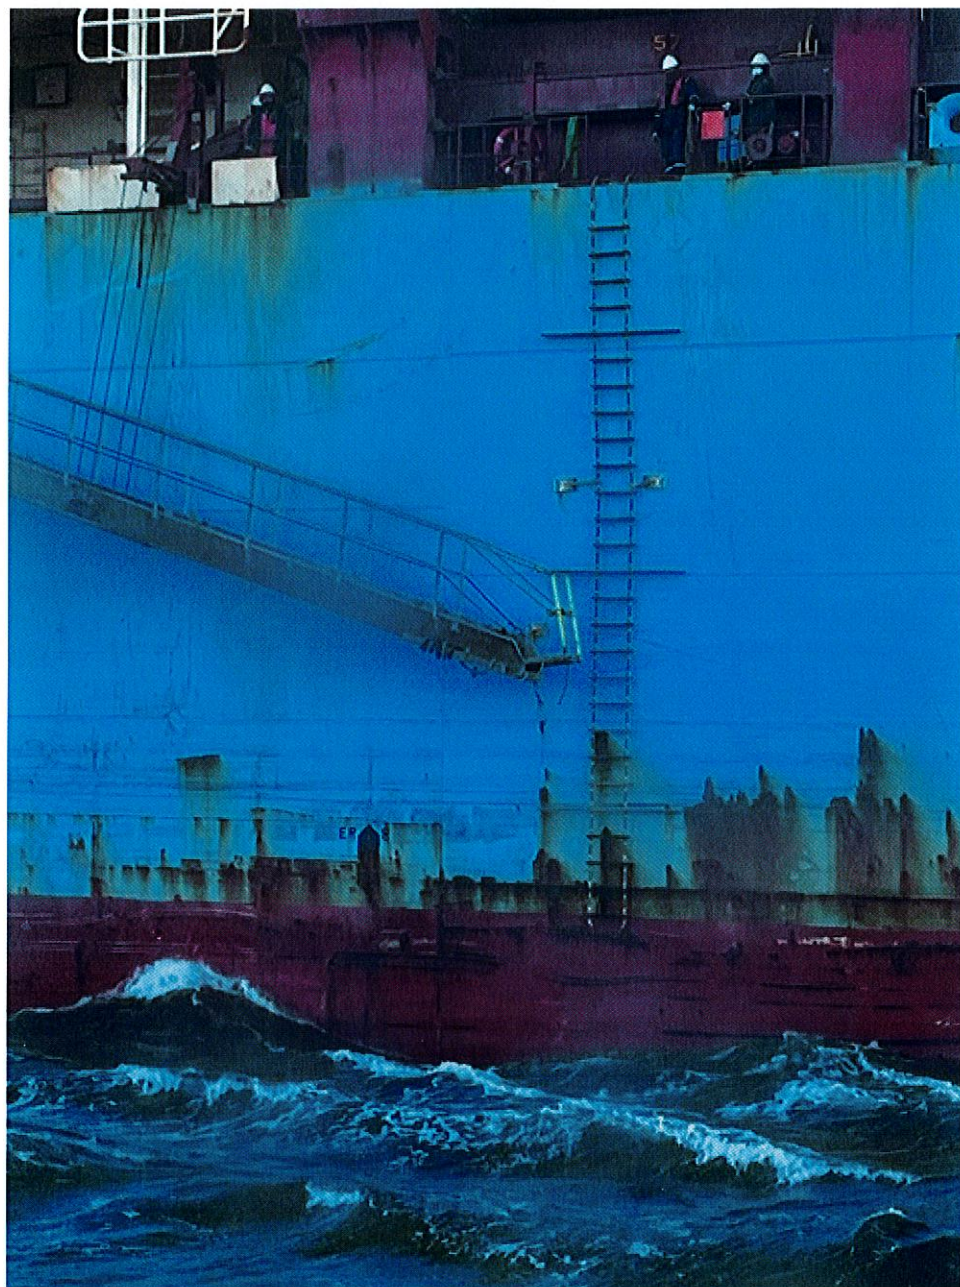
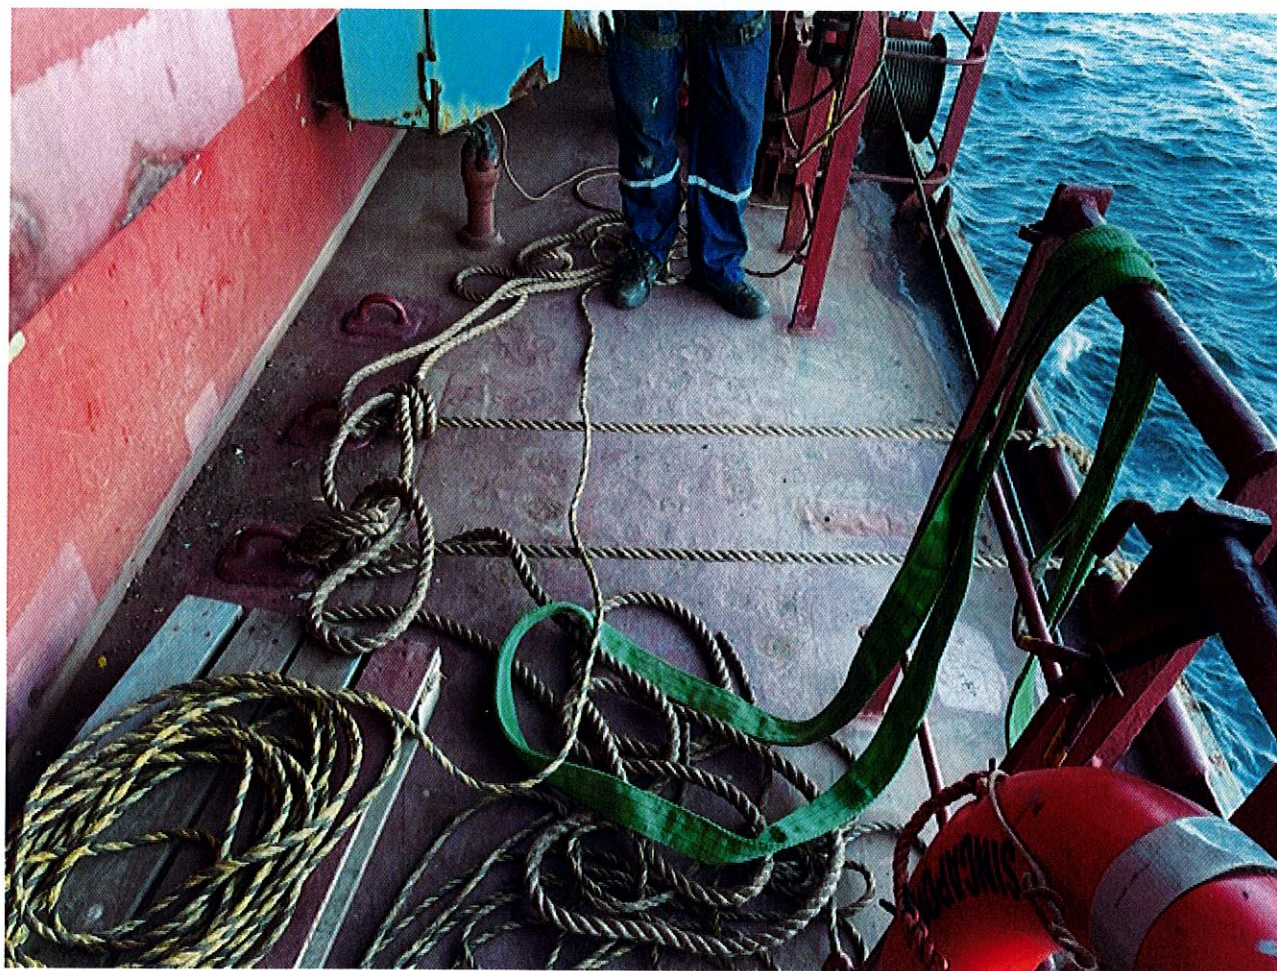
Trap door on stbd side as backup. Second accom ladder on stbd side not working

Trap door rigged on stbd side as backup. Other accom Ladder used for traditional combo configuration unable to be use

Due to malfunction. Refused trap door and used port side combination ladder. Capt says stbd will be

Fixed prior to sailing. Should be confirmed before leaving port.
