## PILOT BOARDING DEFICIENCY REPORT

DATE: 10/7/2021 TIME: 0600

VESSEL: SCF Prime

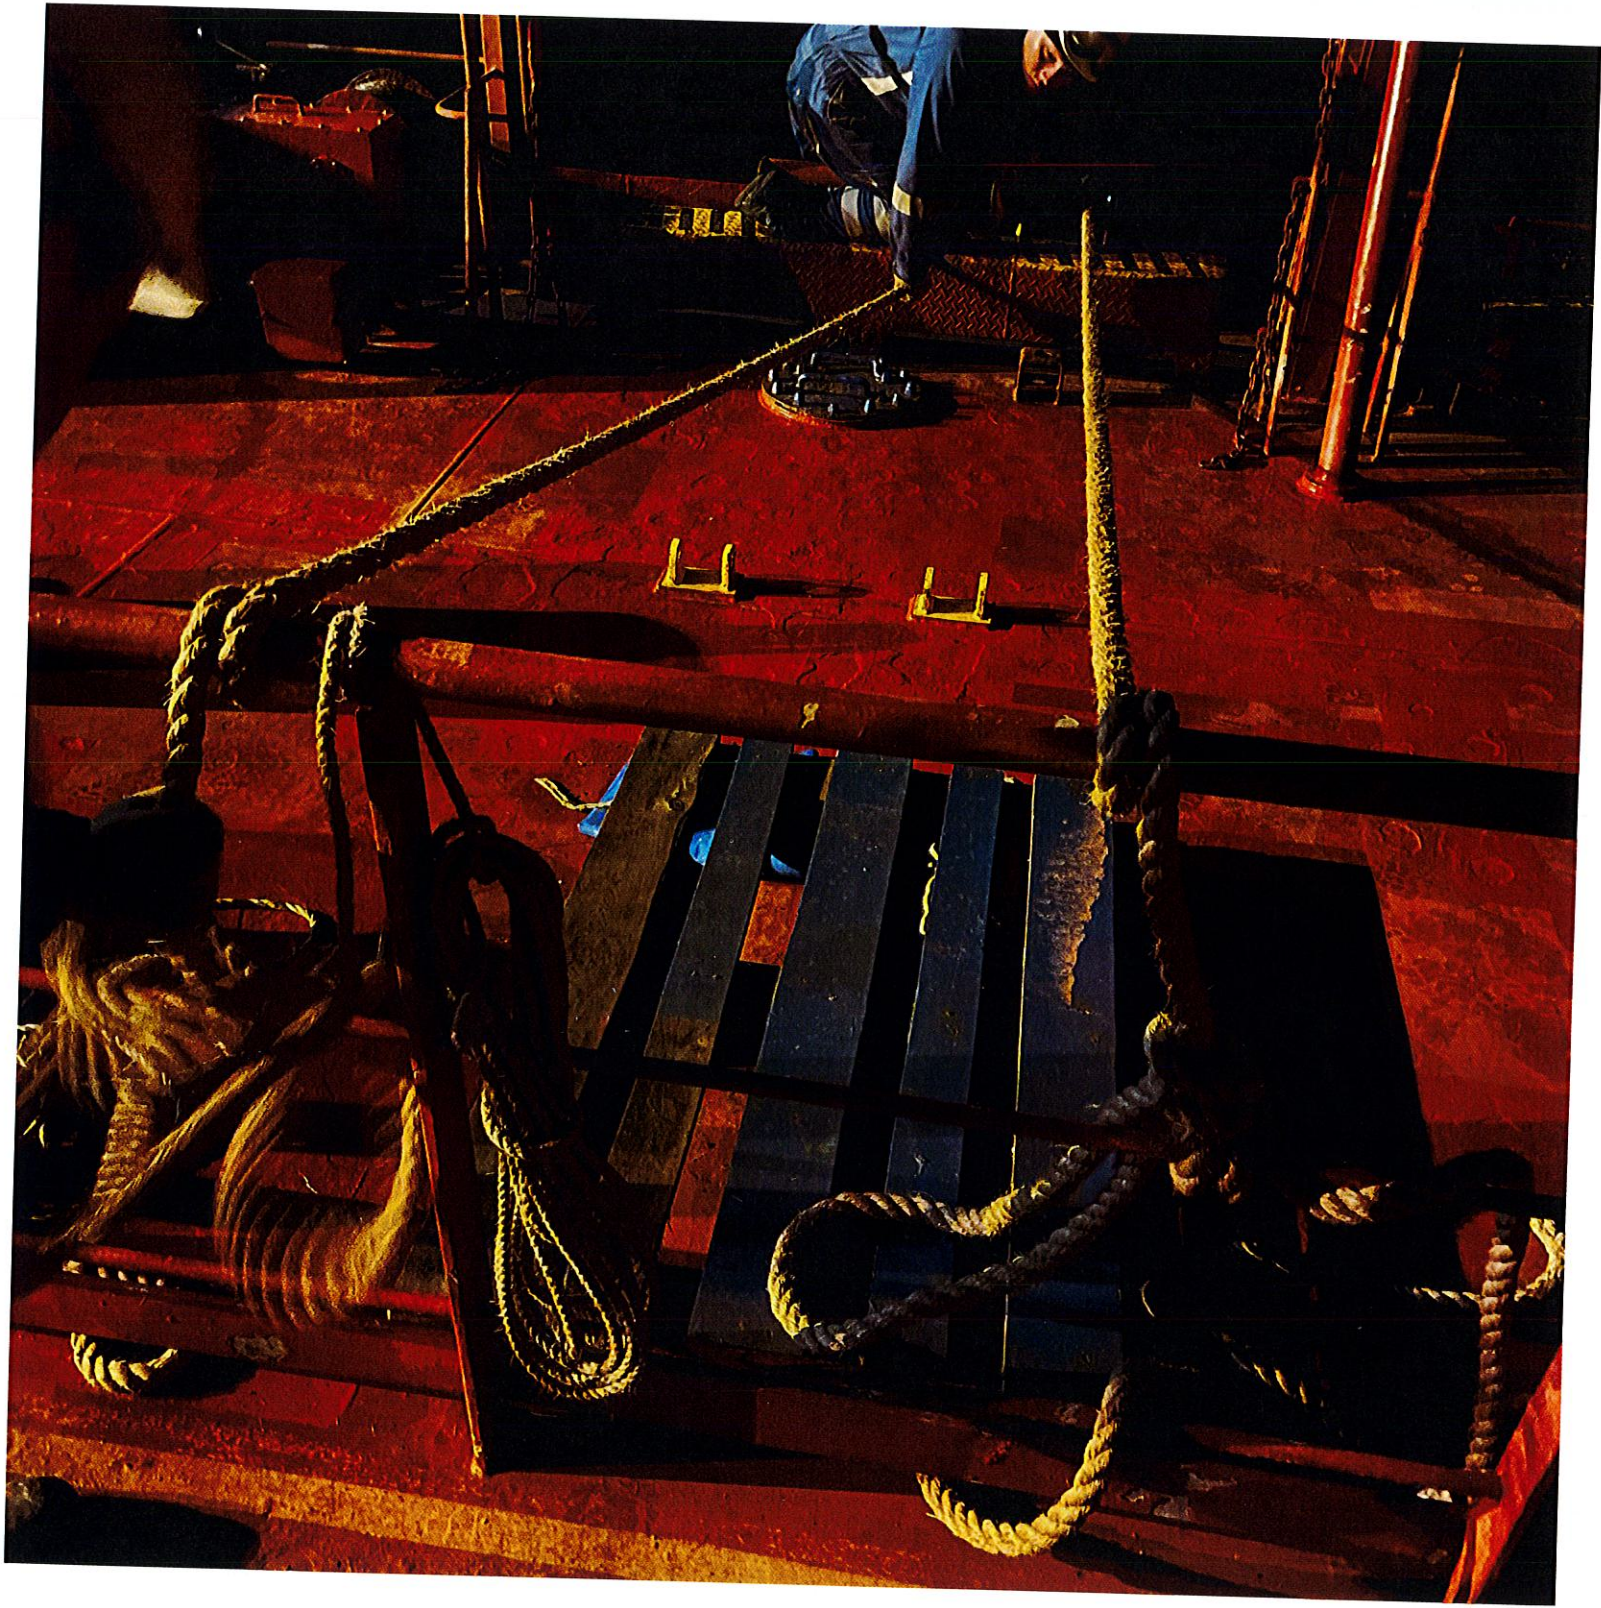
Poor rigging

Crew tied pilot ladder to handrails. (See pics) Strong points on deck were available. Had crew properly tie off

Ladder to strong points.
