## PILOT BOARDING DEFICIENCY REPORT

DATE: 6 SEP 21 TIME: 0000

VESSEL: SEA BONT

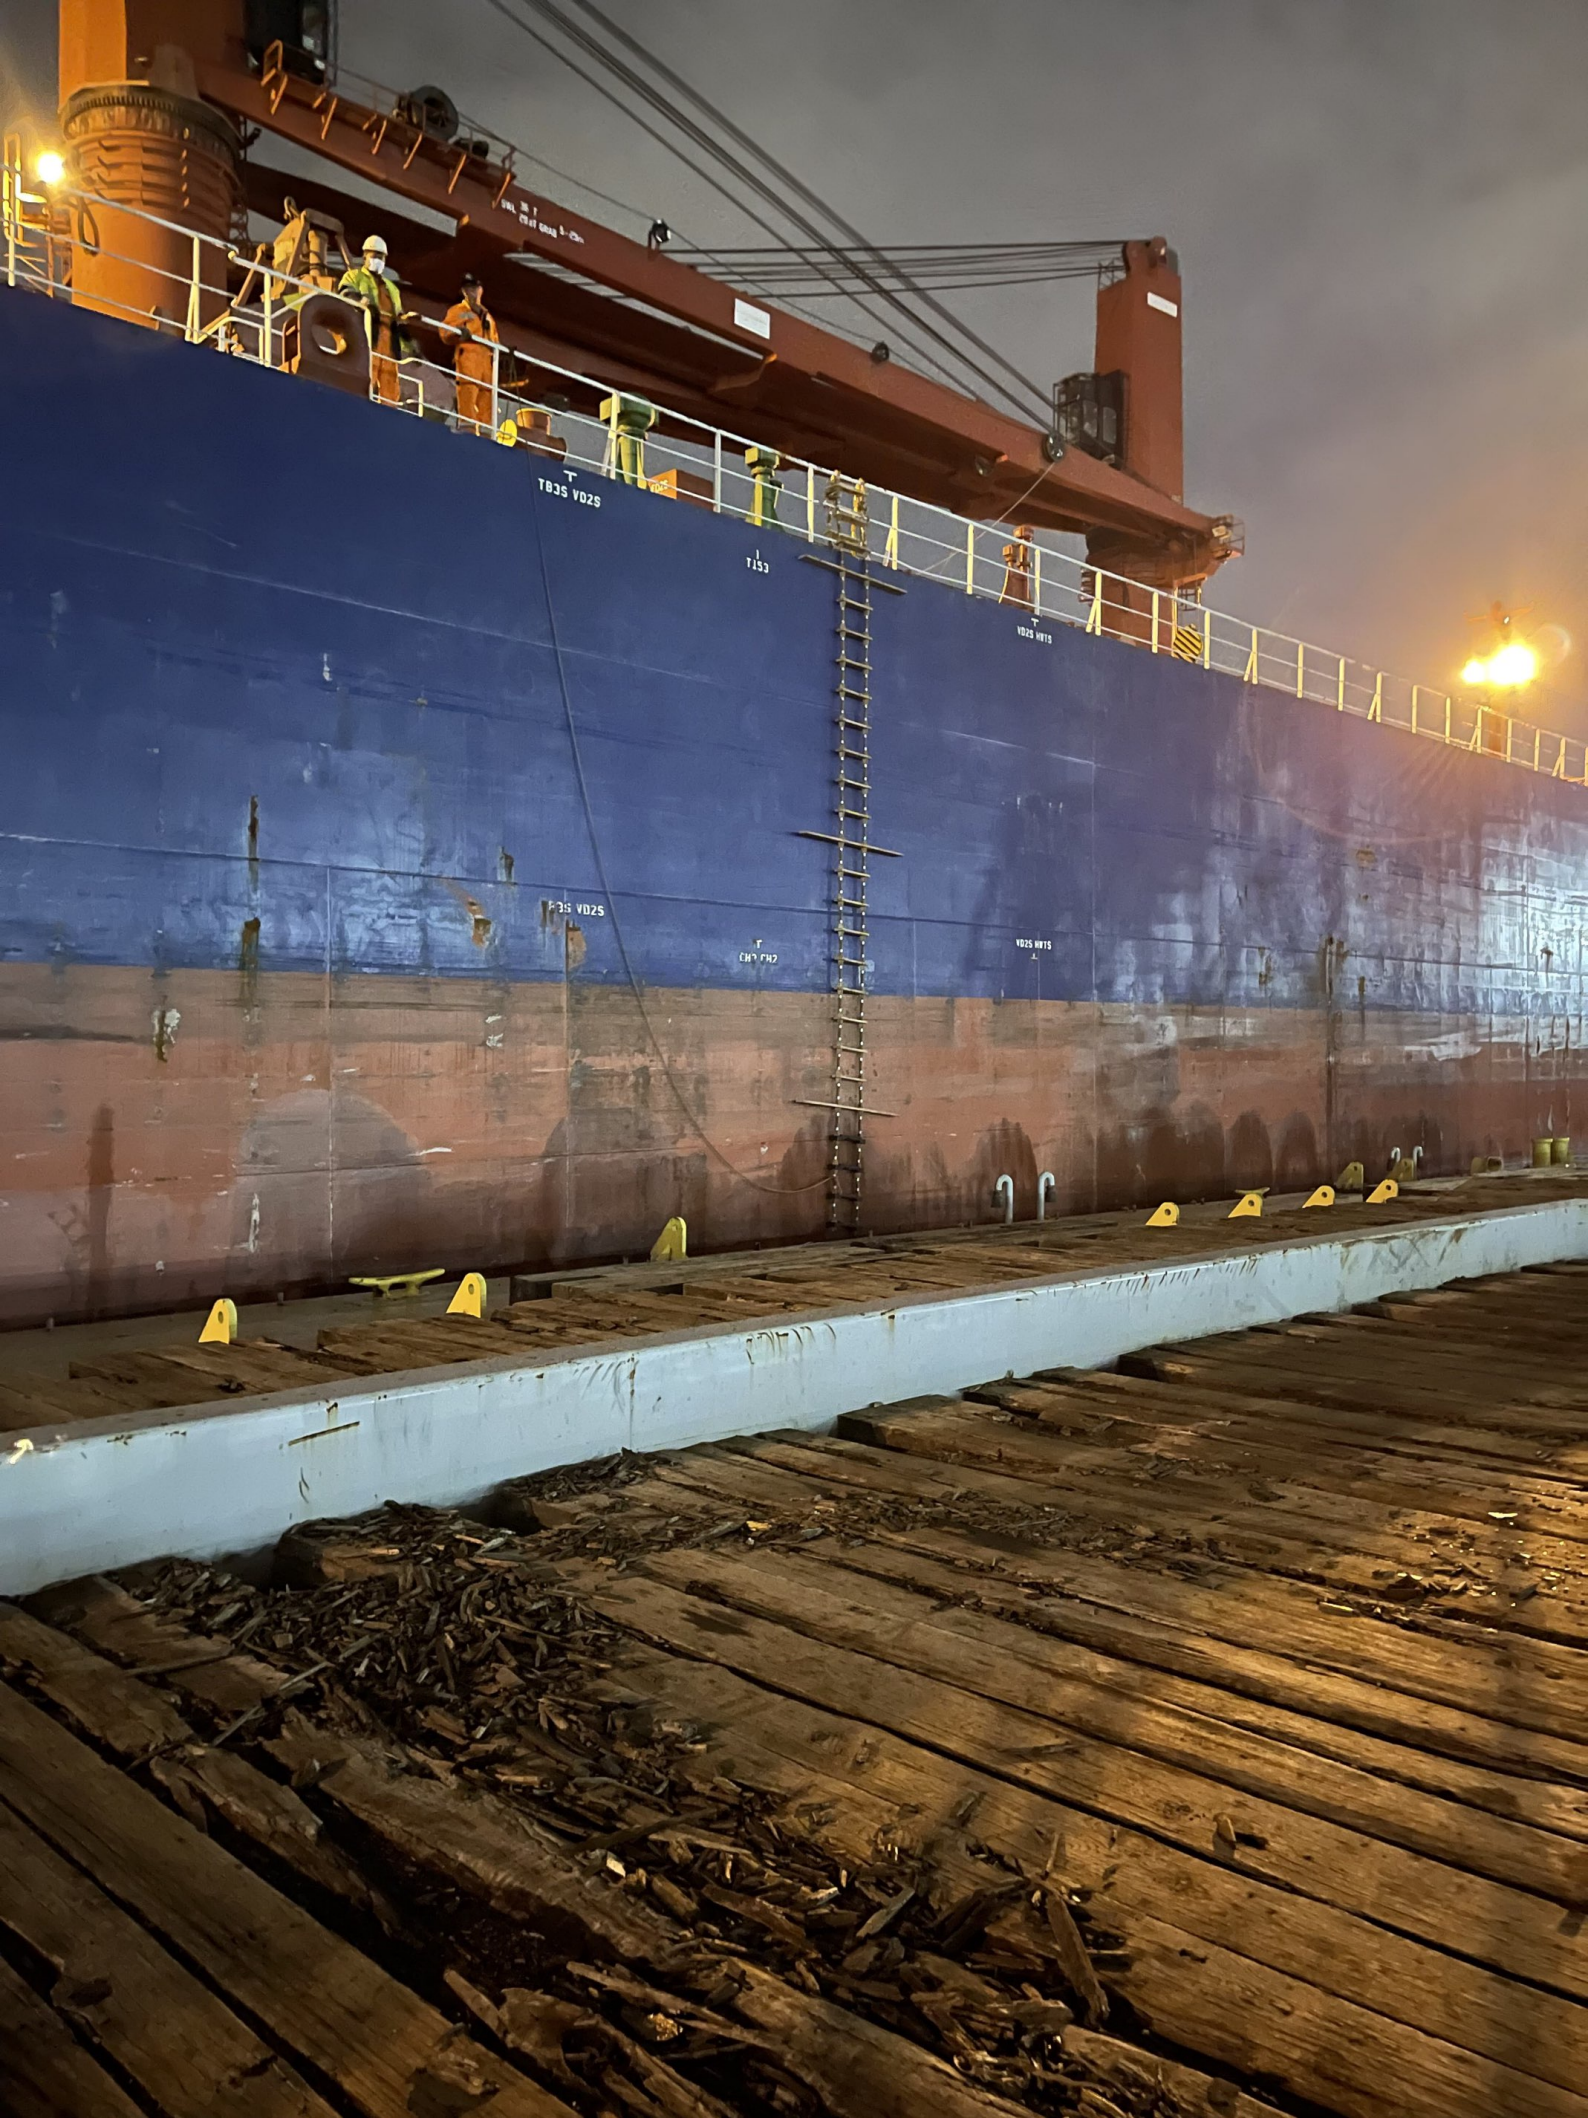
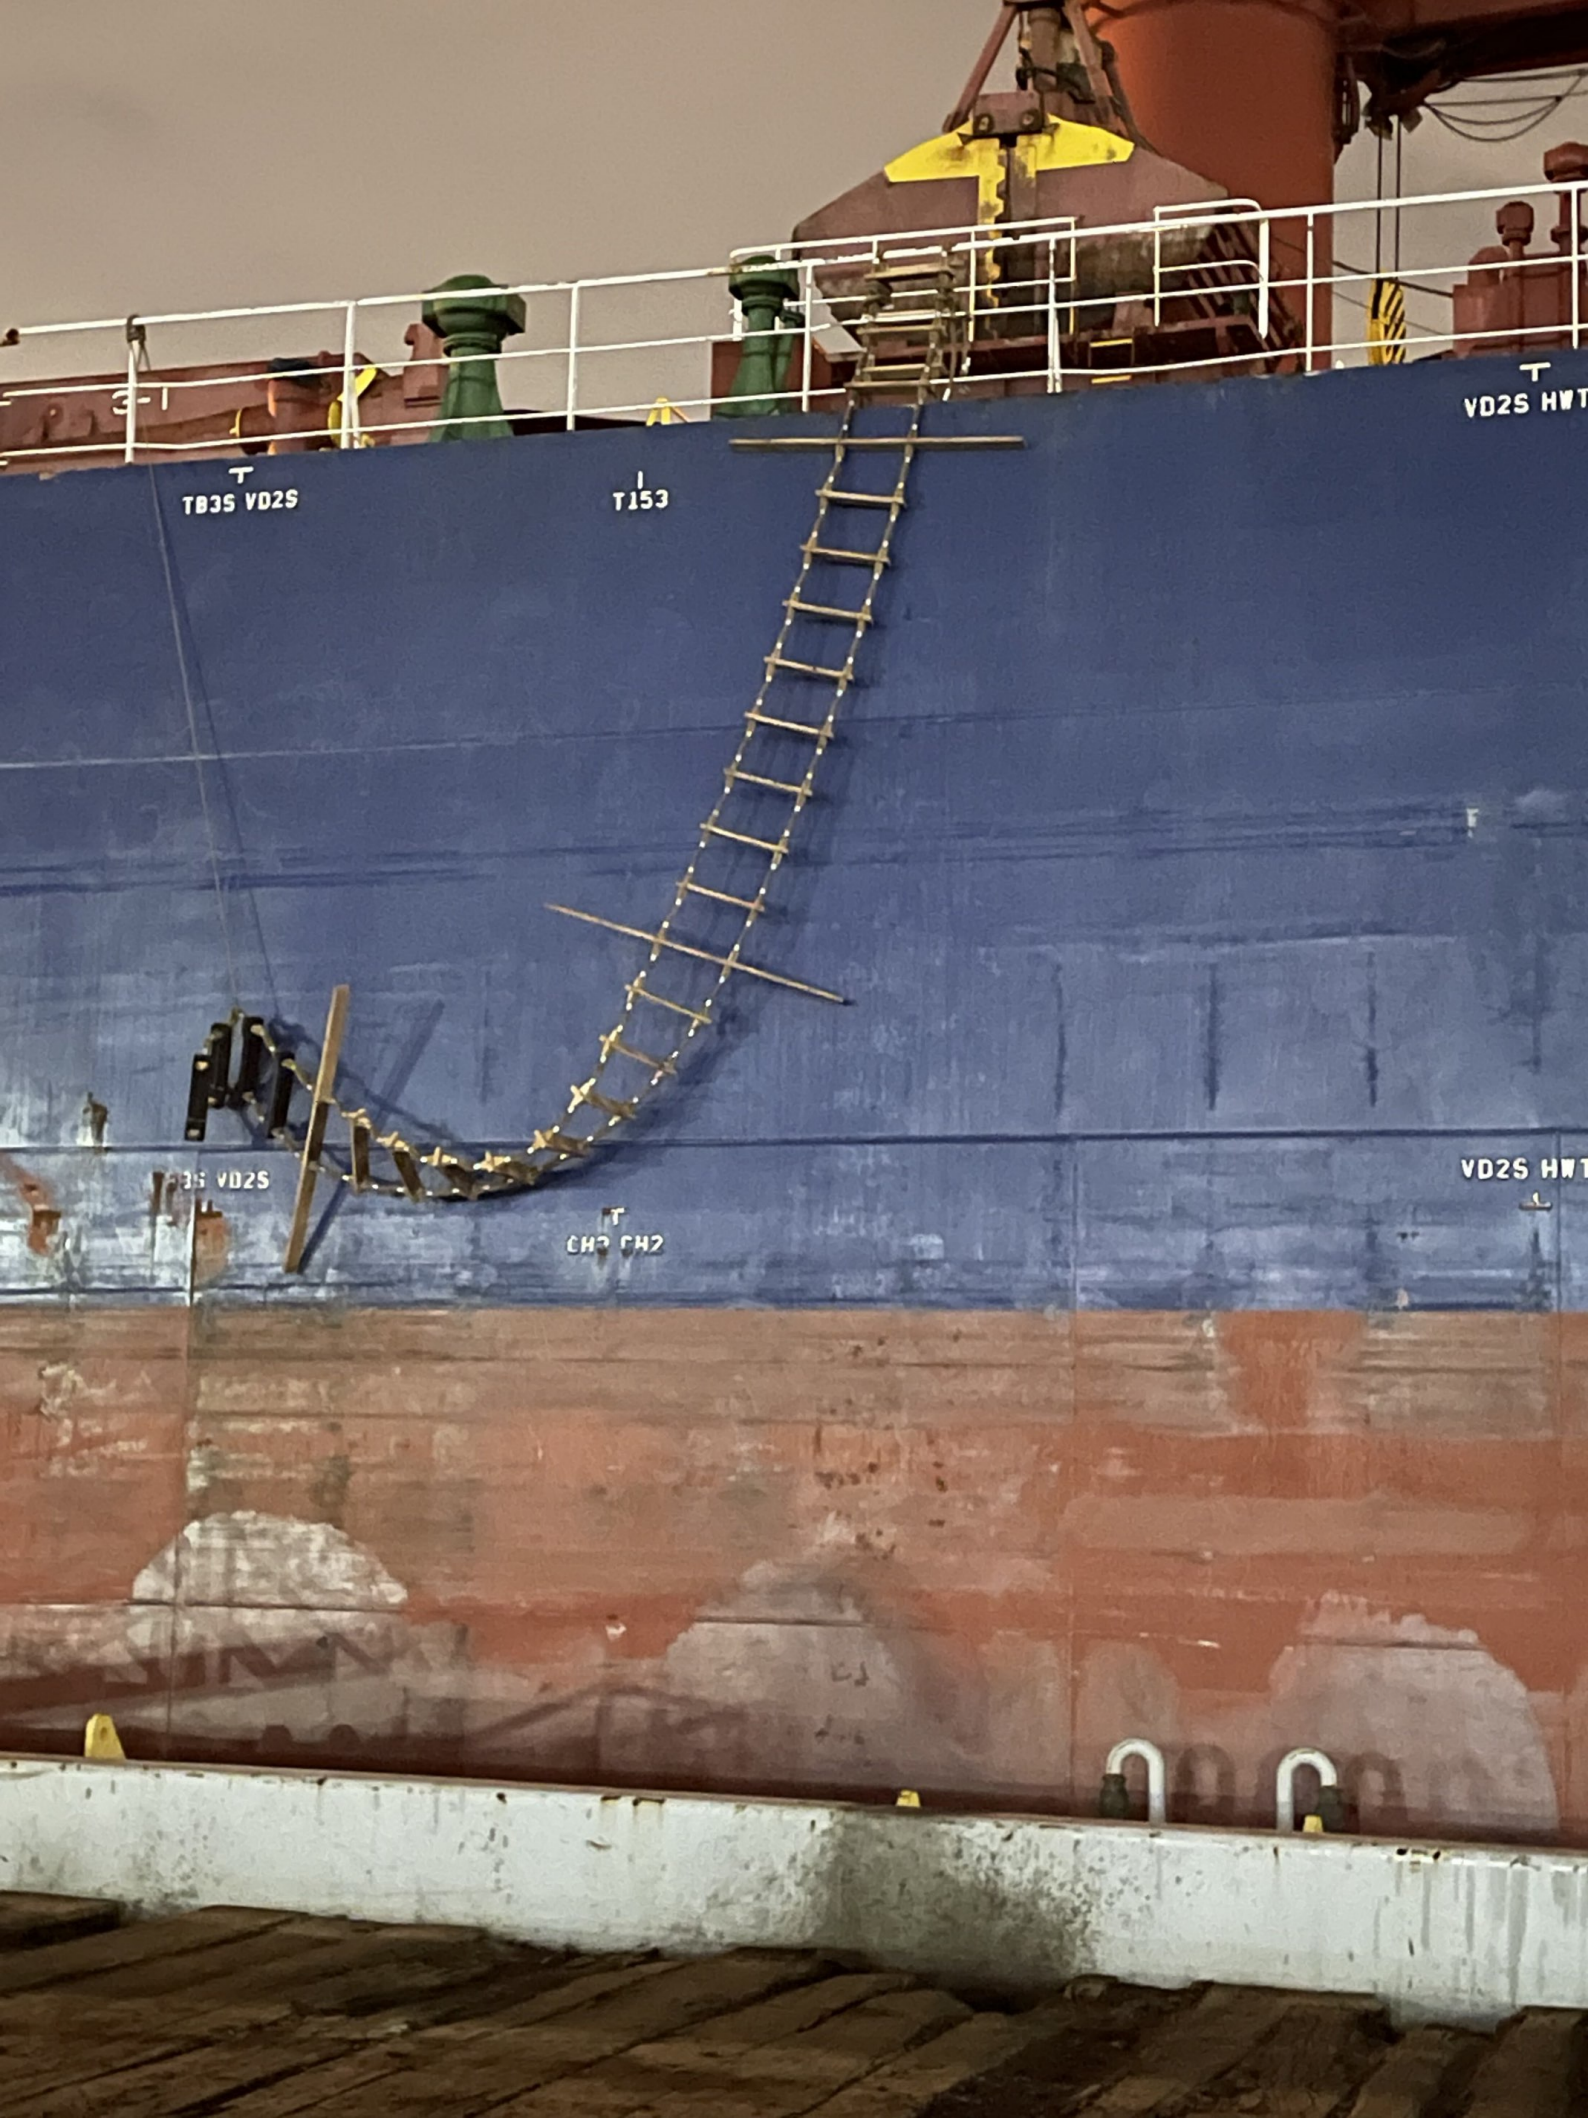
Unsafe deck access

Ship was docked starboard side to, along a barge. Because of this, everything aft of amidships was over the water (gangway). The Miriam Moran was able to get under the bow lines & pick me up off the barge
