PILOT BOARDING DEFICIENCY REPORT

DATE: 10/21/2021 TIME: 1730

VESSEL: Term Resilience

PILOT: M. P. Haley

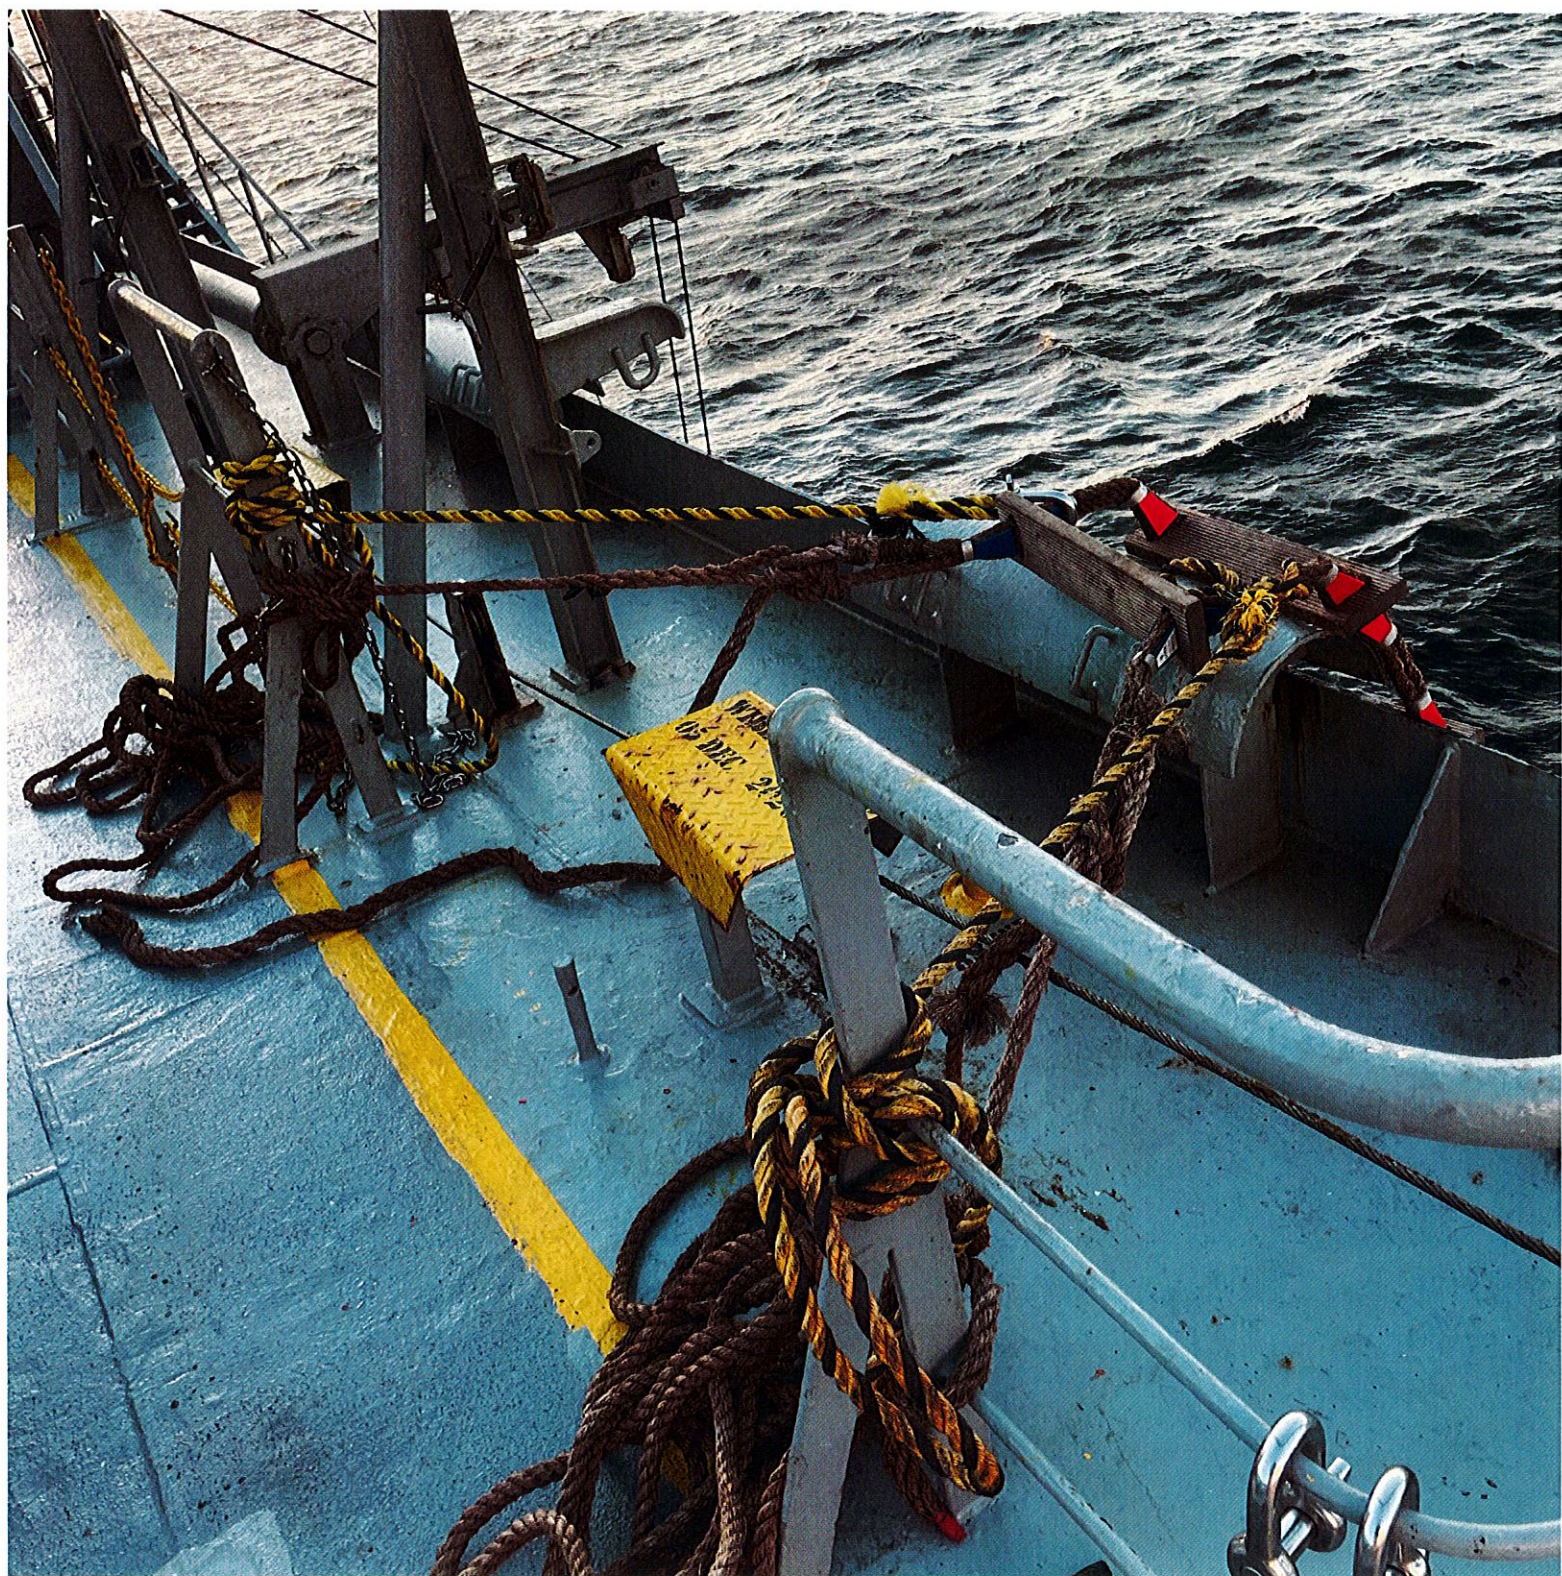
- ☒ GENERAL ARRANGEMENT (ie: Insufficient lighting, no officer, unsafe deck access, etc.)
Ship has 10-10.5m freeboard. Combination ladder not rigged. Only pilot ladder. See Pic
- ☒ PILOT LADDER (ie: Poor condition/wear, not resting on hull, poor rigging, etc.)
Upon re-rigging pilot ladder secured using handrails. Not "strongpoints on deck"
- ☐ COMBINATION LADDER (ie: Poor condition/wear, not secured, platform too low, etc.)
- ☐ MAN ROPES (ie: Poor condition/wear, incorrect diameter, poor rigging, etc.)
- ☐ DOCKSIDE (ie: Gangway condition/pitch, netting, poor rigging, etc.)

Ladder rigged right next to hull markings showing more than 9m freeboard. Vessel is capable of rigging a combo ladder
With a gangway. Refused to board until rigged configured properly using a combination. Vessel
Rigged combination. After boarding saw the ladder secured only to handrail. See pic
