PILOT BOARDING DEFICIENCY REPORT

DATE: 11/26/2021 TIME: 1500

VESSEL: Wan Hai 515

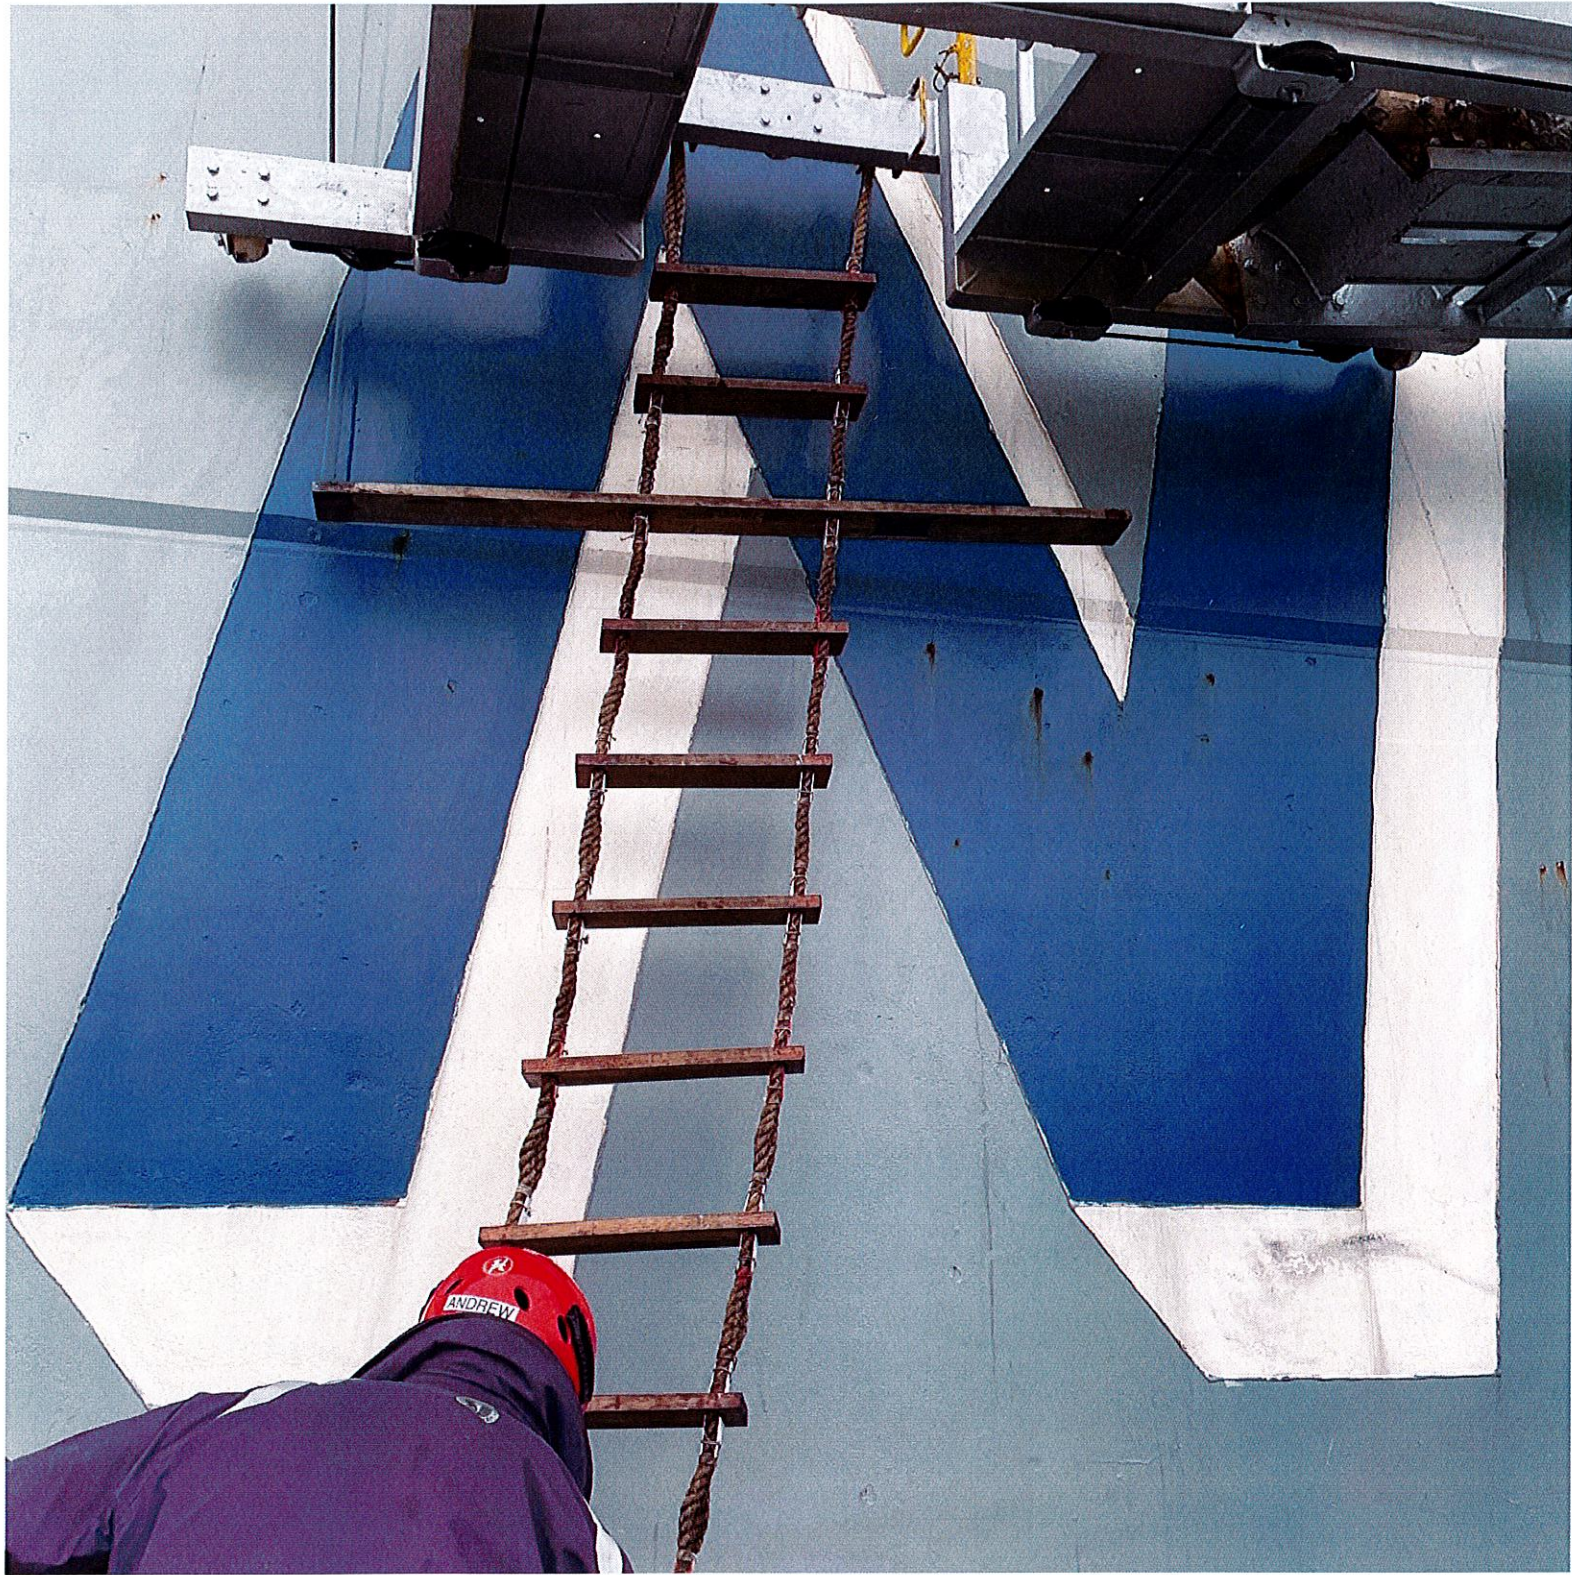
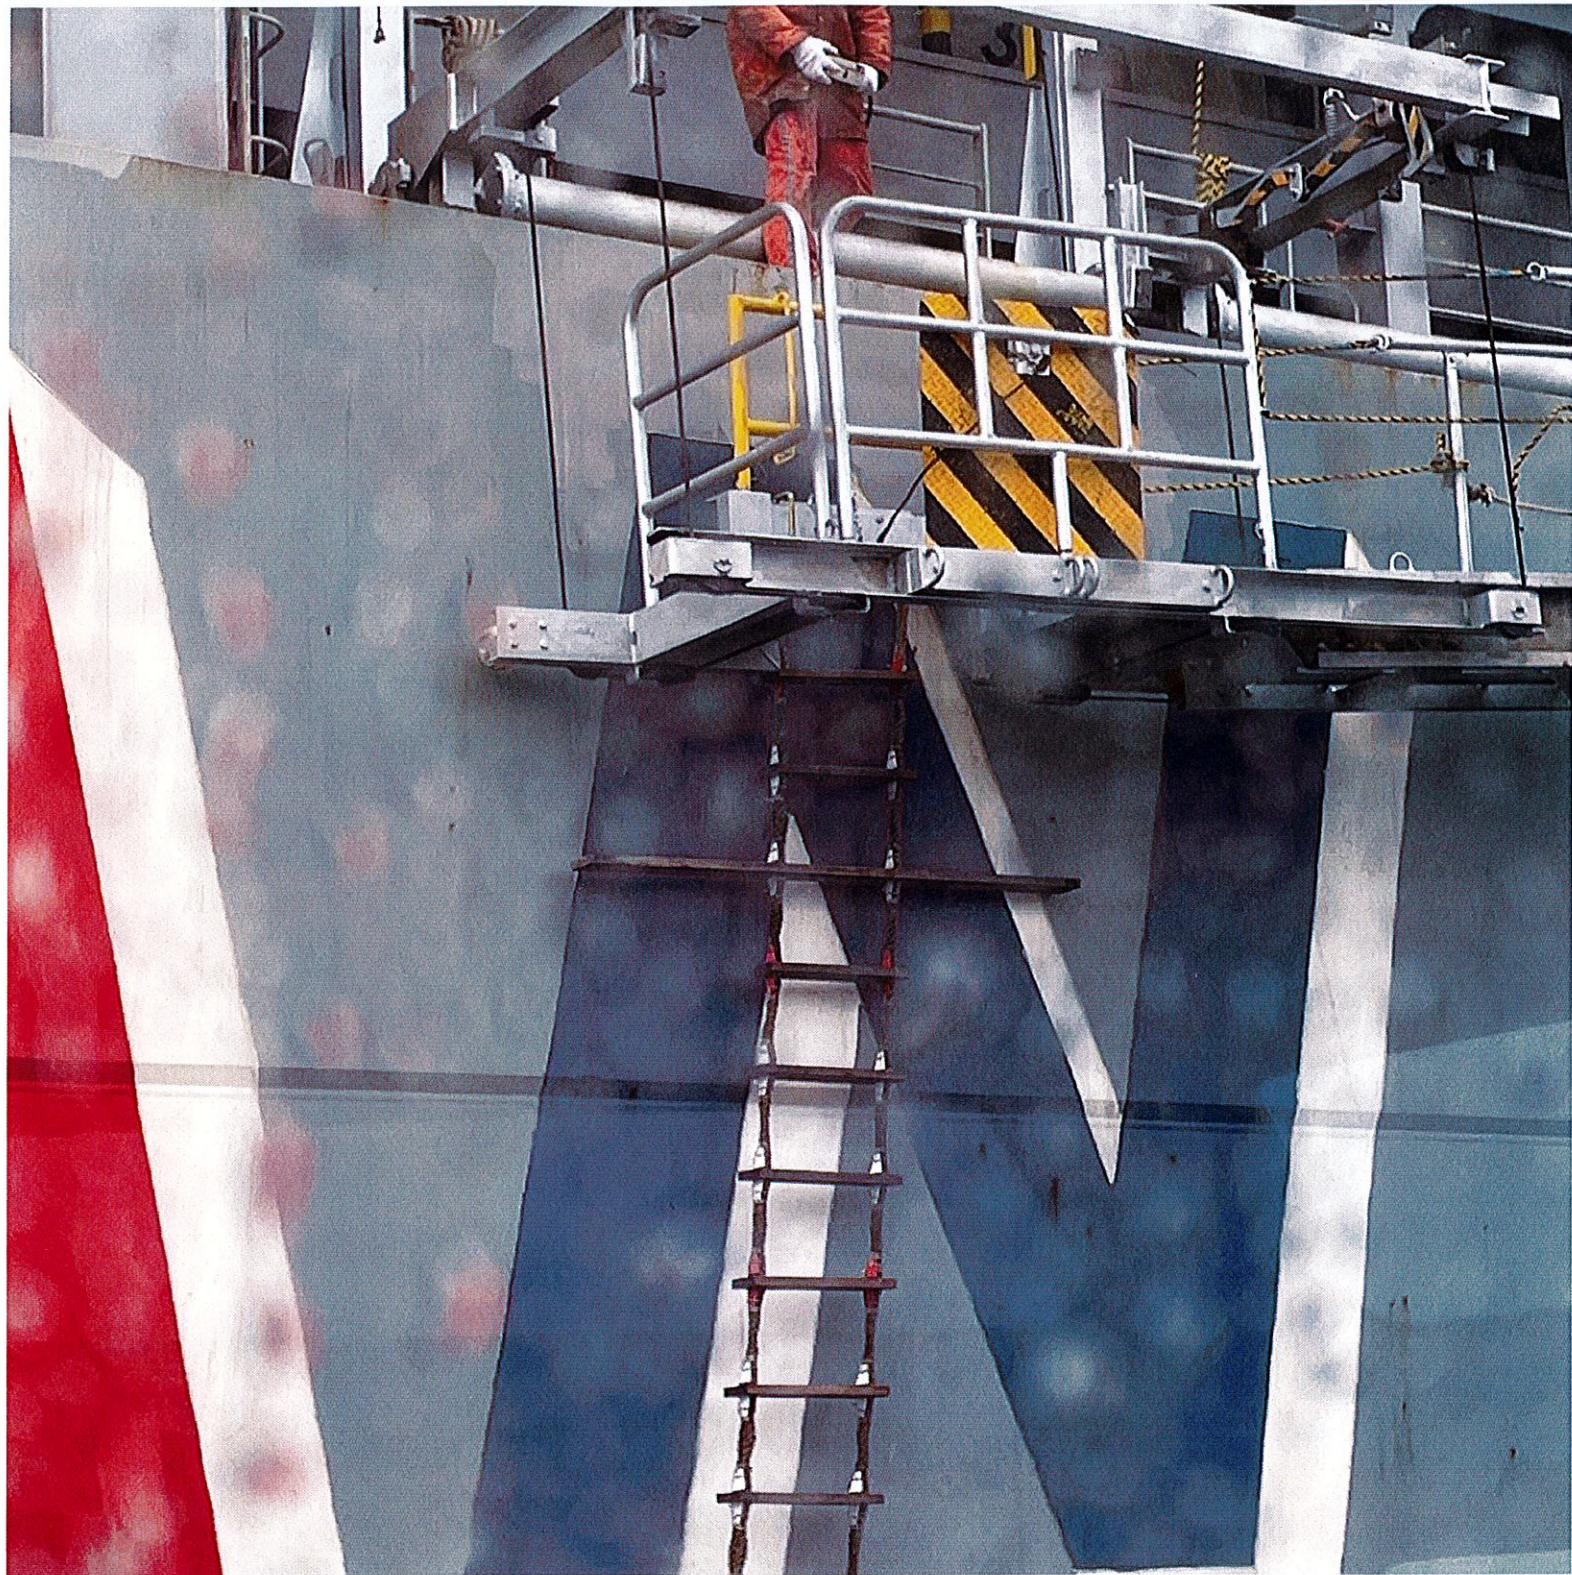
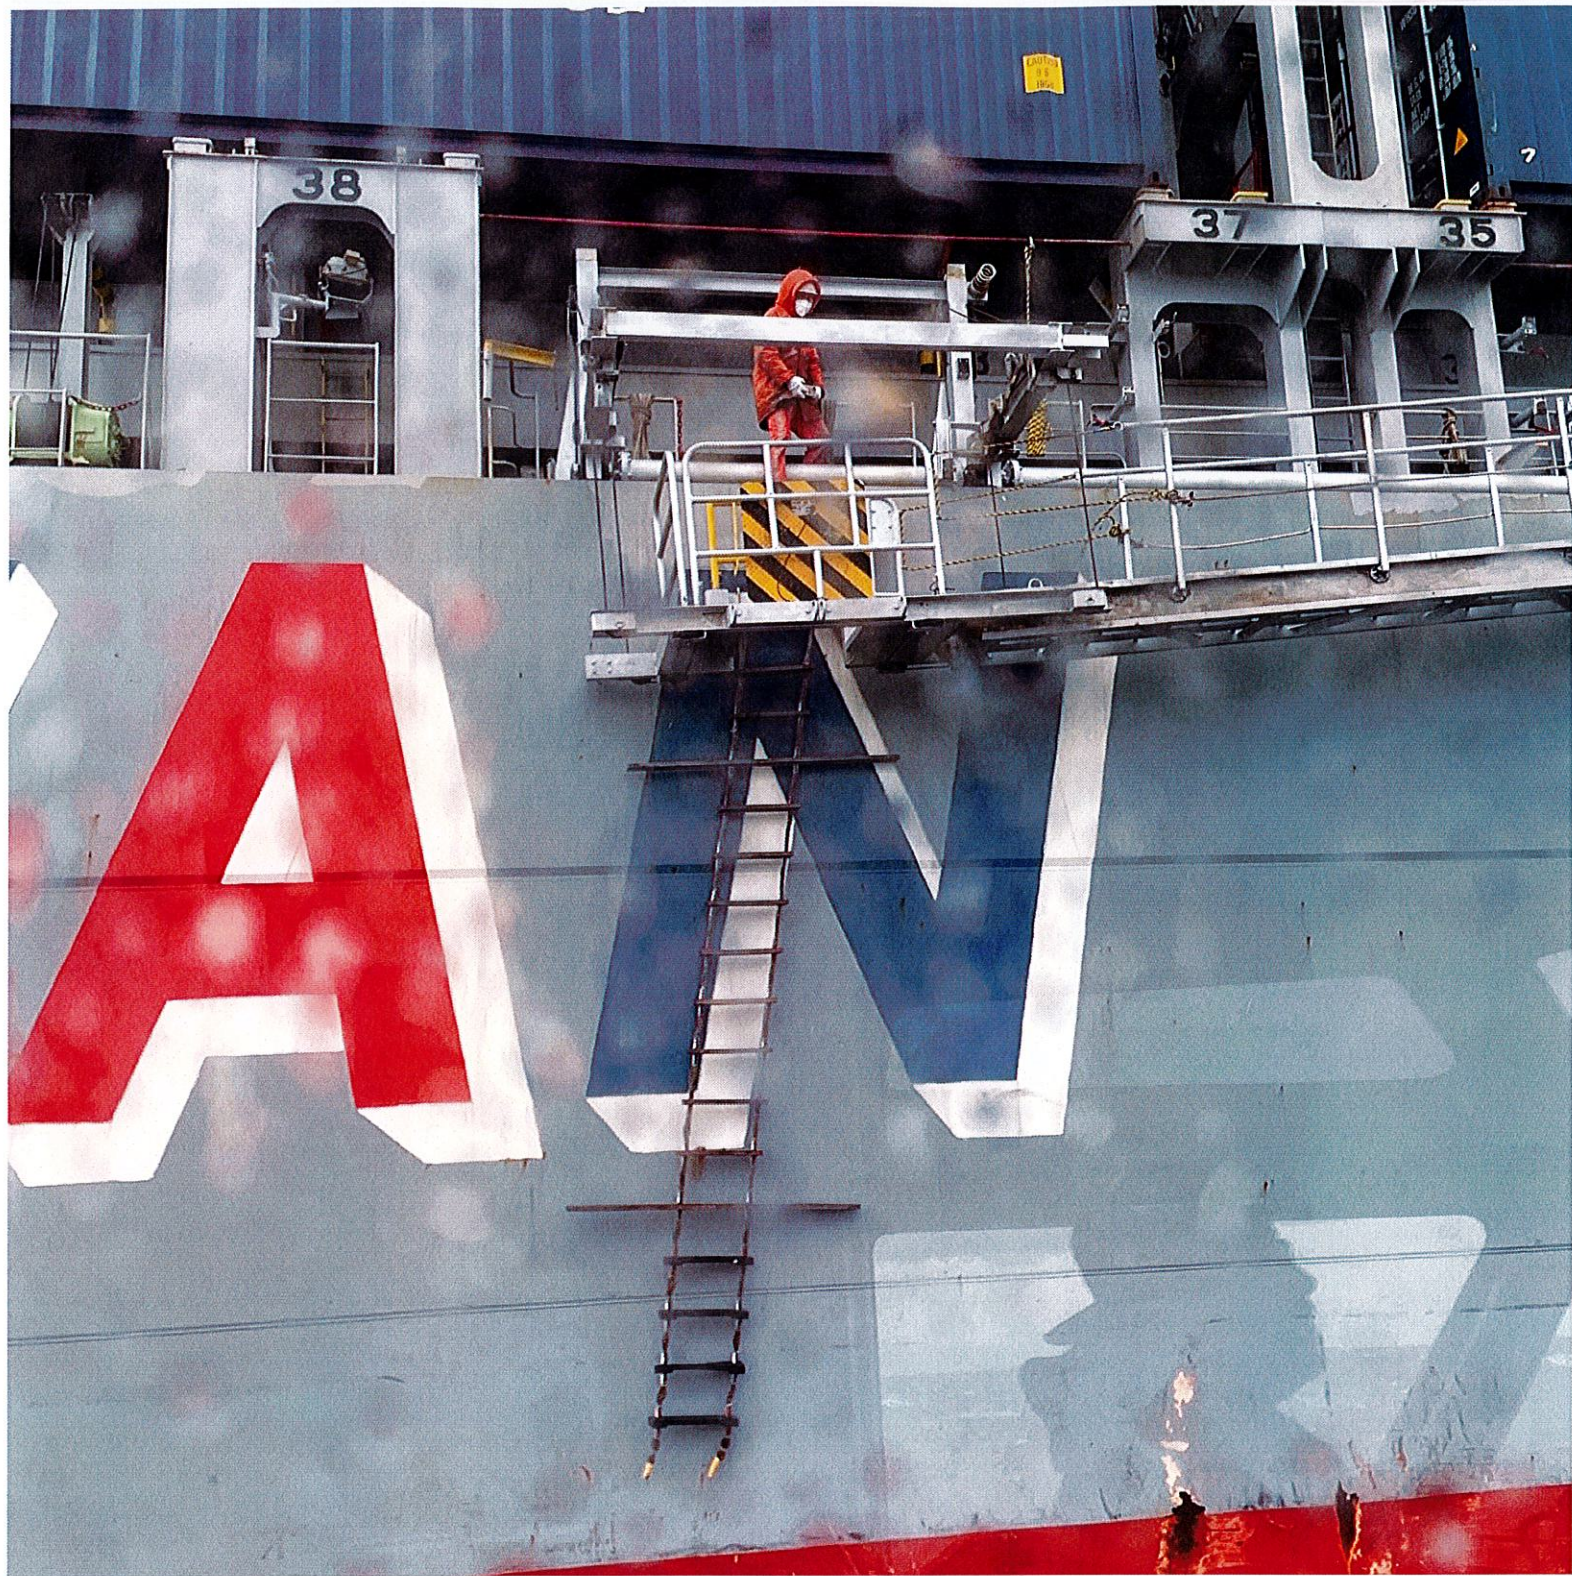
- ☒ GENERAL ARRANGEMENT (ie: Insufficient lighting, no officer, unsafe deck access, etc.)
Non compliant trap door arraignment. Gangway not secured to side of ship.
- ☒ PILOT LADDER (ie: Poor condition/wear, not resting on hull, poor rigging, etc.)
Ladder not resting against hull.
- ☒ COMBINATION LADDER (ie: Poor condition/wear, not secured, platform too low, etc.)
Ladder not fully passing through trap door. Not rigged to "height of handrail"
- ☐ MAN ROPES (ie: Poor condition/wear, incorrect diameter, poor rigging, etc.)
- ☐ DOCKSIDE (ie: Gangway condition/pitch, netting, poor rigging, etc.)

Vessel built in 2013 so shouldn't be "grandfathered in." Due to language barrier on VHF and close proximity to another vessel

On station, I ended up boarding instead of refusing for safety reasons. See pics attached
