## PILOT BOARDING DEFICIENCY REPORT

DATE: August 5, 2021 TIME: 0600

VESSEL: Zhong An Xin Hua Yuan

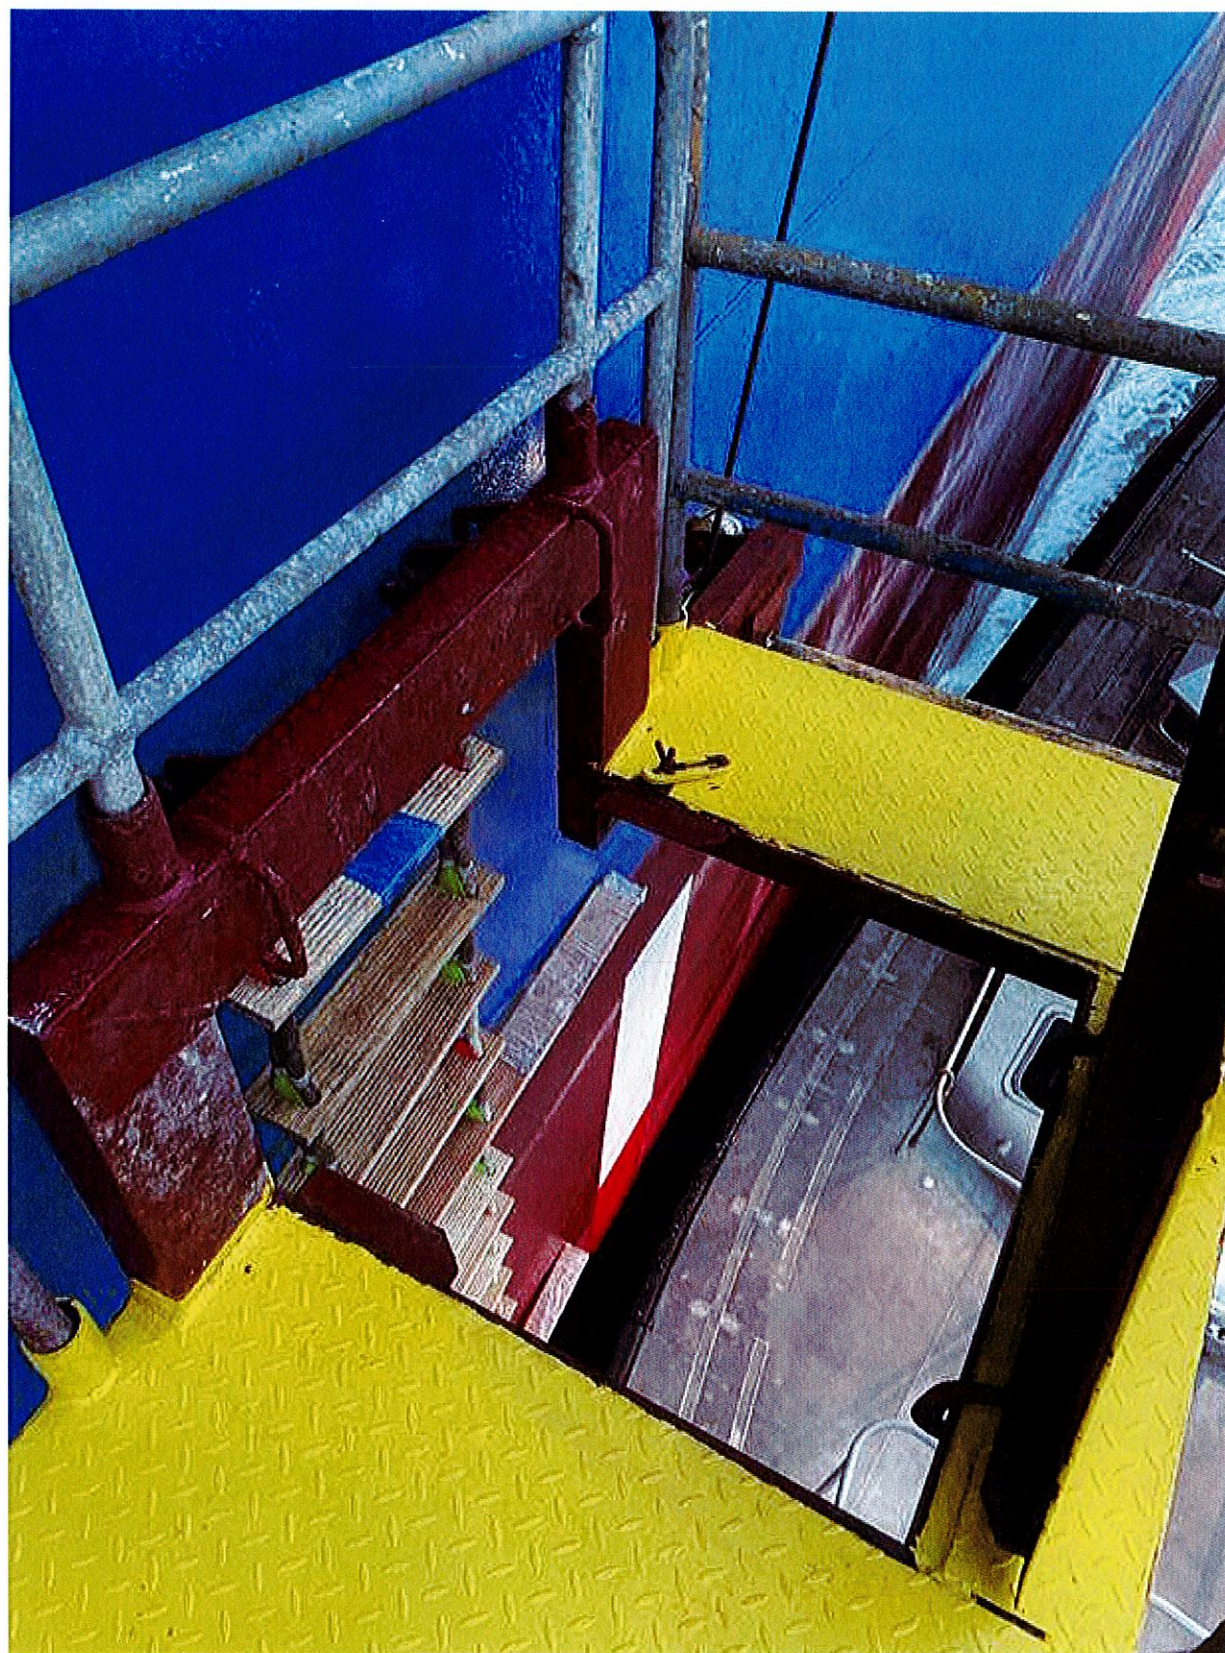
- ☐ GENERAL ARRANGEMENT (ie: Insufficient lighting, no officer, unsafe deck access, etc.)  
\_\_\_\_\_
- ☐ PILOT LADDER (ie: Poor condition/wear, not resting on hull, poor rigging, etc.)  
\_\_\_\_\_
- ☒ COMBINATION LADDER (ie: Poor condition/wear, not secured, platform too low, etc.)  
Trap door arrangement. Ladder does not go through platform as required. Not secured to hull
- ☐ MAN ROPES (ie: Poor condition/wear, incorrect diameter, poor rigging, etc.)  
\_\_\_\_\_
- ☐ DOCKSIDE (ie: Gangway condition/pitch, netting, poor rigging, etc.)  
\_\_\_\_\_
