## PILOT BOARDING DEFICIENCY REPORT

DATE: 12/30/19 TIME: 0625

VESSEL: maersk Kensington

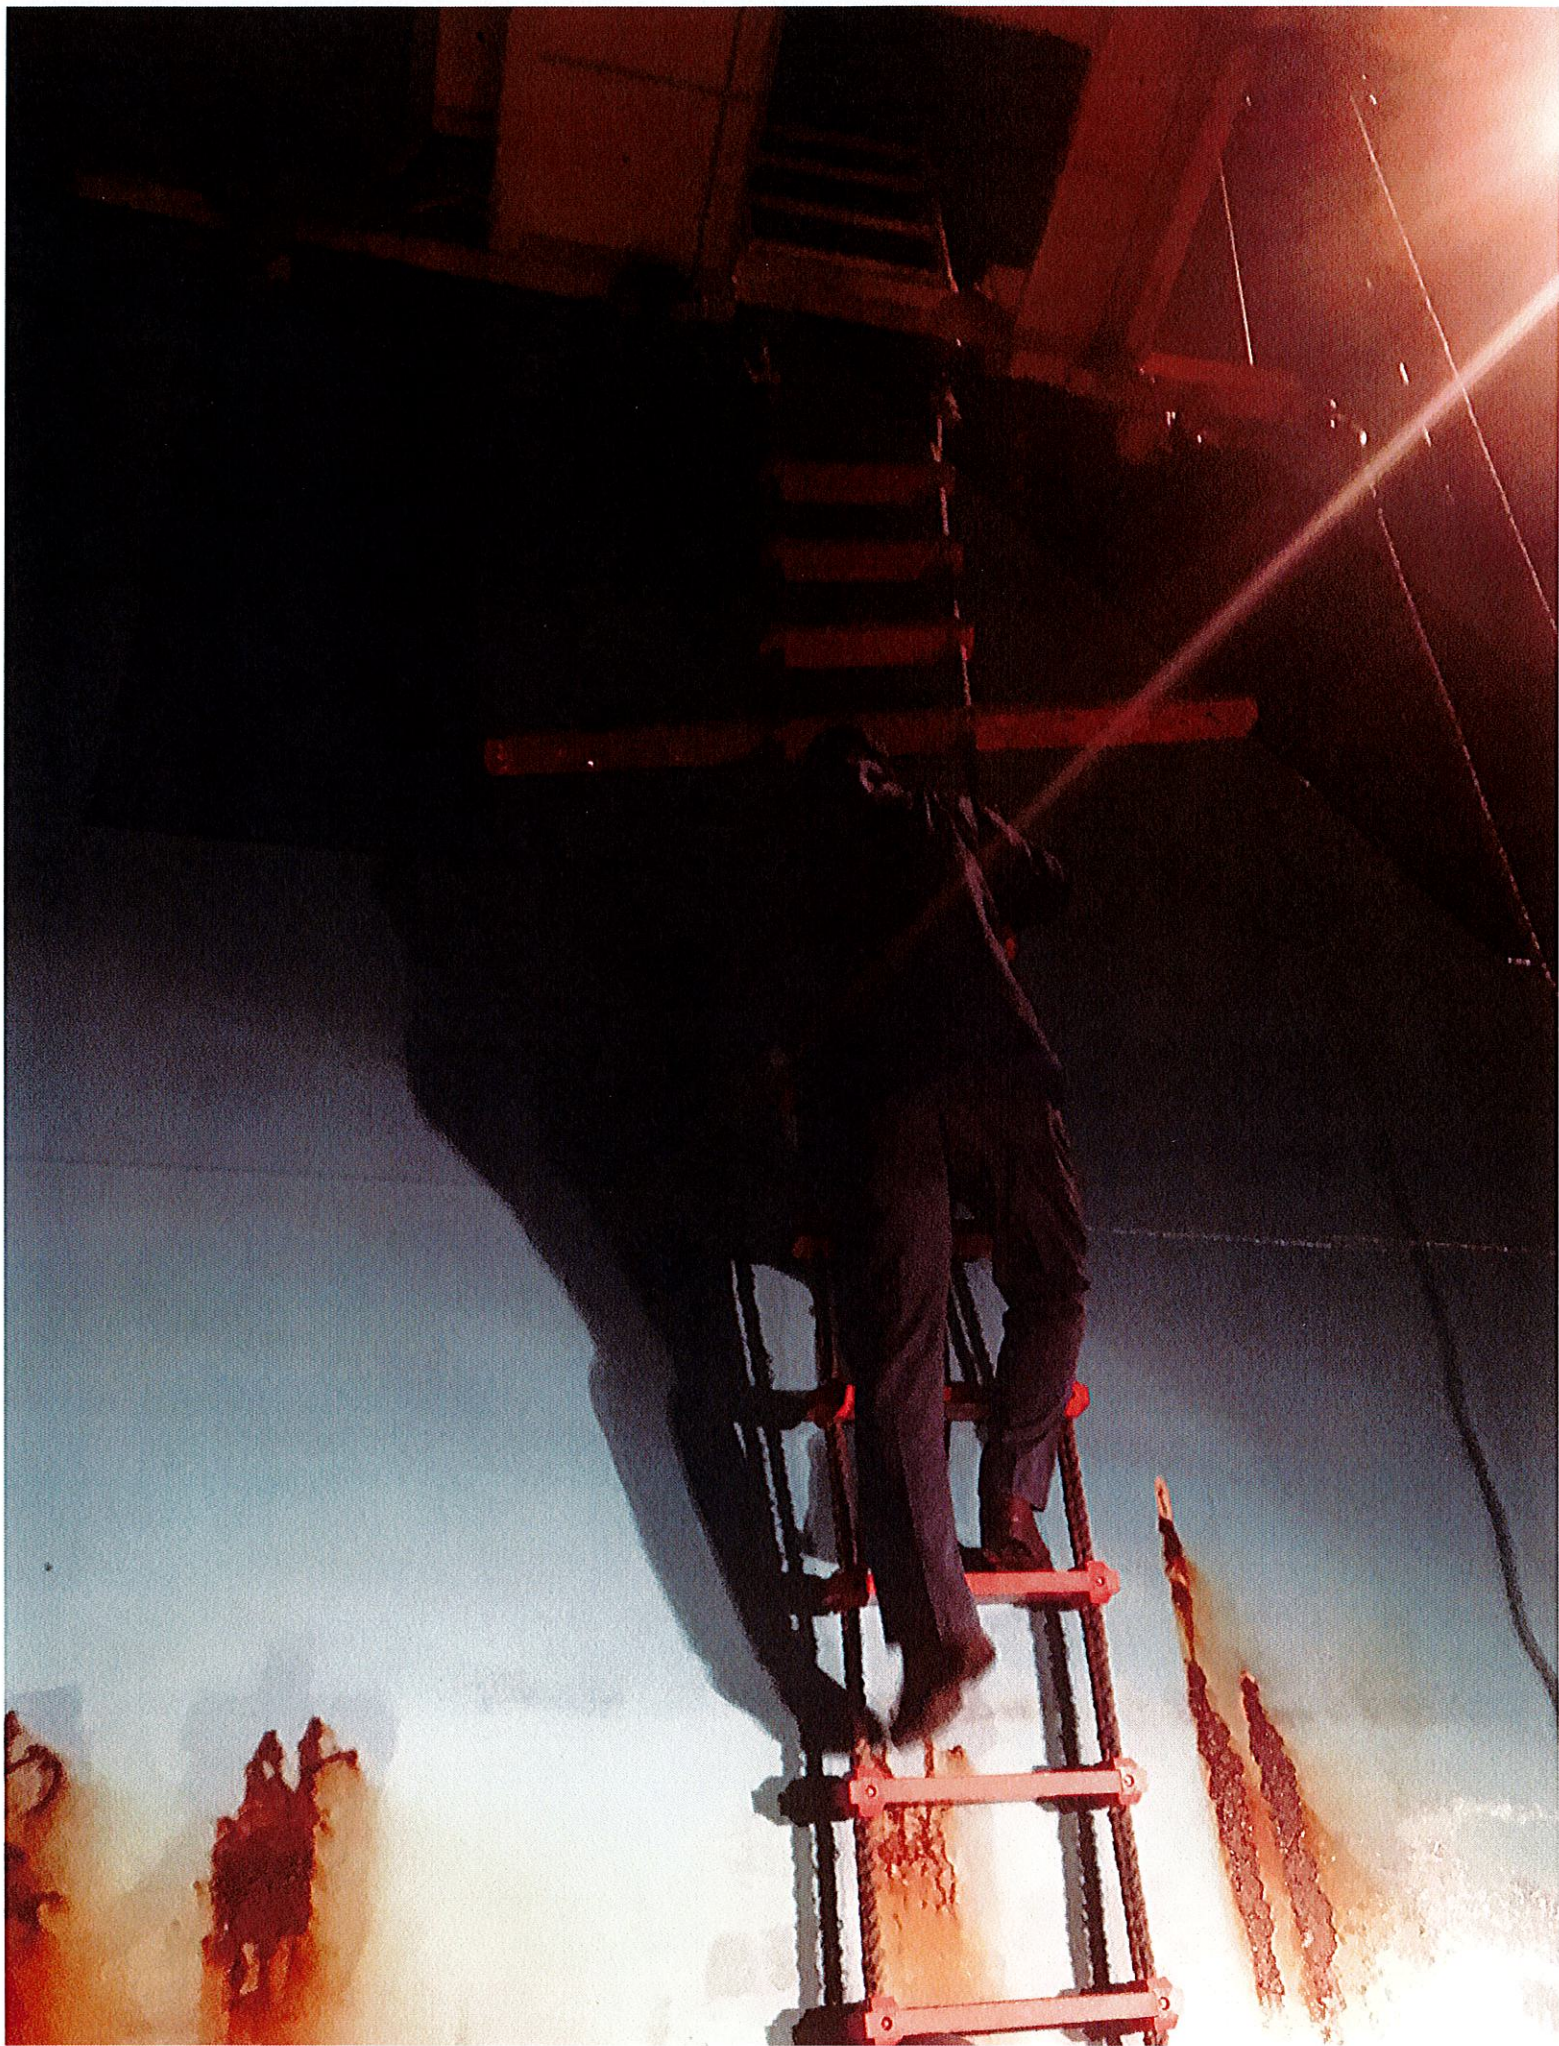
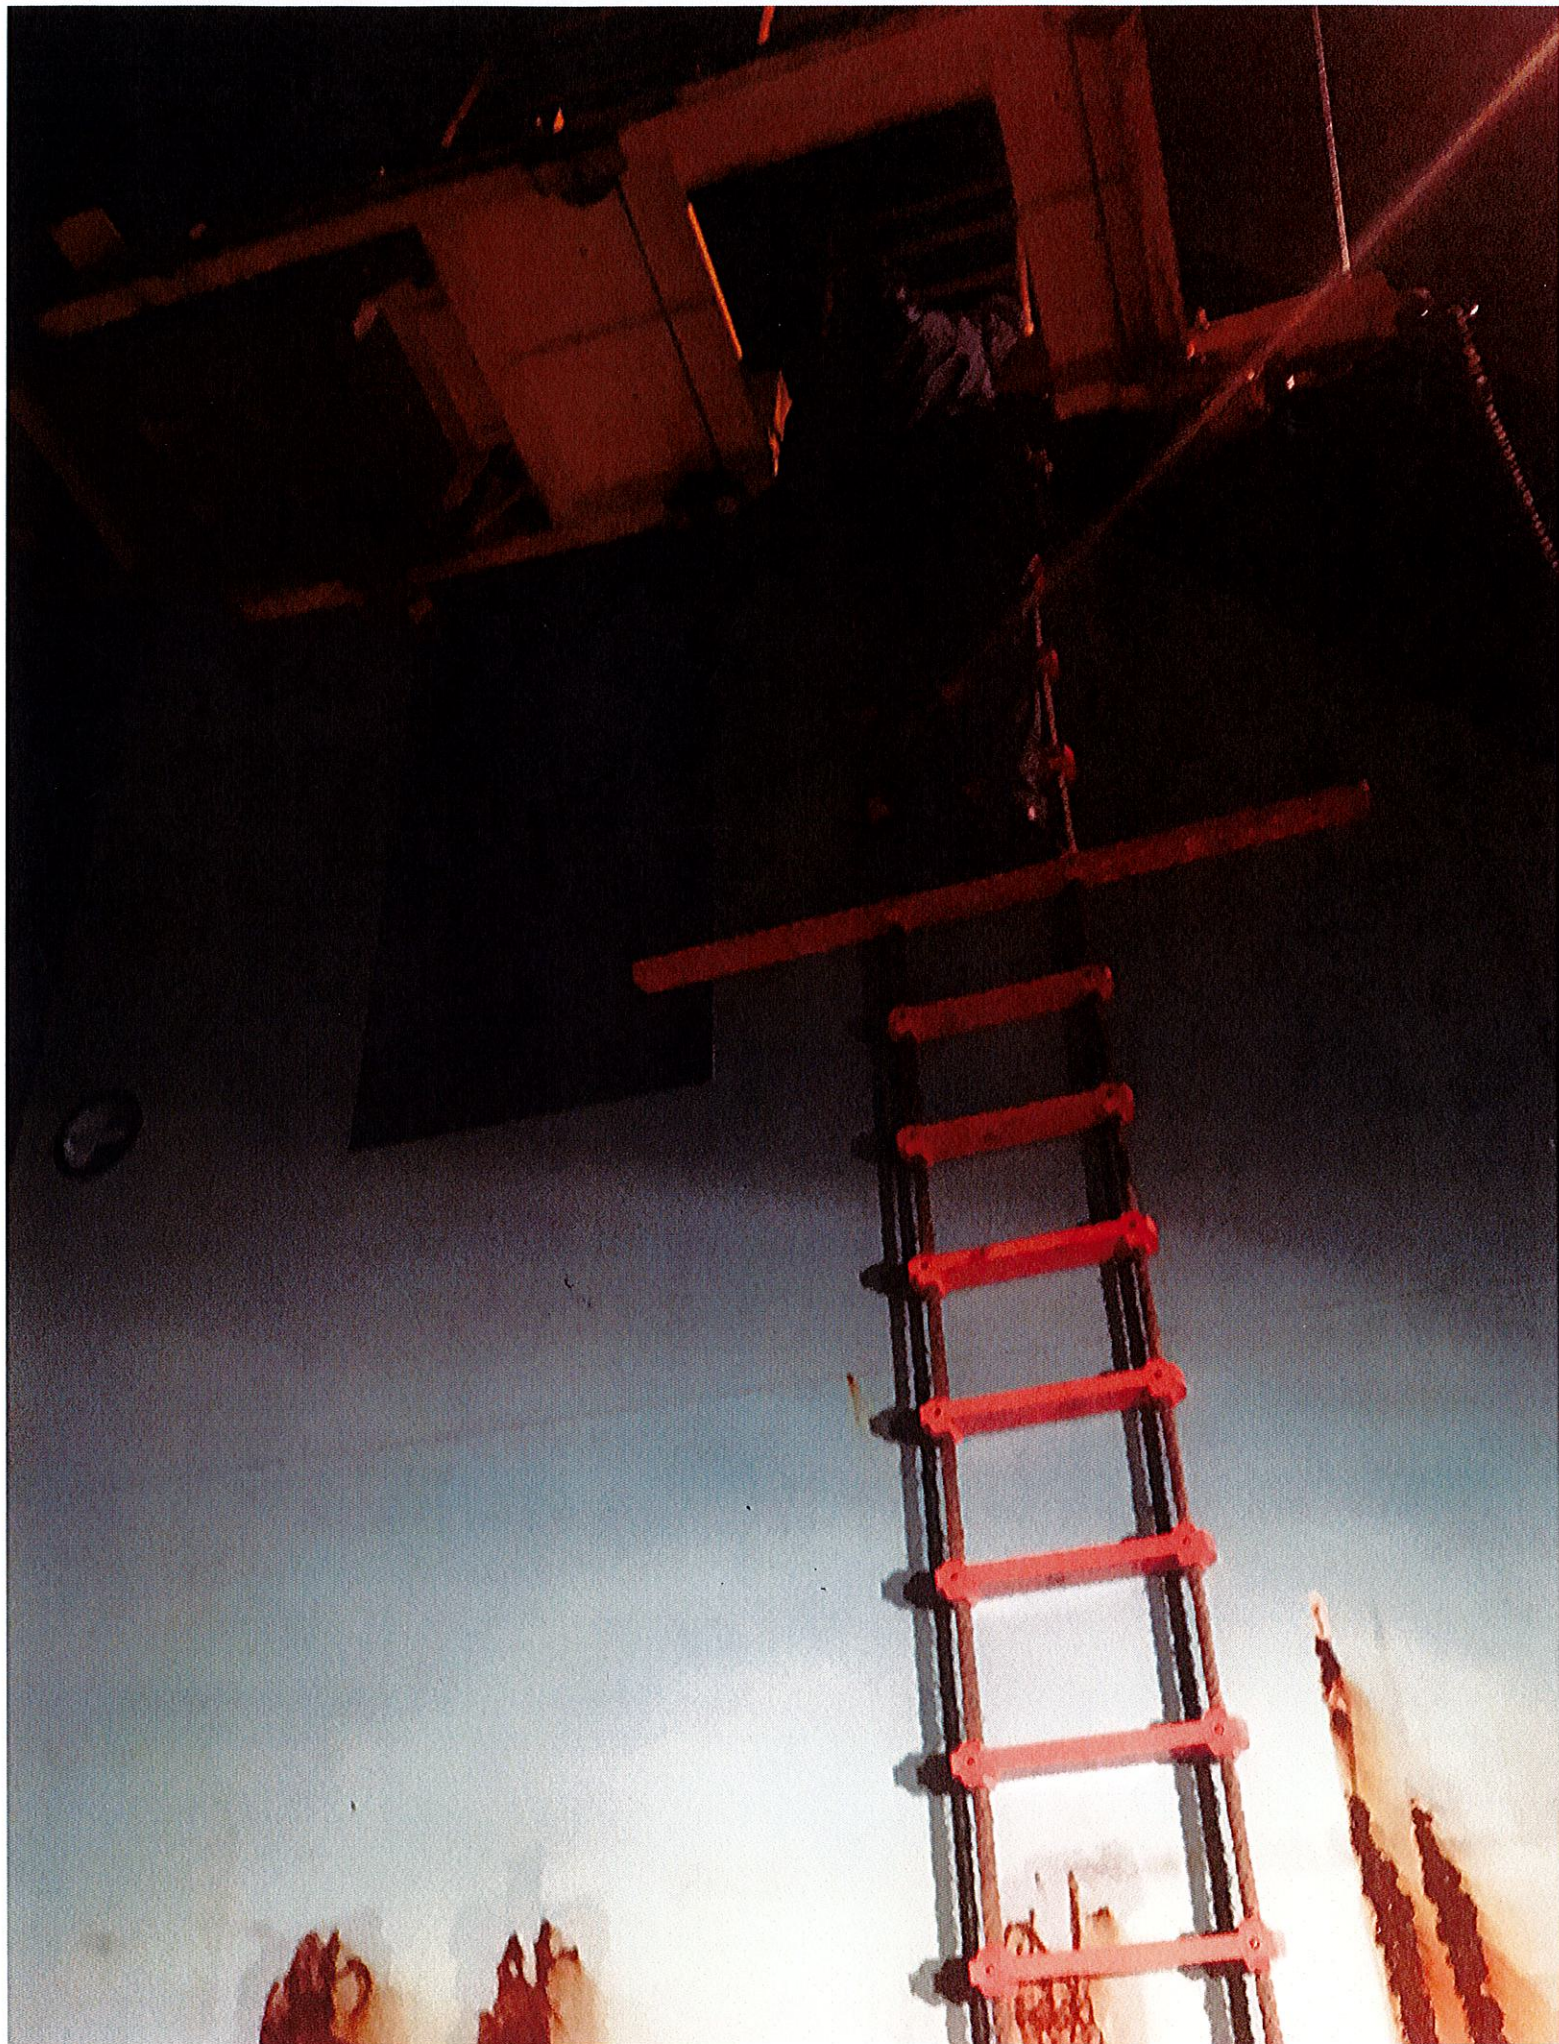
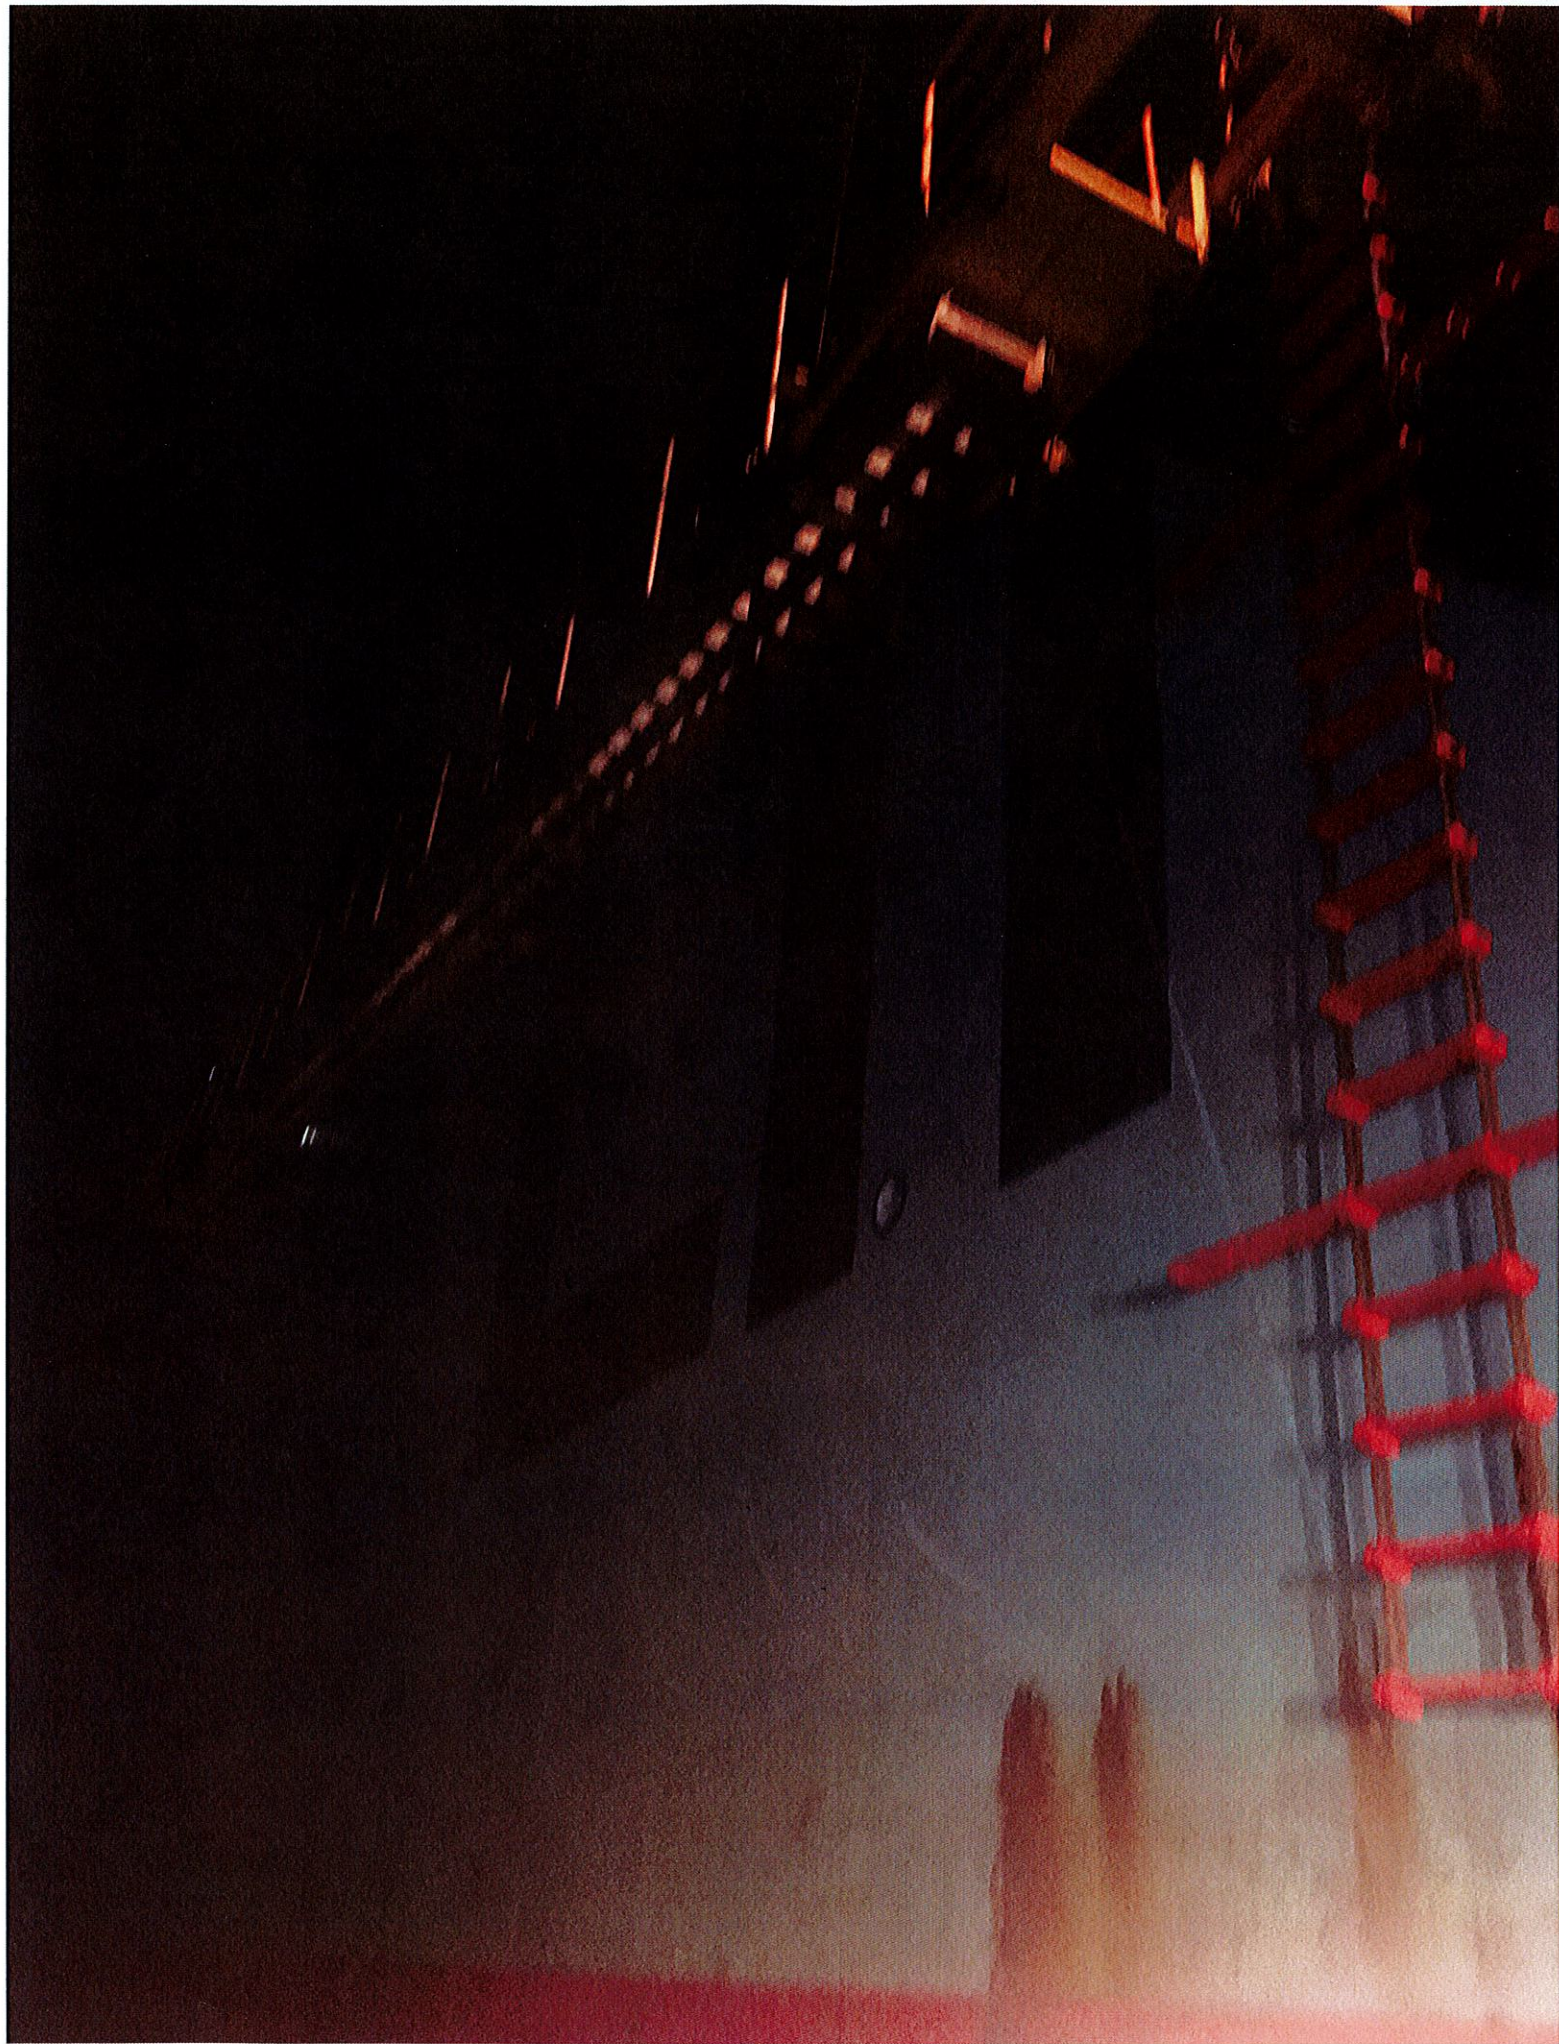
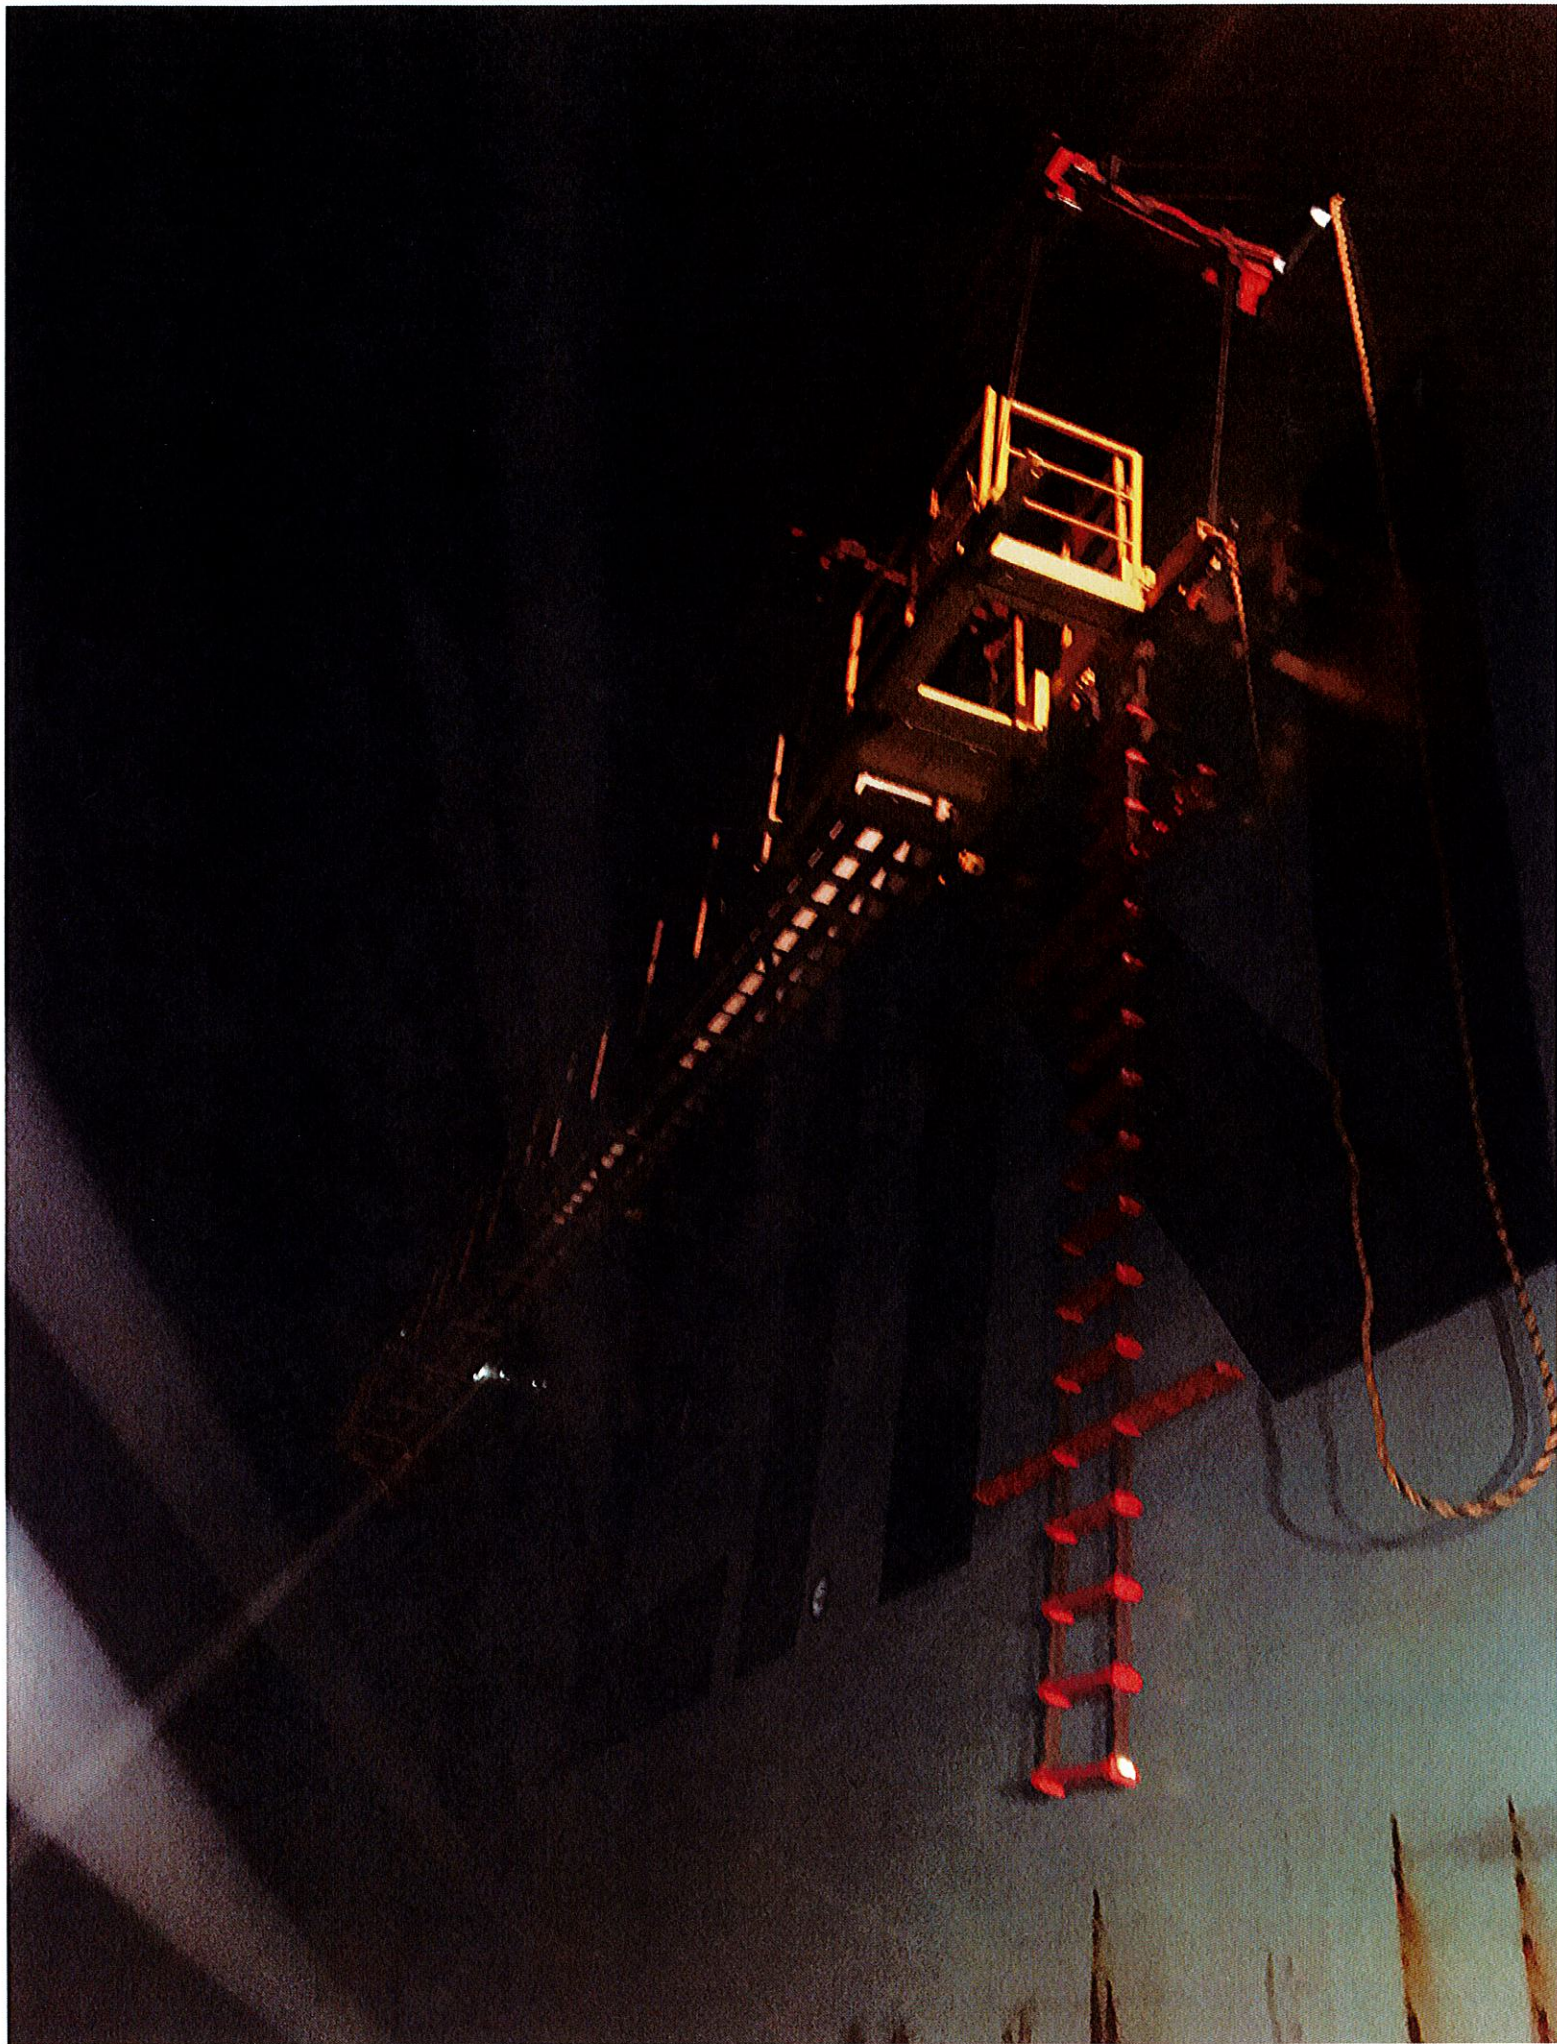
insufficient lighting at platform

not resting on hull, distance from top rung to platform too great

distance between platform & hull too great

top ladder rung should be flush w/ or slightly above the platform for safe transition. Ladder & platform should both be flush to / touching the hull per SOLAS/IMO. Request for crew member standing by on platform for Pilot's transition from ladder to platform.
