# PILOT BOARDING DEFICIENCY REPORT

DATE: OCT 30, 2020 TIME: 1900

VESSEL: MOL GLIDE

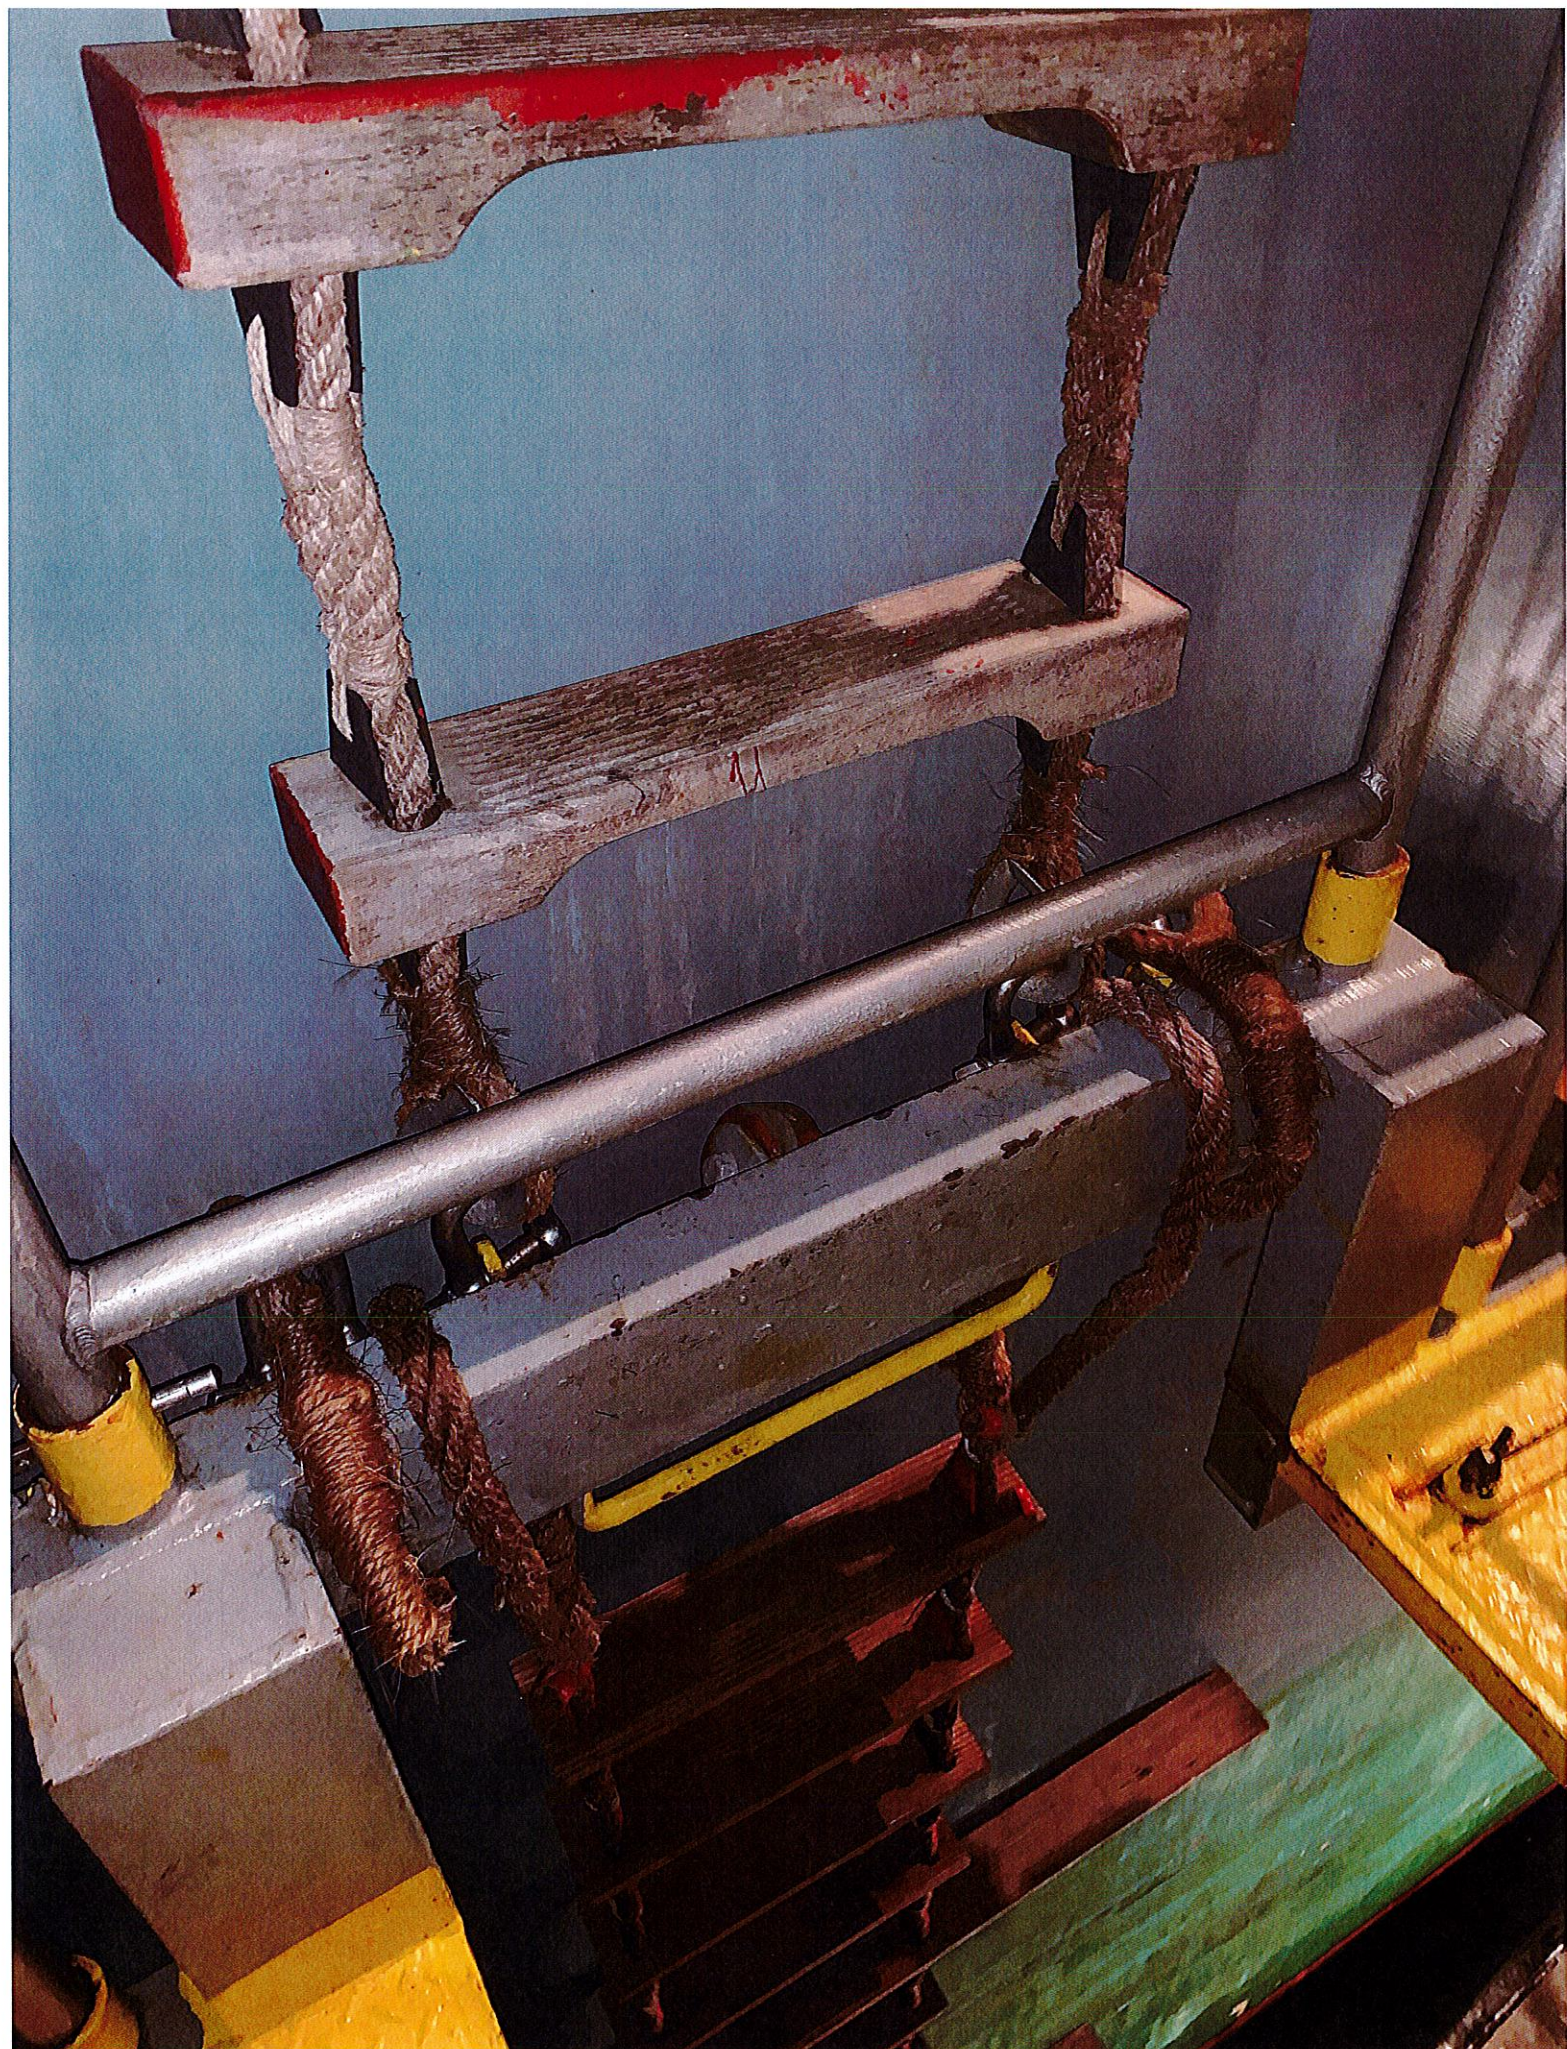
LADDER NOT IN COMPLIANCE. DOES NOT PASS THROUGH TRAP DOOR.

LADDER ATTACHED ABOVE AND BELOW CROSS BAR AS SEEN IN PICTURE.  
BOARDING WAS HAZARDOUS DUE TO THIS ARRANGEMENT.
