## PILOT BOARDING DEFICIENCY REPORT

DATE: 5/26/21 TIME: 0800

VESSEL: Celsius Rimini

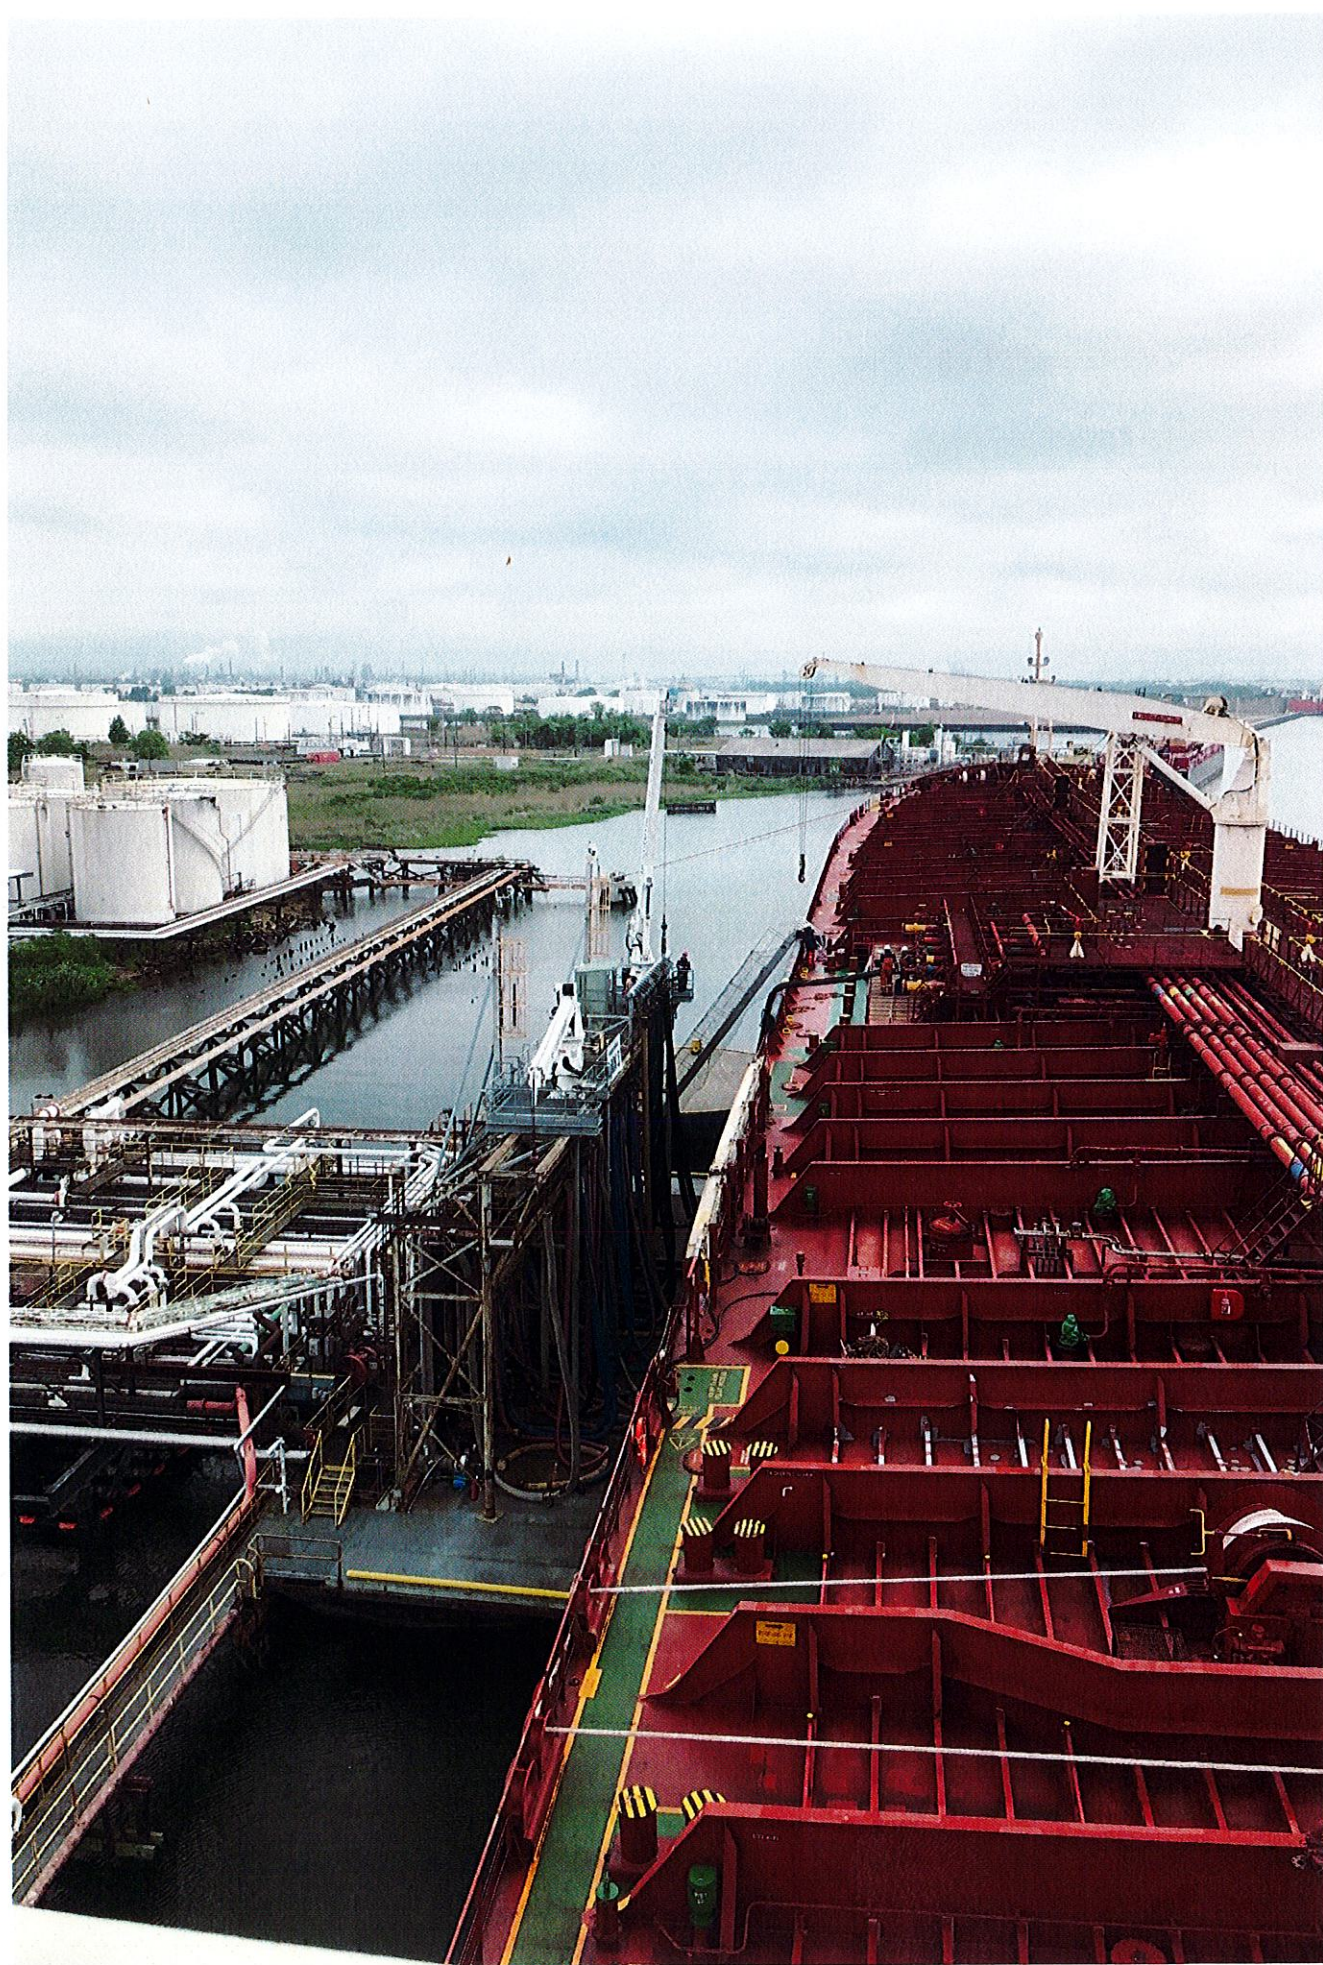
Gangway was excessively pitched at dangerously high angle. (see photos)

Although properly netted and attended by a sailor, the gangway's  
pitch was dangerous.
