PILOT BOARDING DEFICIENCY REPORT

DATE: March 06, TIME: 1200
VESSEL: MAERSK PITTSBURGH

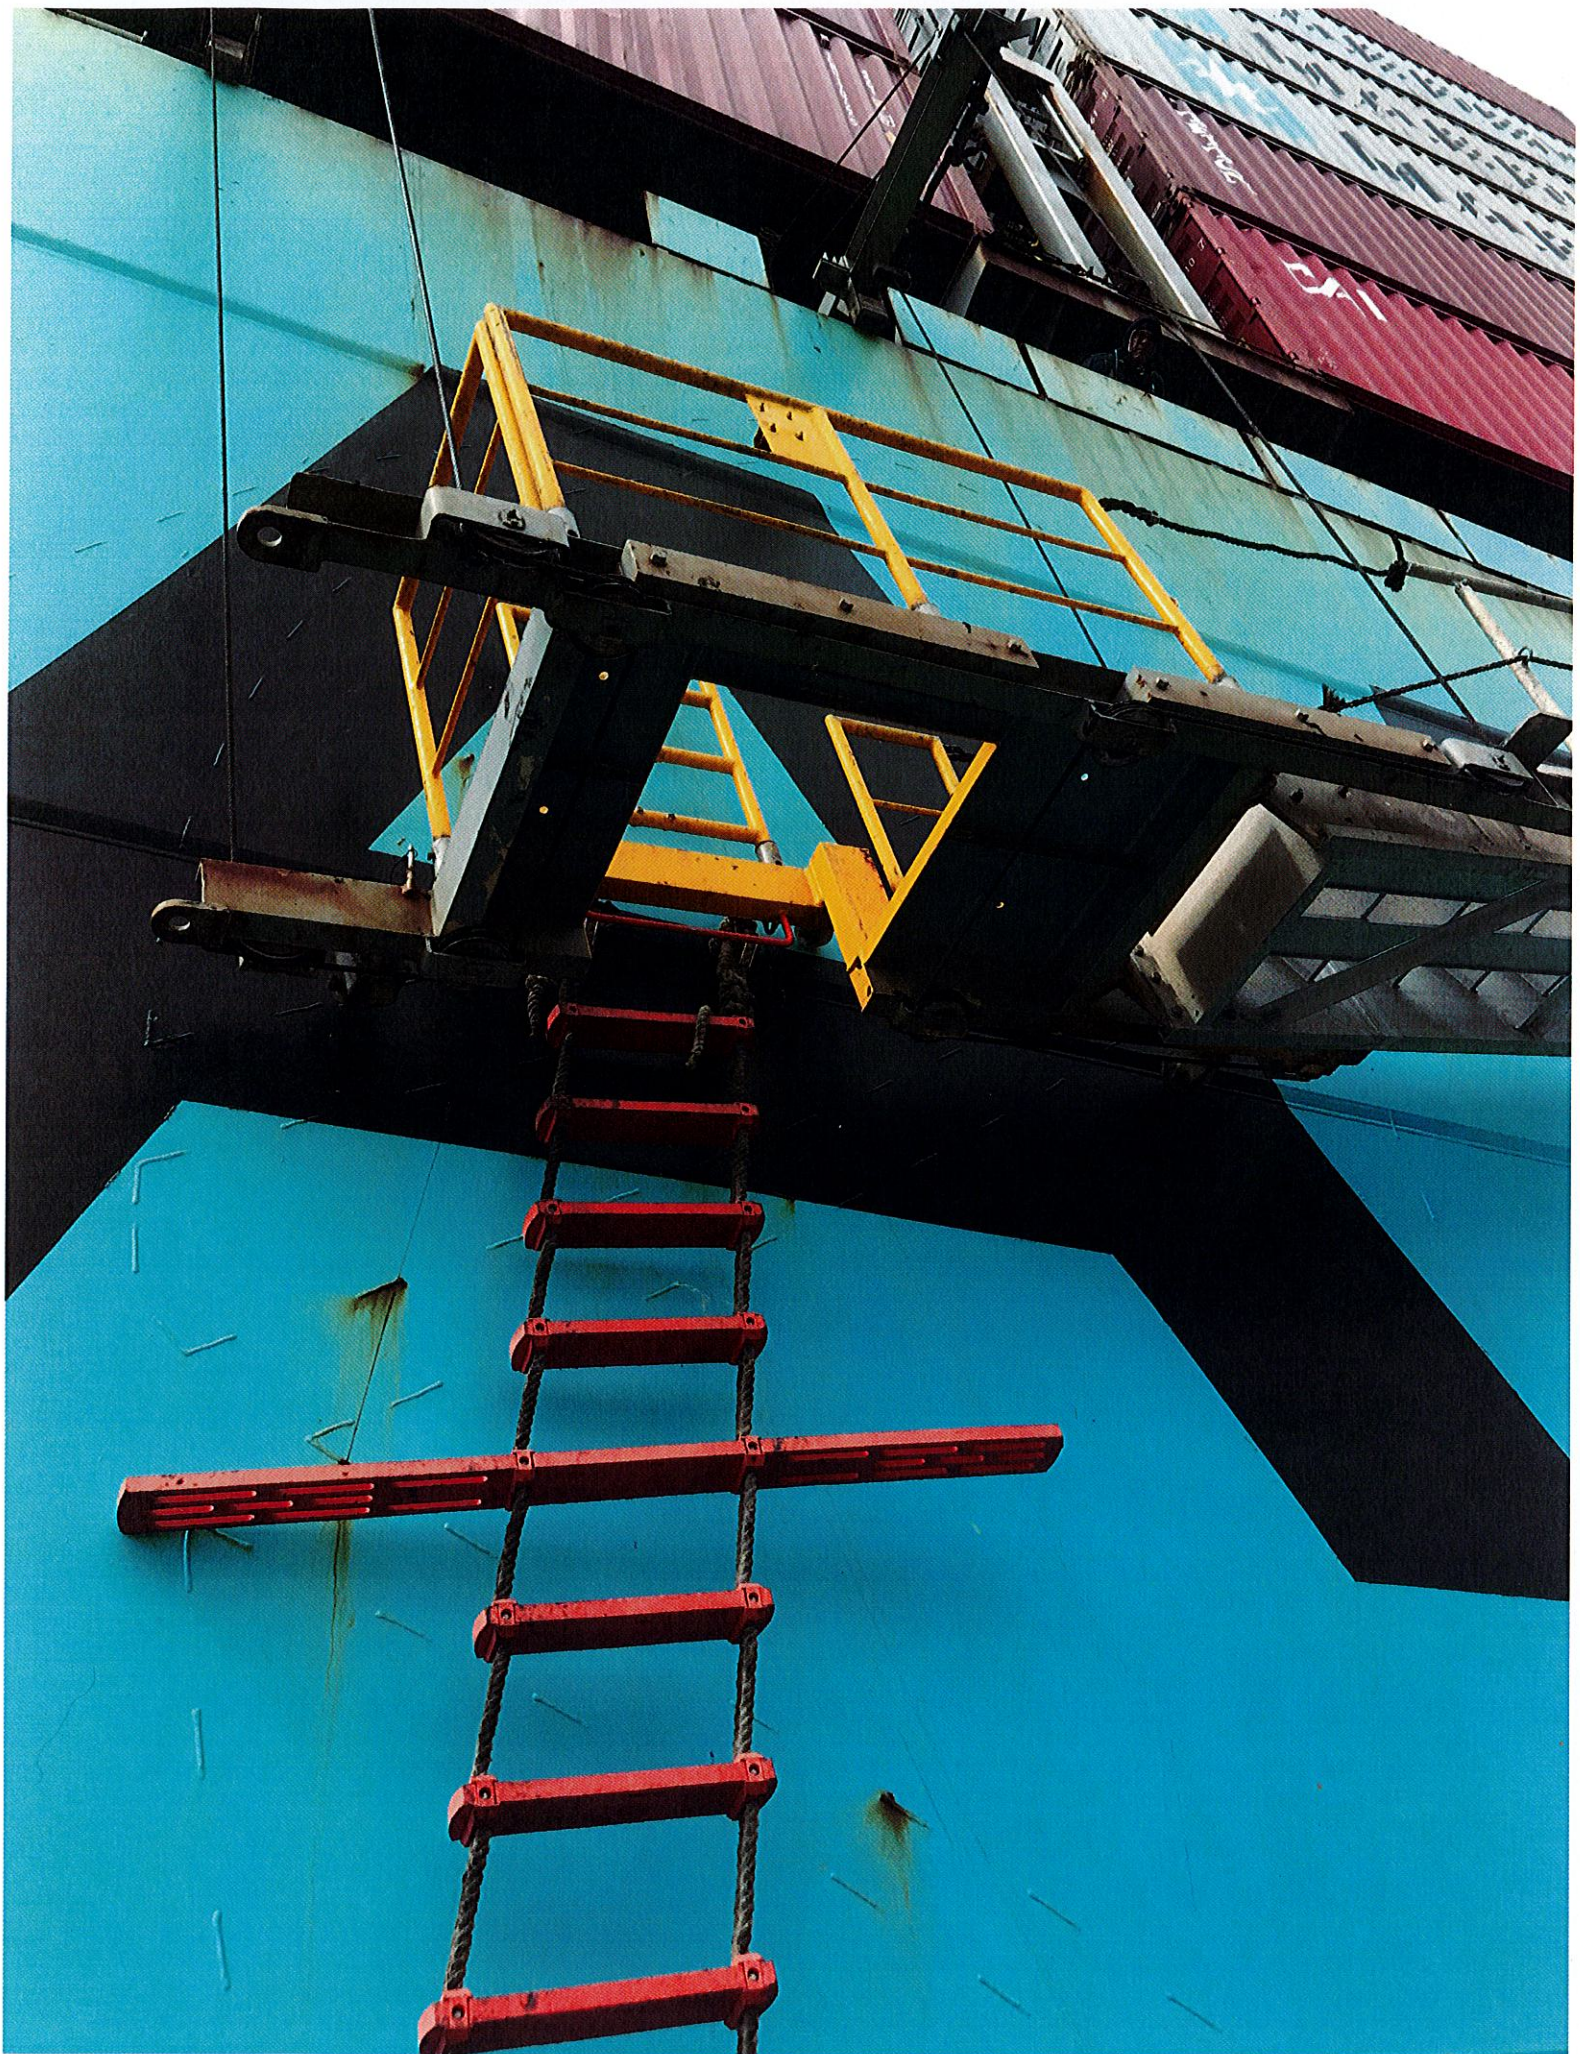
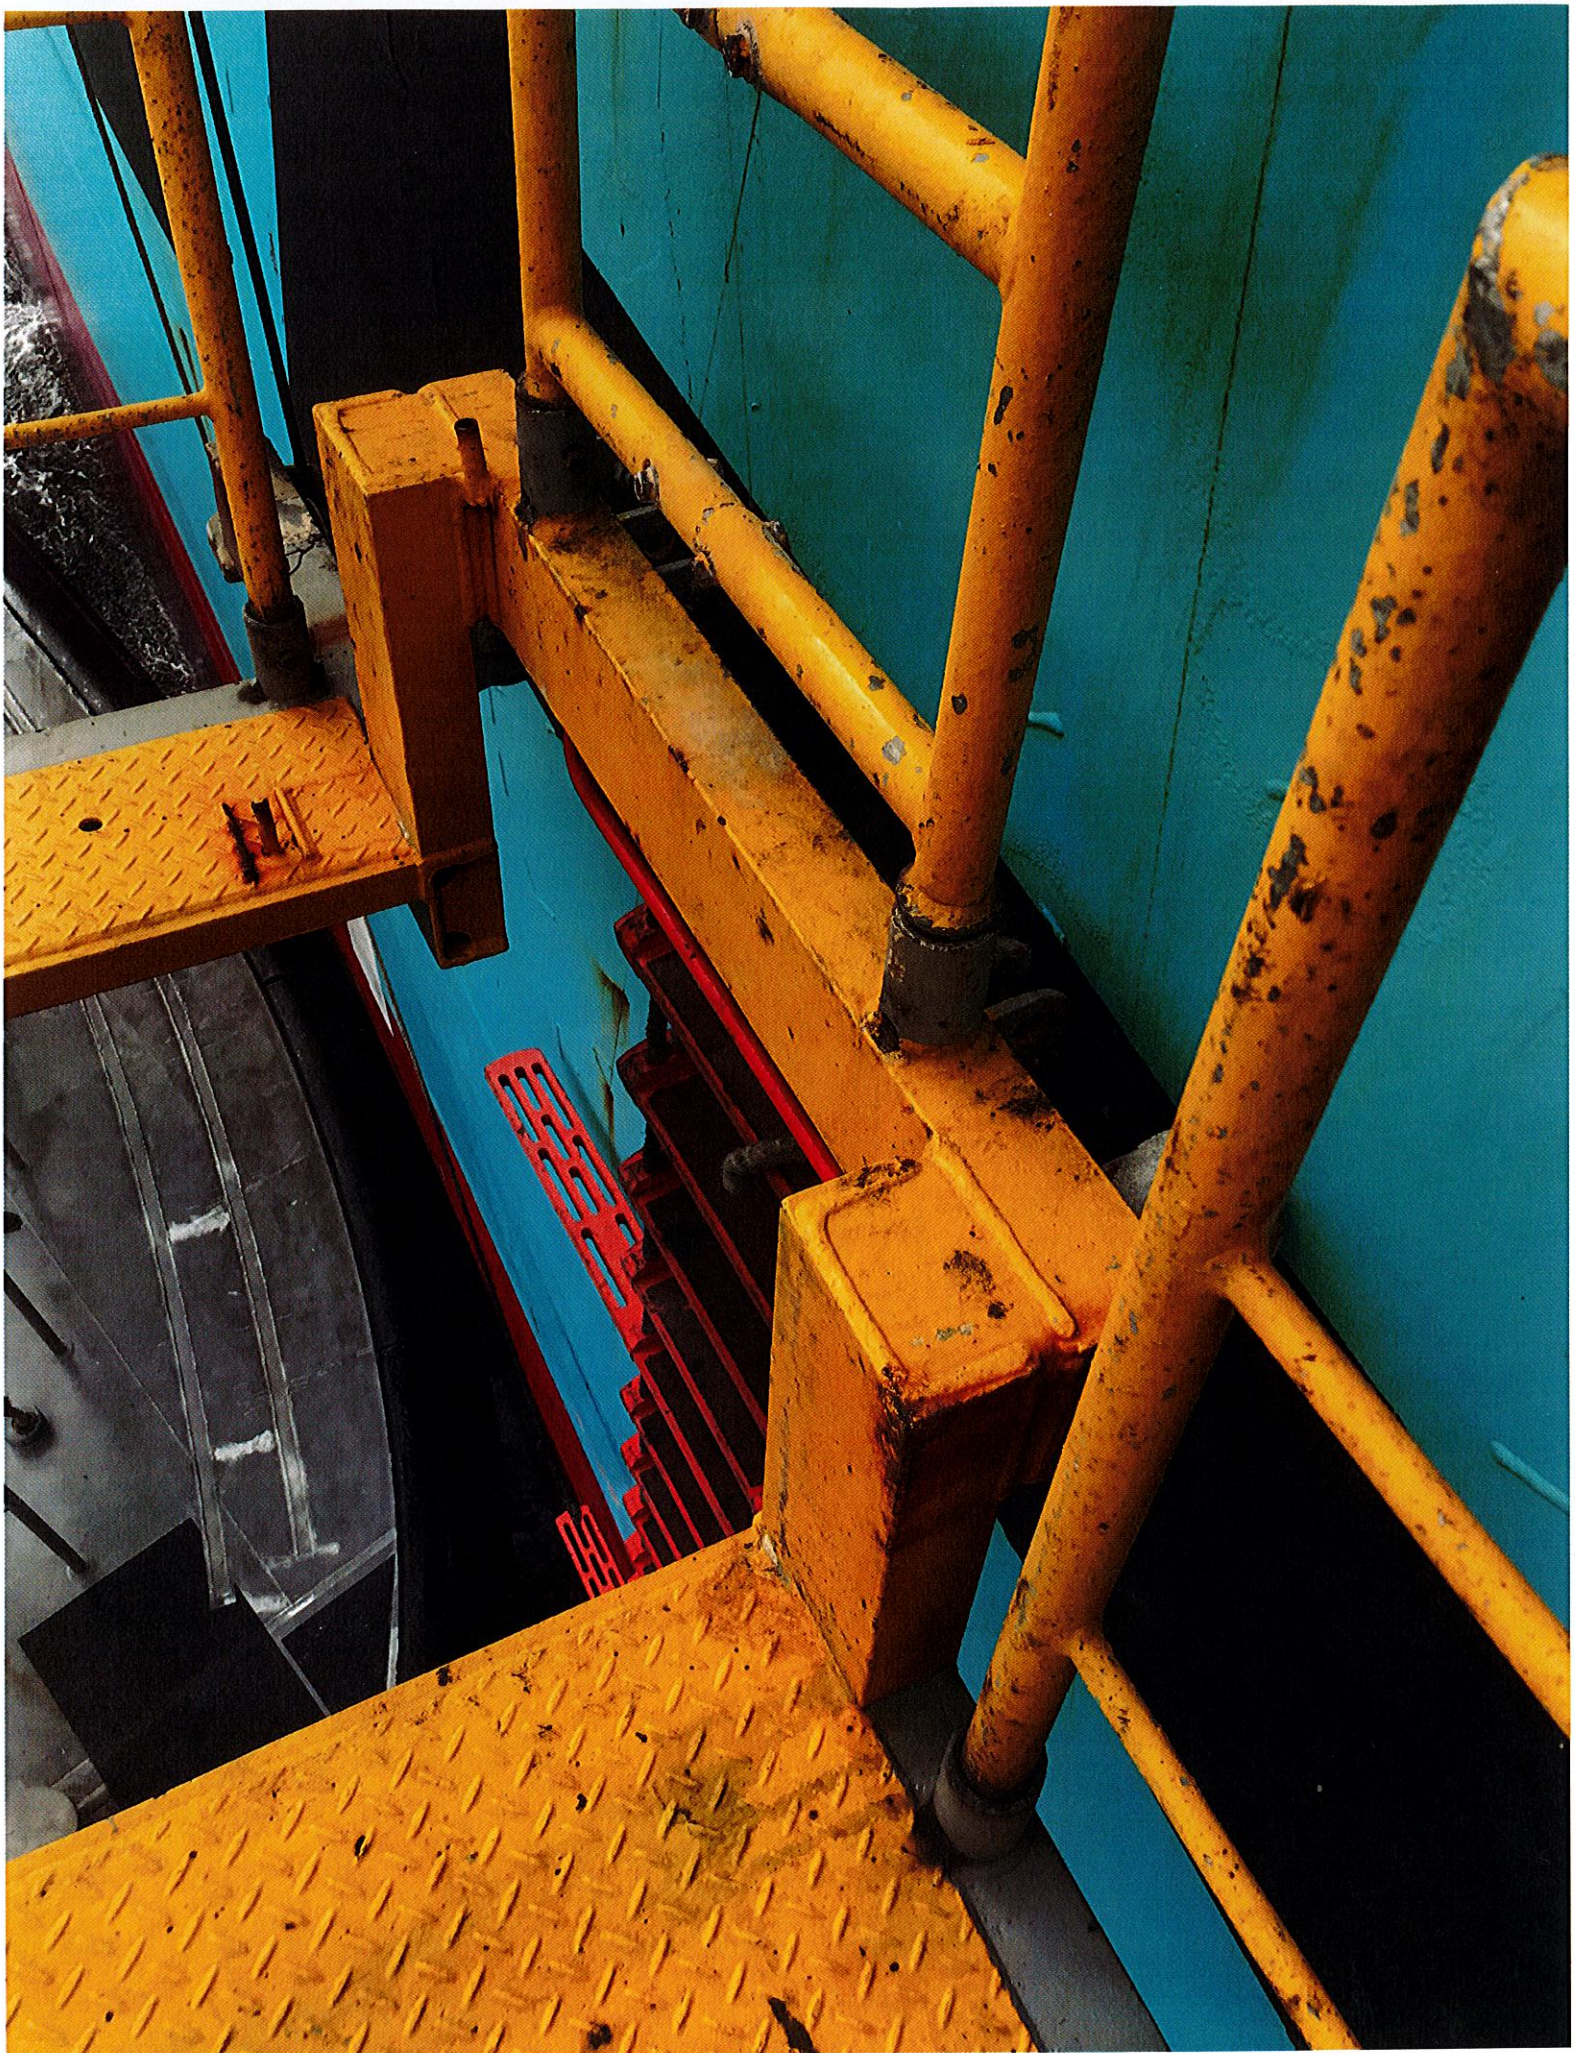
☒ COMBINATION LADDER (ie: Poor condition/wear, not secured, platform too low, etc.)

There is a bar in the way when transferring from ladder to
gangway. Captain is well aware of problem. Captain stated MAERSK
has plans to make modifications, but does not know when it will
be done.
