PILOT BOARDING DEFICIENCY REPORT

DATE: 02/11/21 TIME: 0830

VESSEL: MAERSK SERANGOON

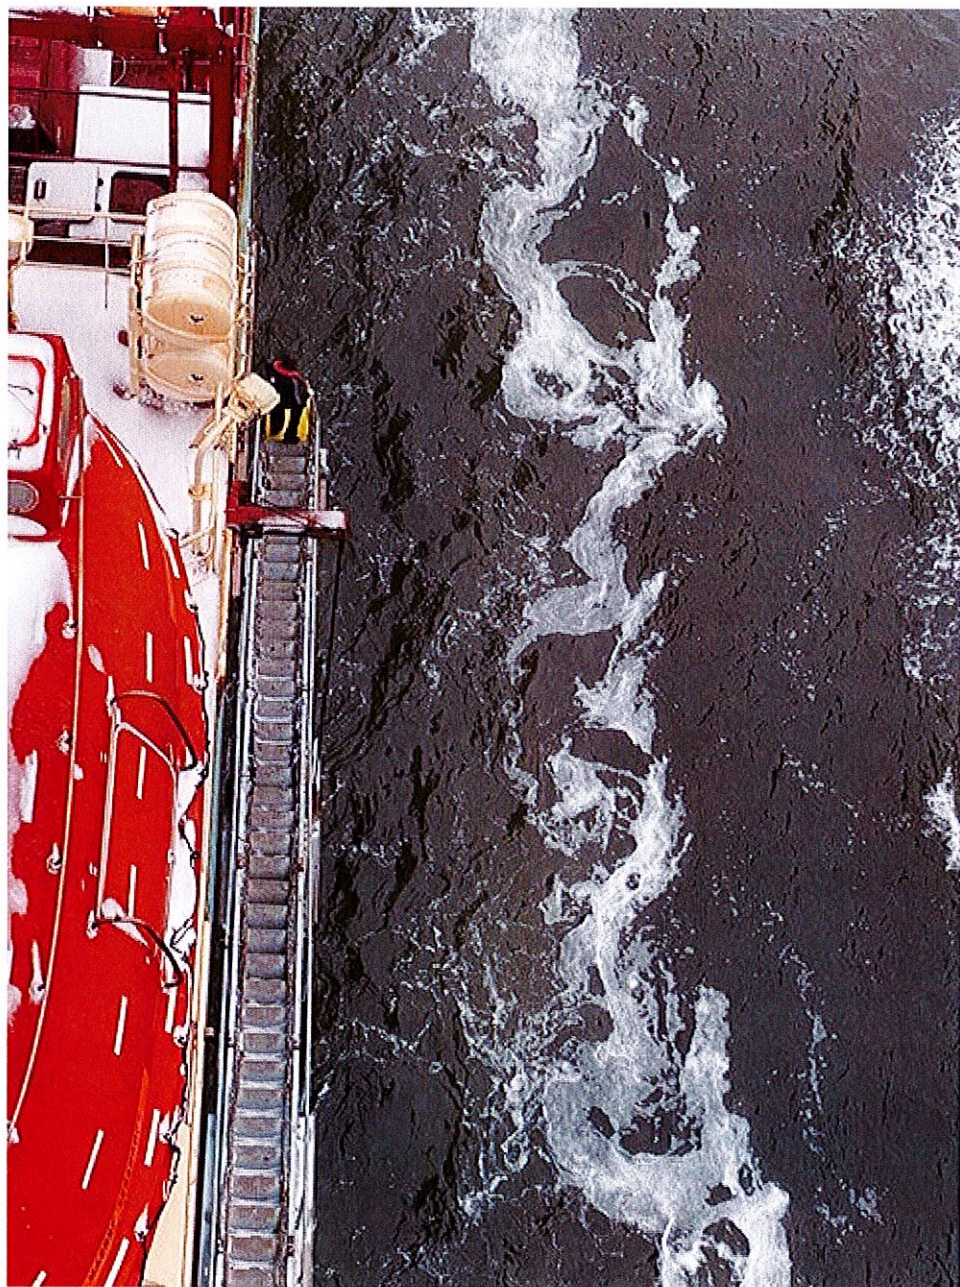
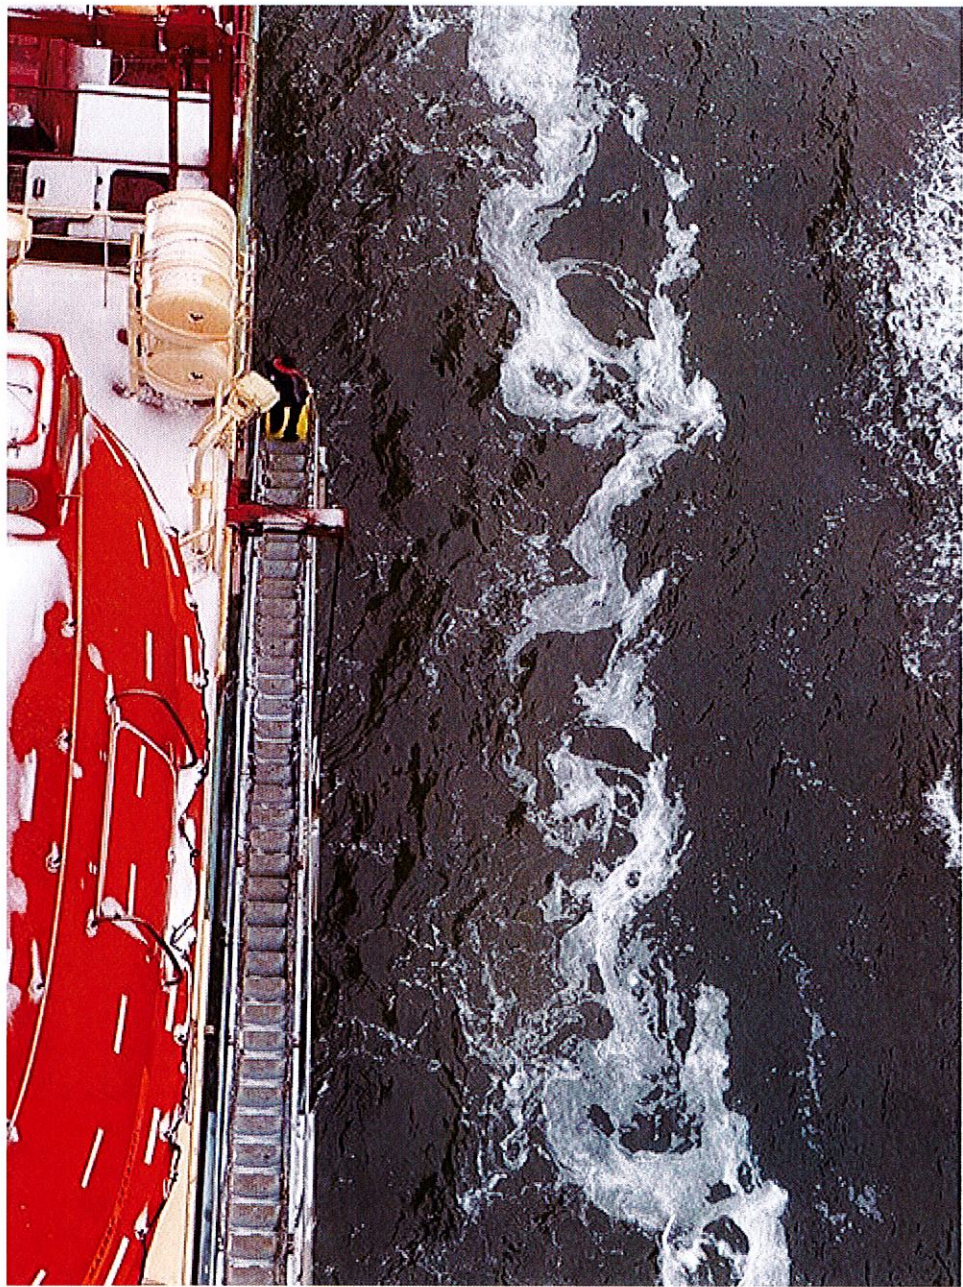
The general arrangement was not safe, there was a wide gap to transfer
☒ PILOT LADDER (ie: Poor condition/wear, not resting on hull, poor rigging, etc.) from ladder to gangway

Ladder was not secured against the hull by magnets
☒ COMBINATION LADDER (ie: Poor condition/wear, not secured, platform too low, etc.)

As mentioned wide gap to transfer and there was a crew member
☐ MAN ROPES (ie: Poor condition/wear, incorrect diameter, poor rigging, etc.) at the bottom of the gangway who was in the way.

The ladder was not secured to the hull. At the bottom of the gangway there was a crew member trying to steady the ladder. He was in the way & there was a wide distance between the ladder & gangway
