# PILOT BOARDING DEFICIENCY REPORT

DATE: Feb 14, 2021 TIME: 0330

VESSEL: MOL GLIDE

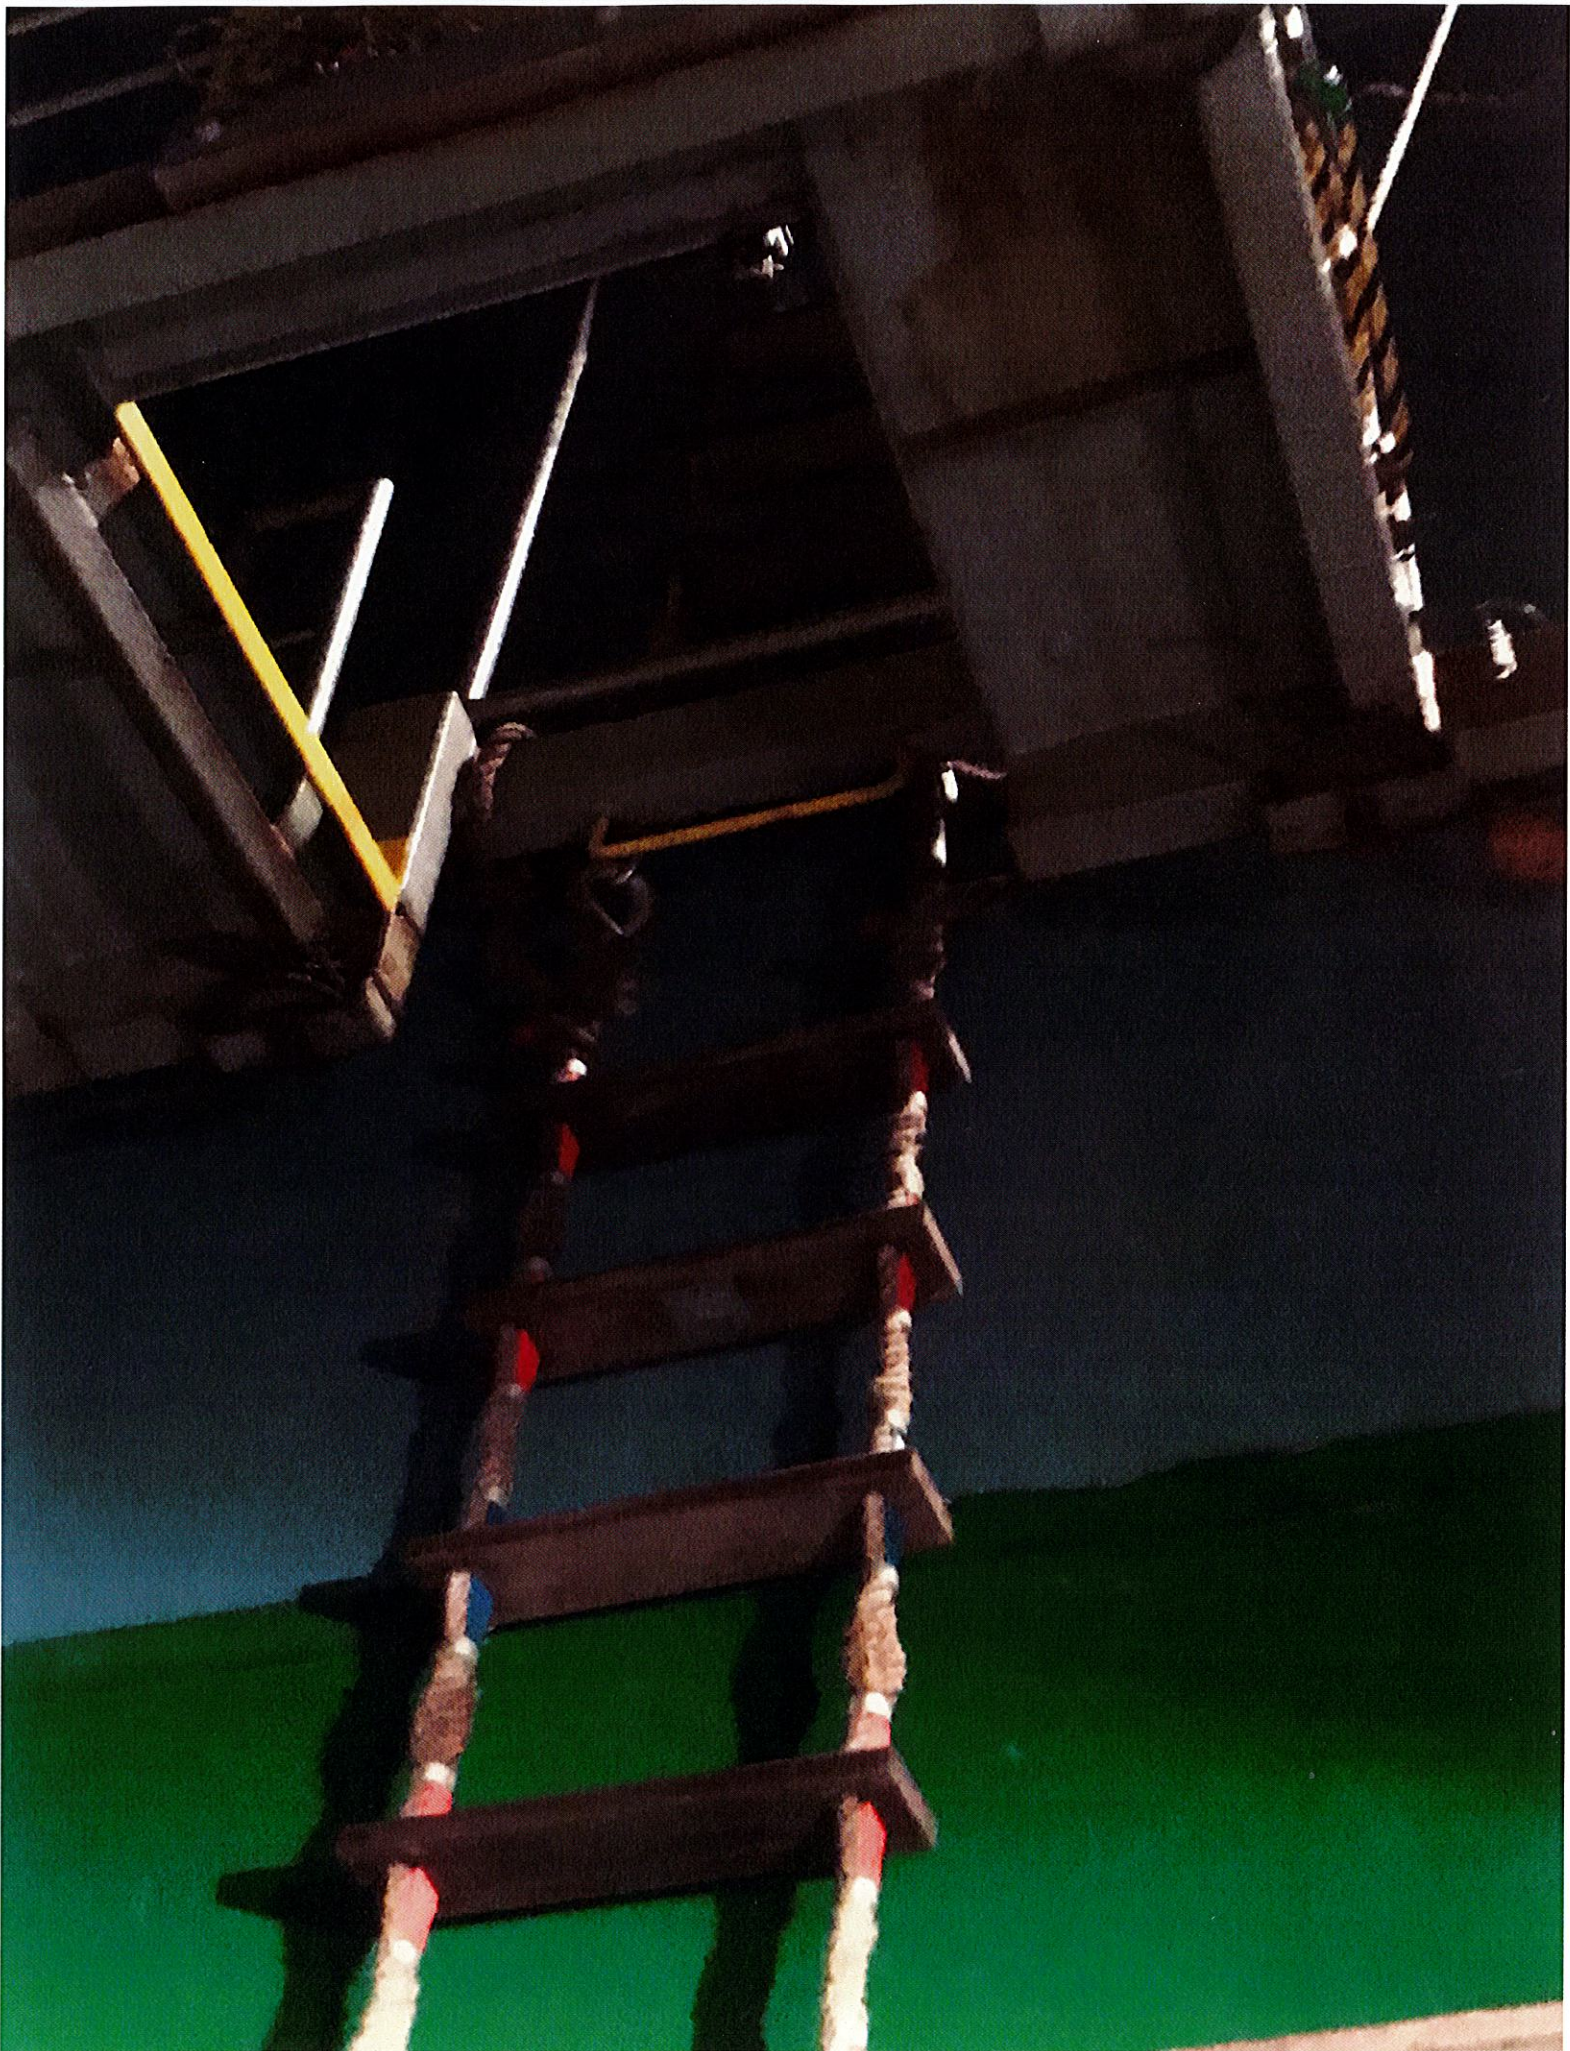
☒ COMBINATION LADDER (ie: Poor condition/wear, not secured, platform too low, etc.)

TRAP DOOR WITH CROSS BAR in the way

ADDITIONAL REMARKS: Capt and OWNERS AWARE TRAP DOOR needs to be corrected. Capt  
gave pilot copy of plans for modifications APPROVED BY  
ABS (CLASSIFICATION society) Capt stated he hopes OWNERS WILL

HAVE MODIFICATIONS MADE IN A FEW MONTHS.
