JOURNAL OF THE MARITIME INDUSTRY

## Pilots make progress on boarding safety efforts

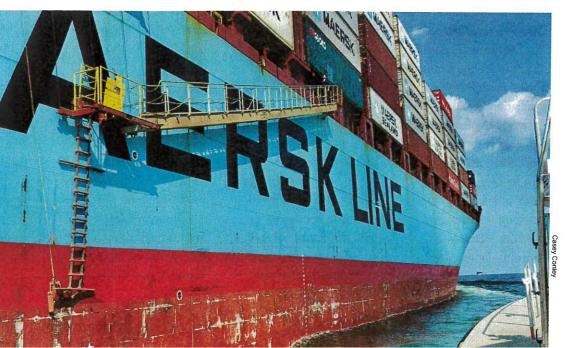
Left, Maersk is working to address pilot boarding arrangements across its fleet. The arrangement on *Maersk Atlanta* from August 2018 did not meet international standards, as the pilot ladder does not extend through the trapdoor to the height of the platform handrails. Opposite page, the APA diagram shows how a fully compliant arrangement should look.

These same IMO regulations make clear that for a combination arrangement using a platform with a trapdoor, the ladder must extend through the trapdoor to at least the height of the platform's handrail. The purpose of this requirement is to bring the ladder steps up to a level from which the pilot can step across to the platform rather than pull himself or herself up to it.
