PILOT BOARDING DEFICIENCY REPORT

DATE: 2/12/2020 TIME: 1130

VESSEL: Al Qibla

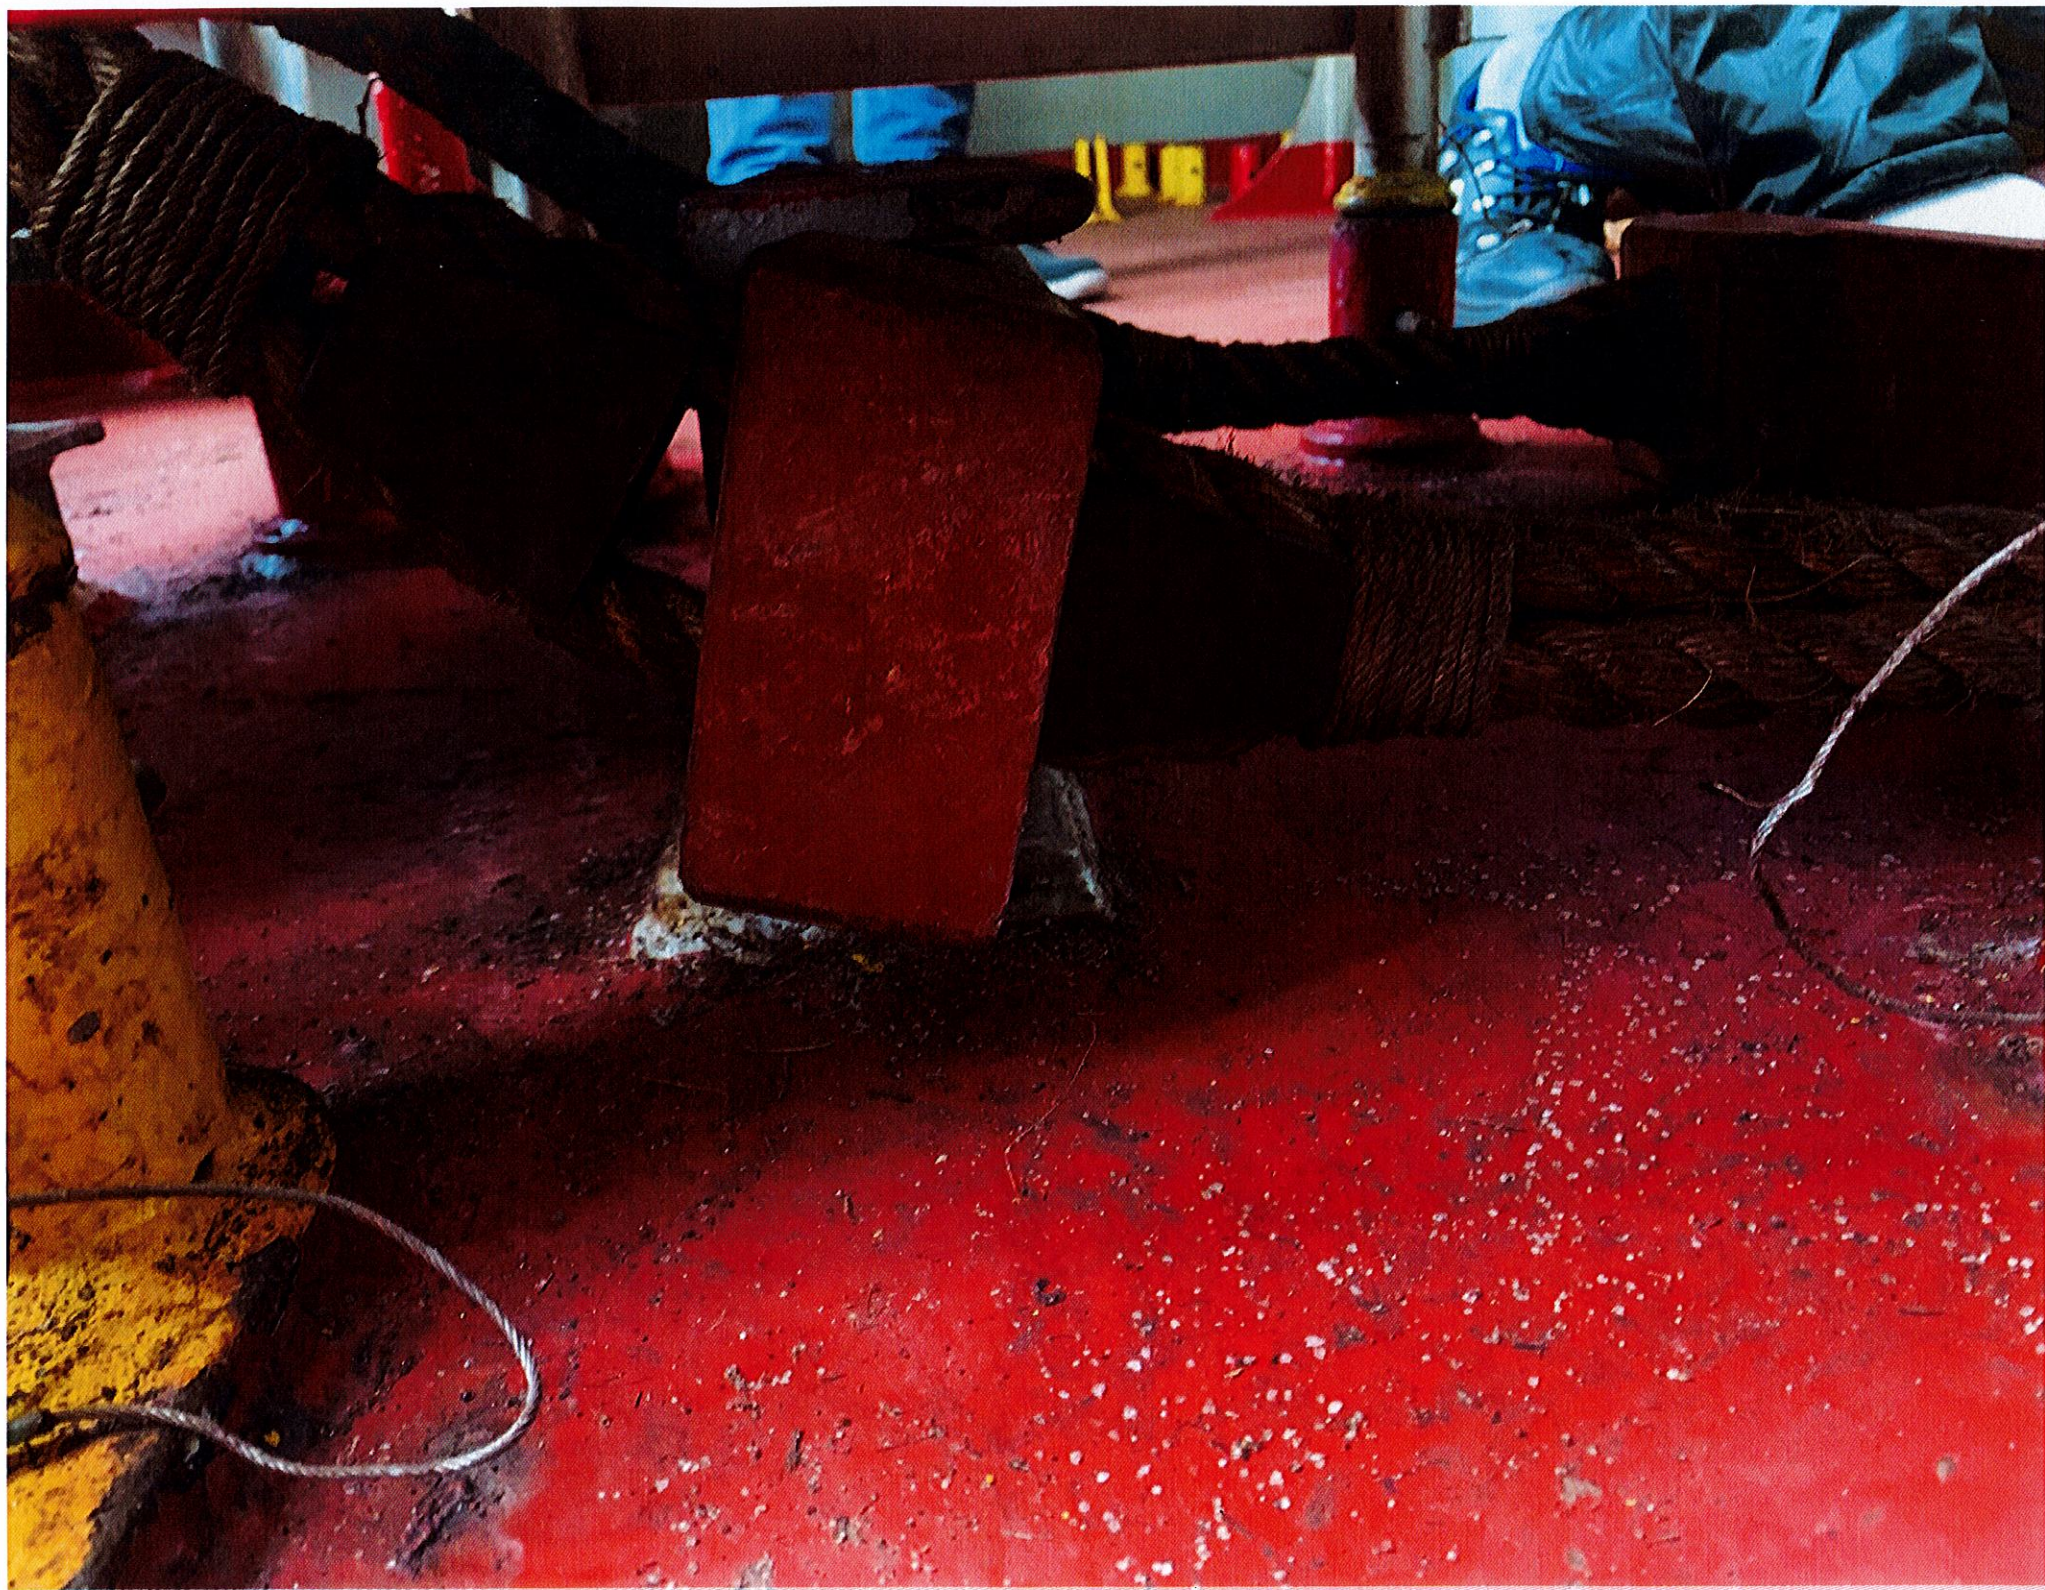
Ladder not properly secured from strong point on deck to side ropes. Deck tongue in use.

Securing method hidden under platform. Looked underneath saw deck tongue as only means of securing

All the weight of ladder is resting on the one step. Explained to crew.
