PILOT BOARDING DEFICIENCY REPORT

DATE: 5/28/18 TIME: 0800

VESSEL: CHALLENGE PROCYON

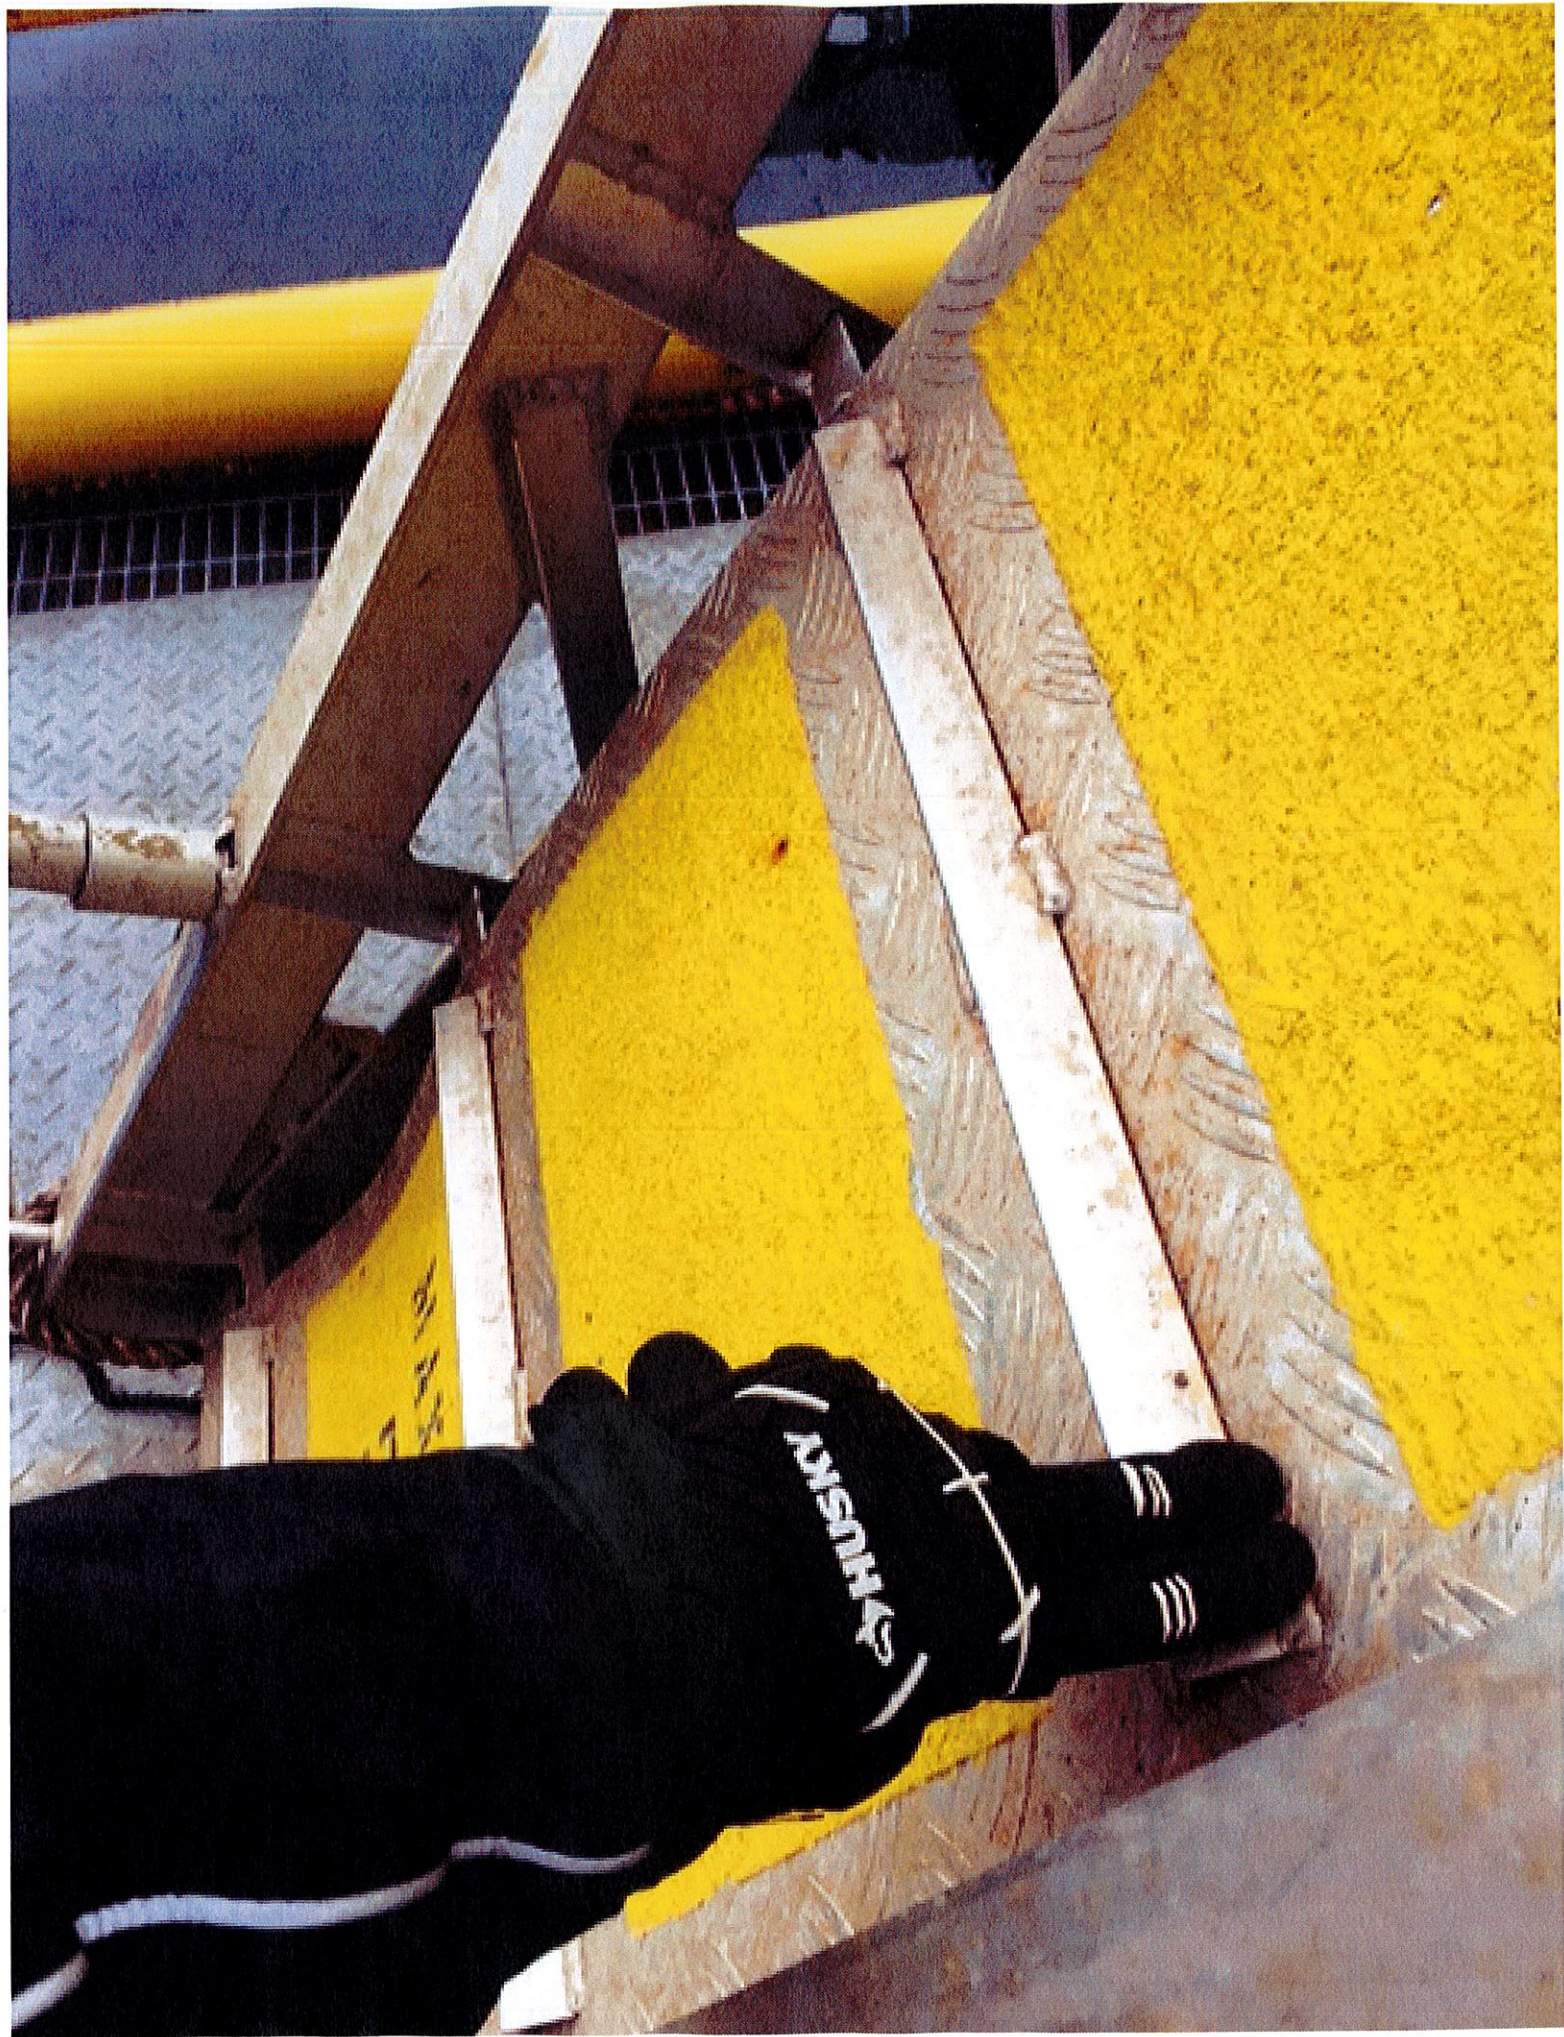
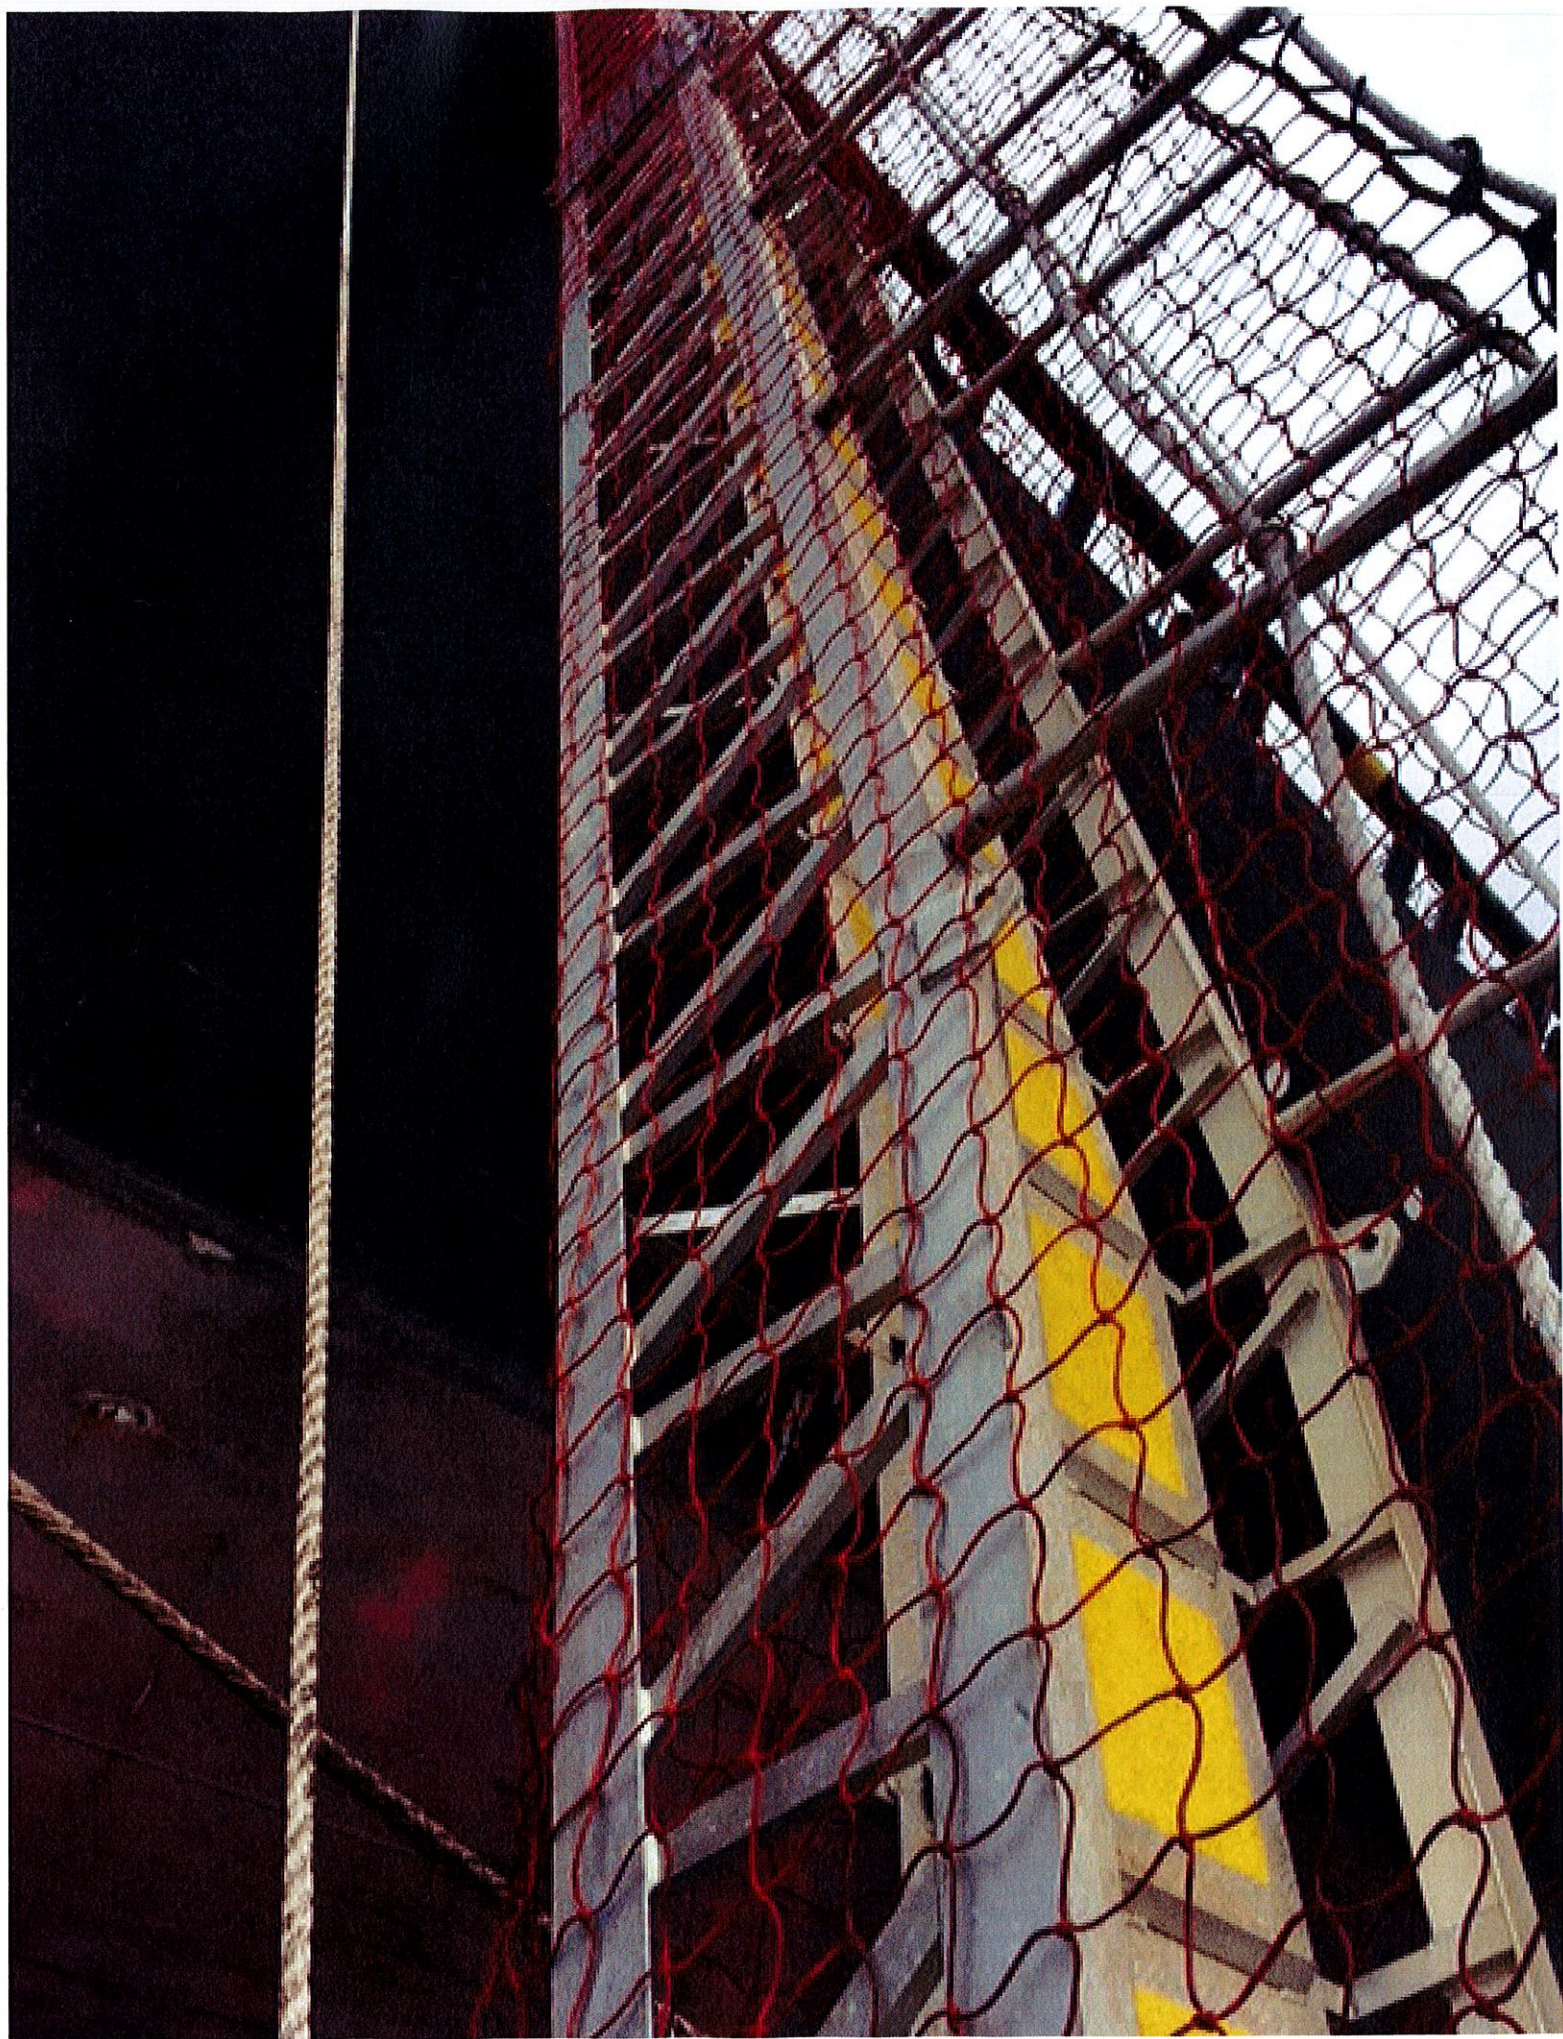
PITCH OF PORTABLE GANGWAY EXCESSIVE.

THE PORTABLE GANGWAY WAS RIGGED AT AN ANGLE THAT FAR EXCEEDED ITS DESIGNED SAFE ANGLE. THE TINY TREADS WERE INADEQUATE AT SUCH AN ANGLE.
