## PILOT BOARDING DEFICIENCY REPORT

DATE: 2/18/18 TIME: 0200

VESSEL: Cont Equator

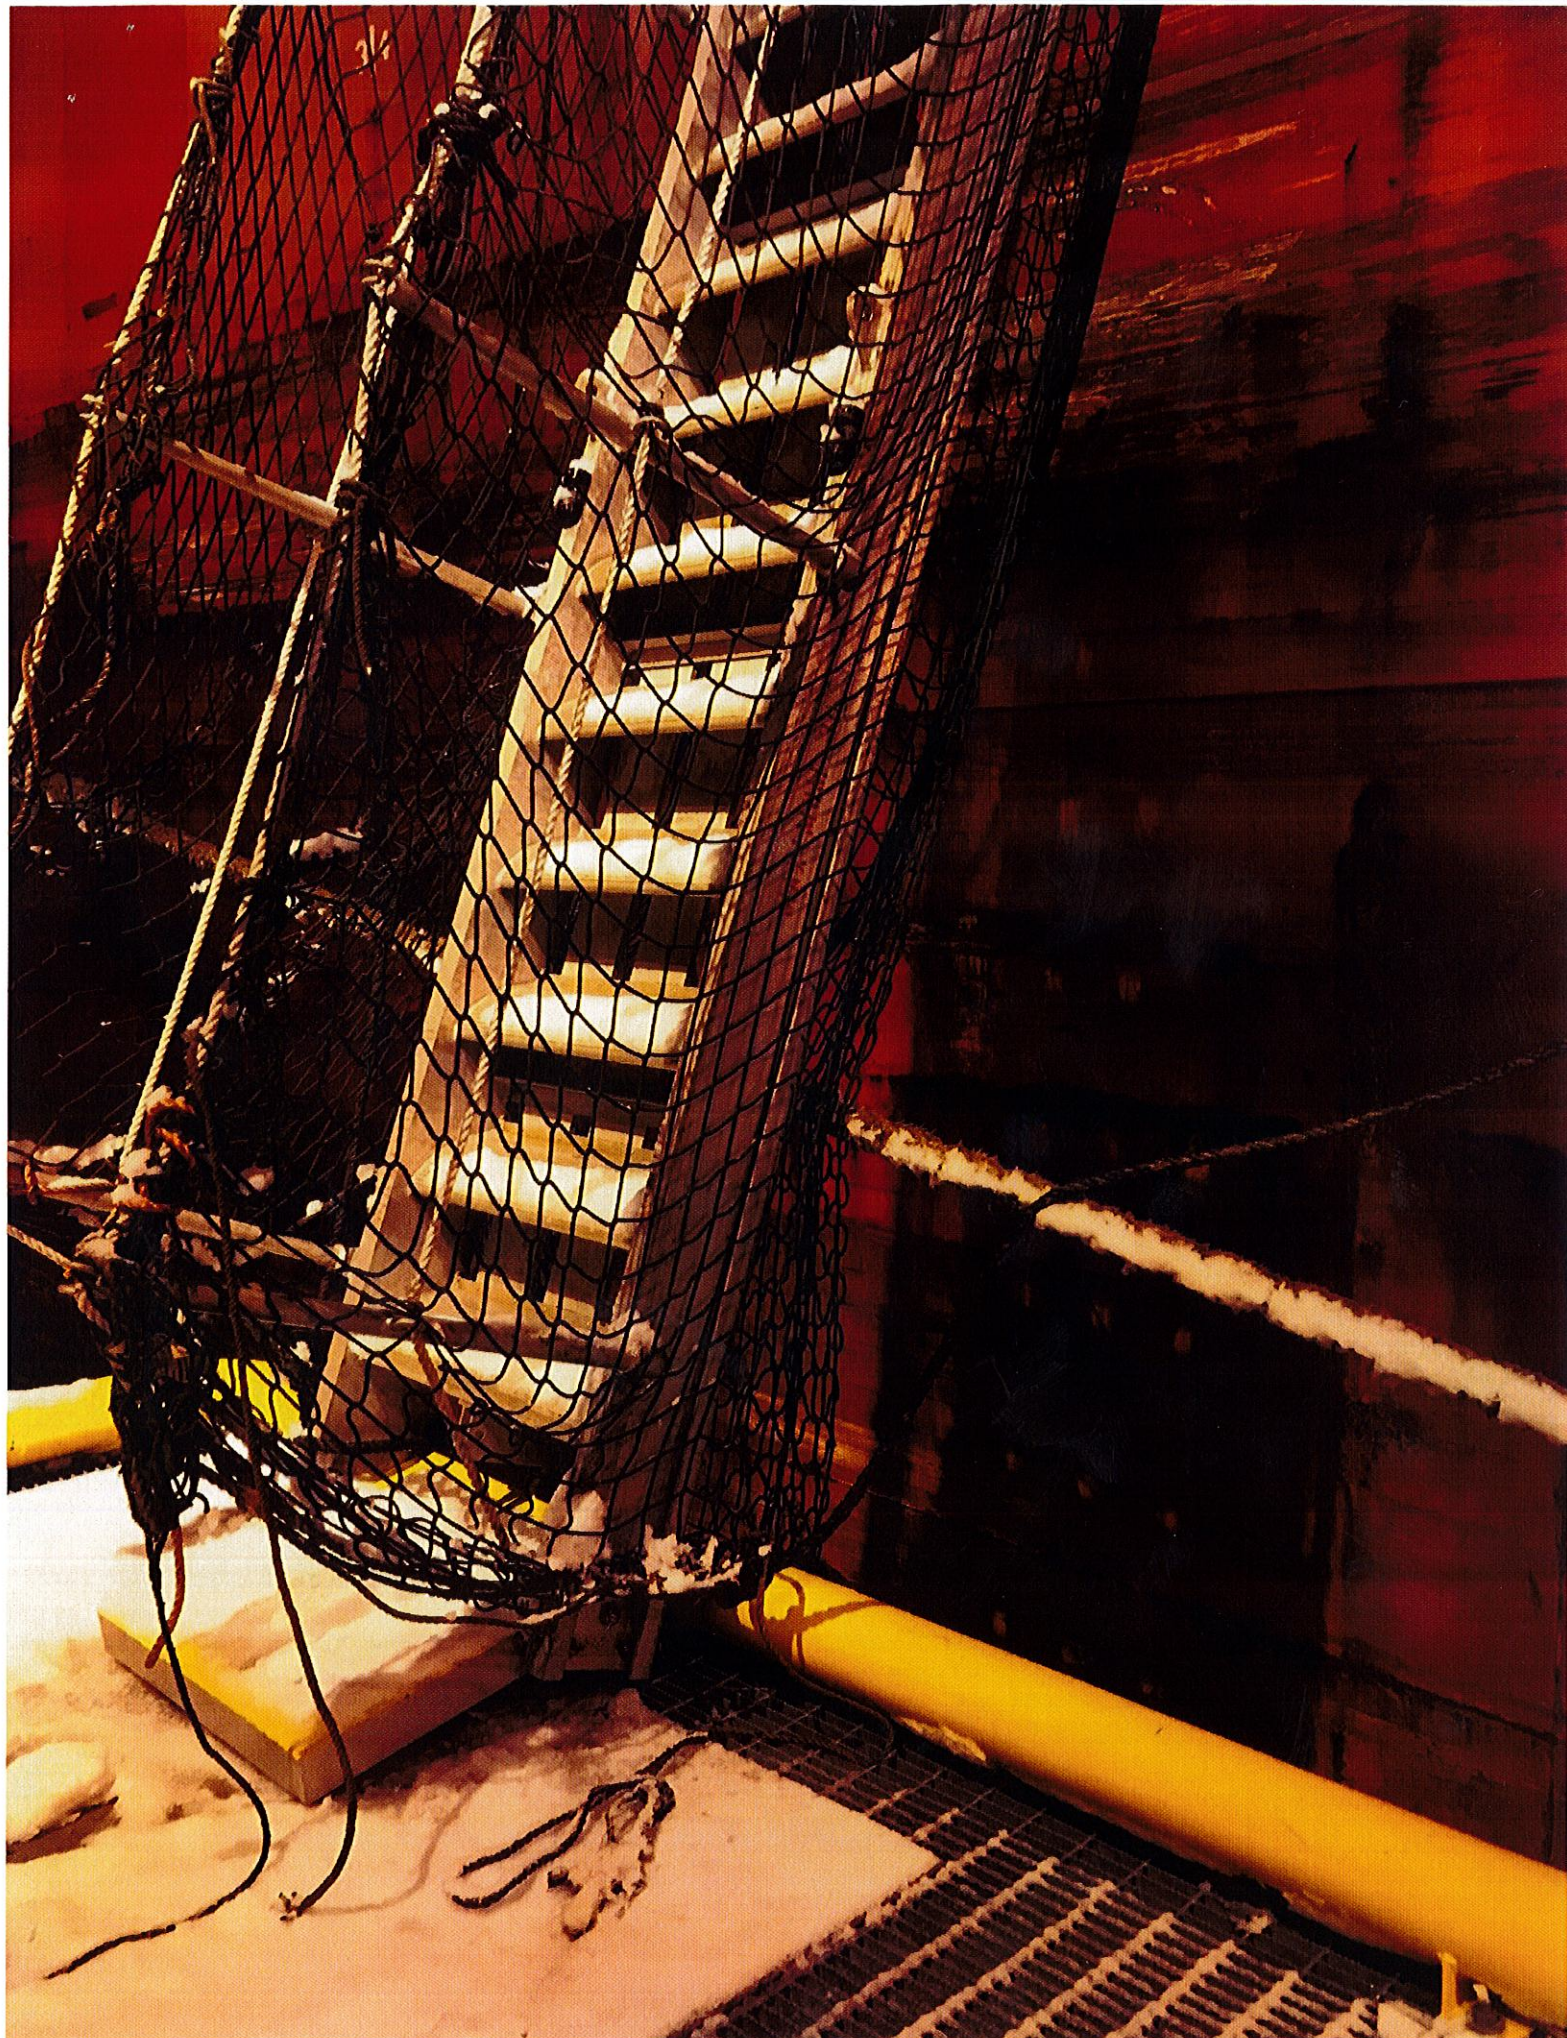
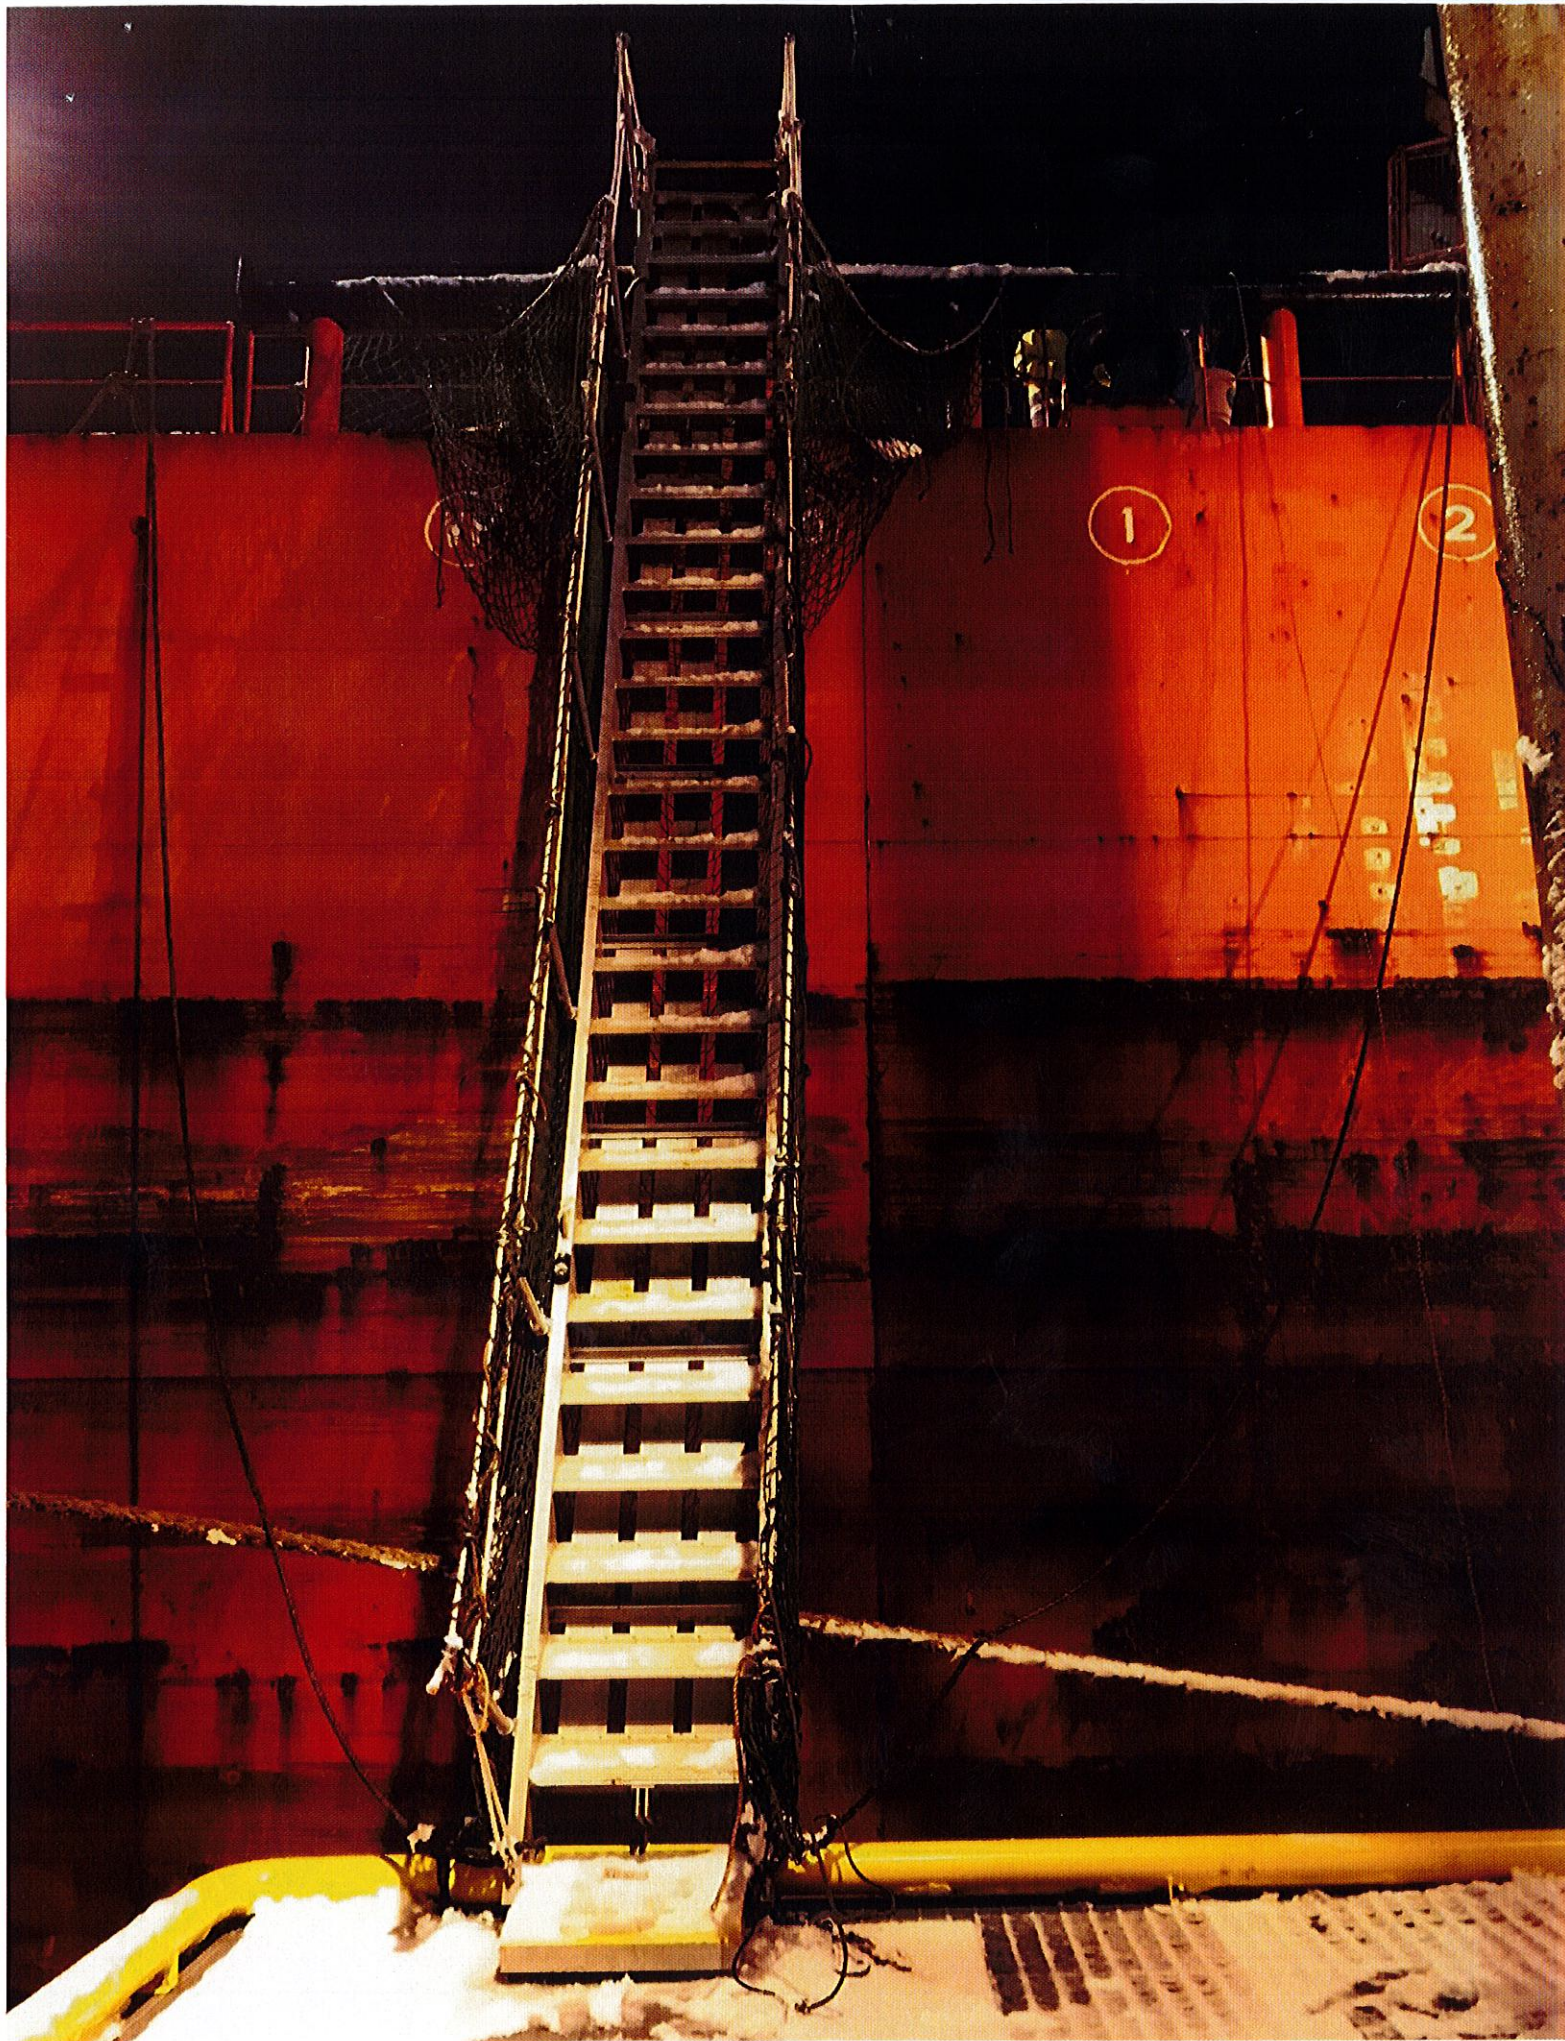
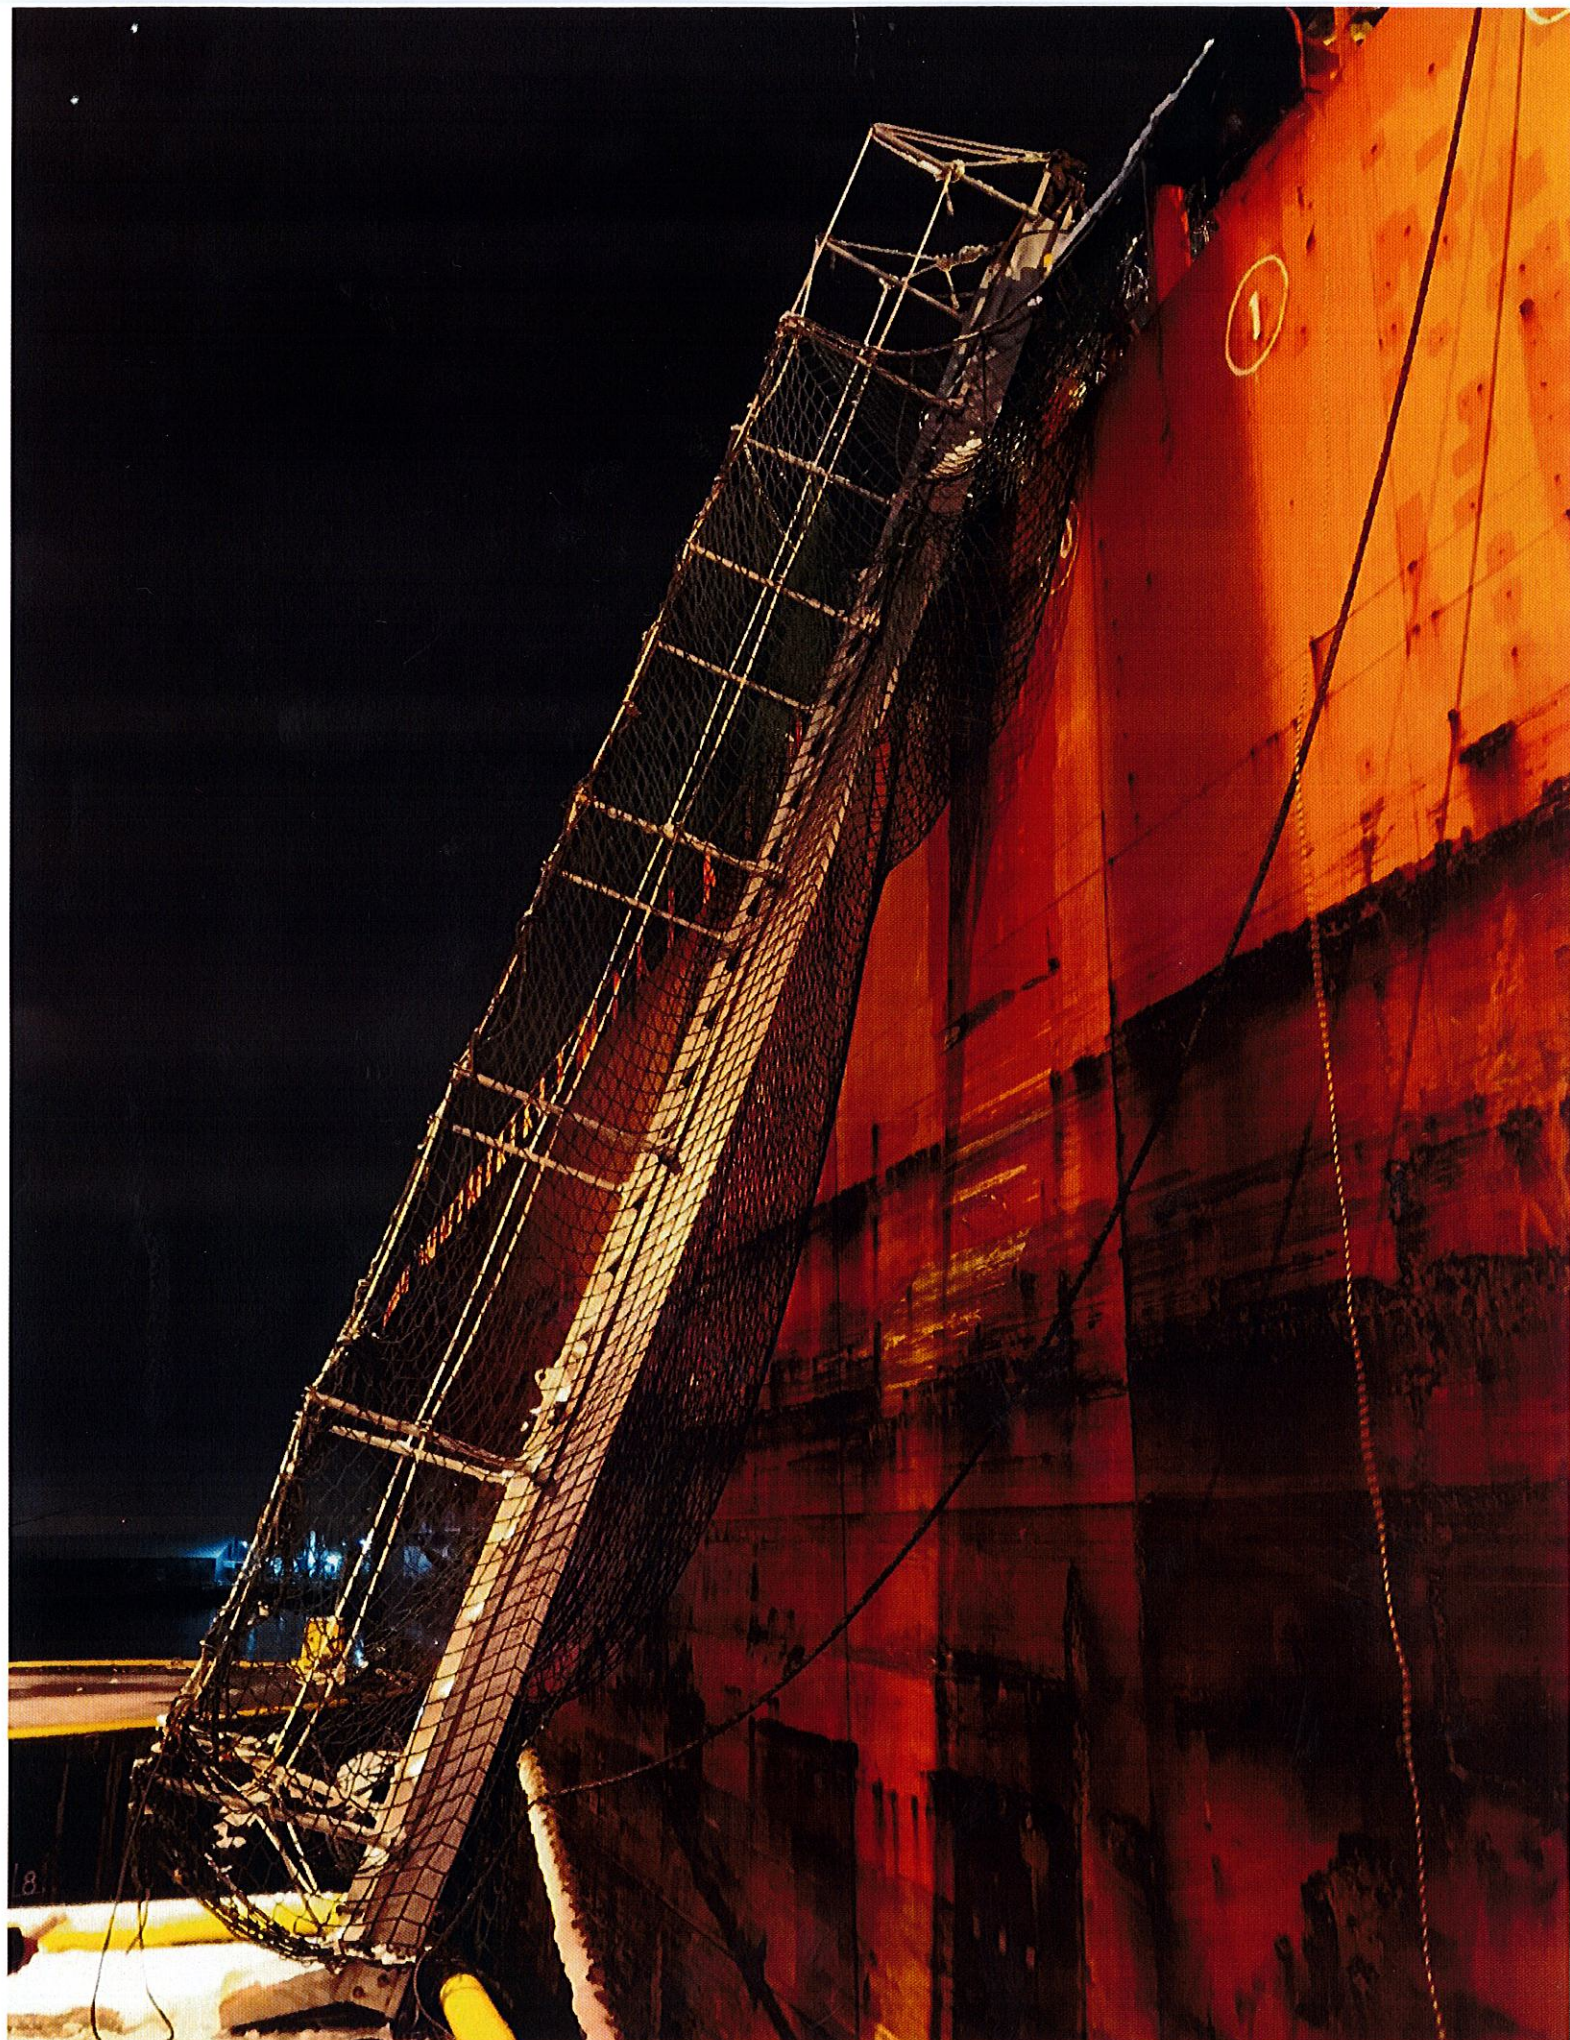
(see photos)

gangway set at dangerous angle; see below

Attempted to climb snow-covered gangway and when  
nearing the top, the gangway made cracking noises. The  
crew implored me to stop and go back down. Top of  
gangway overhung deck by 4-5 feet.
