PILOT BOARDING DEFICIENCY REPORT

DATE: 2/12/2020 TIME: 1900

VESSEL: Noble Ace

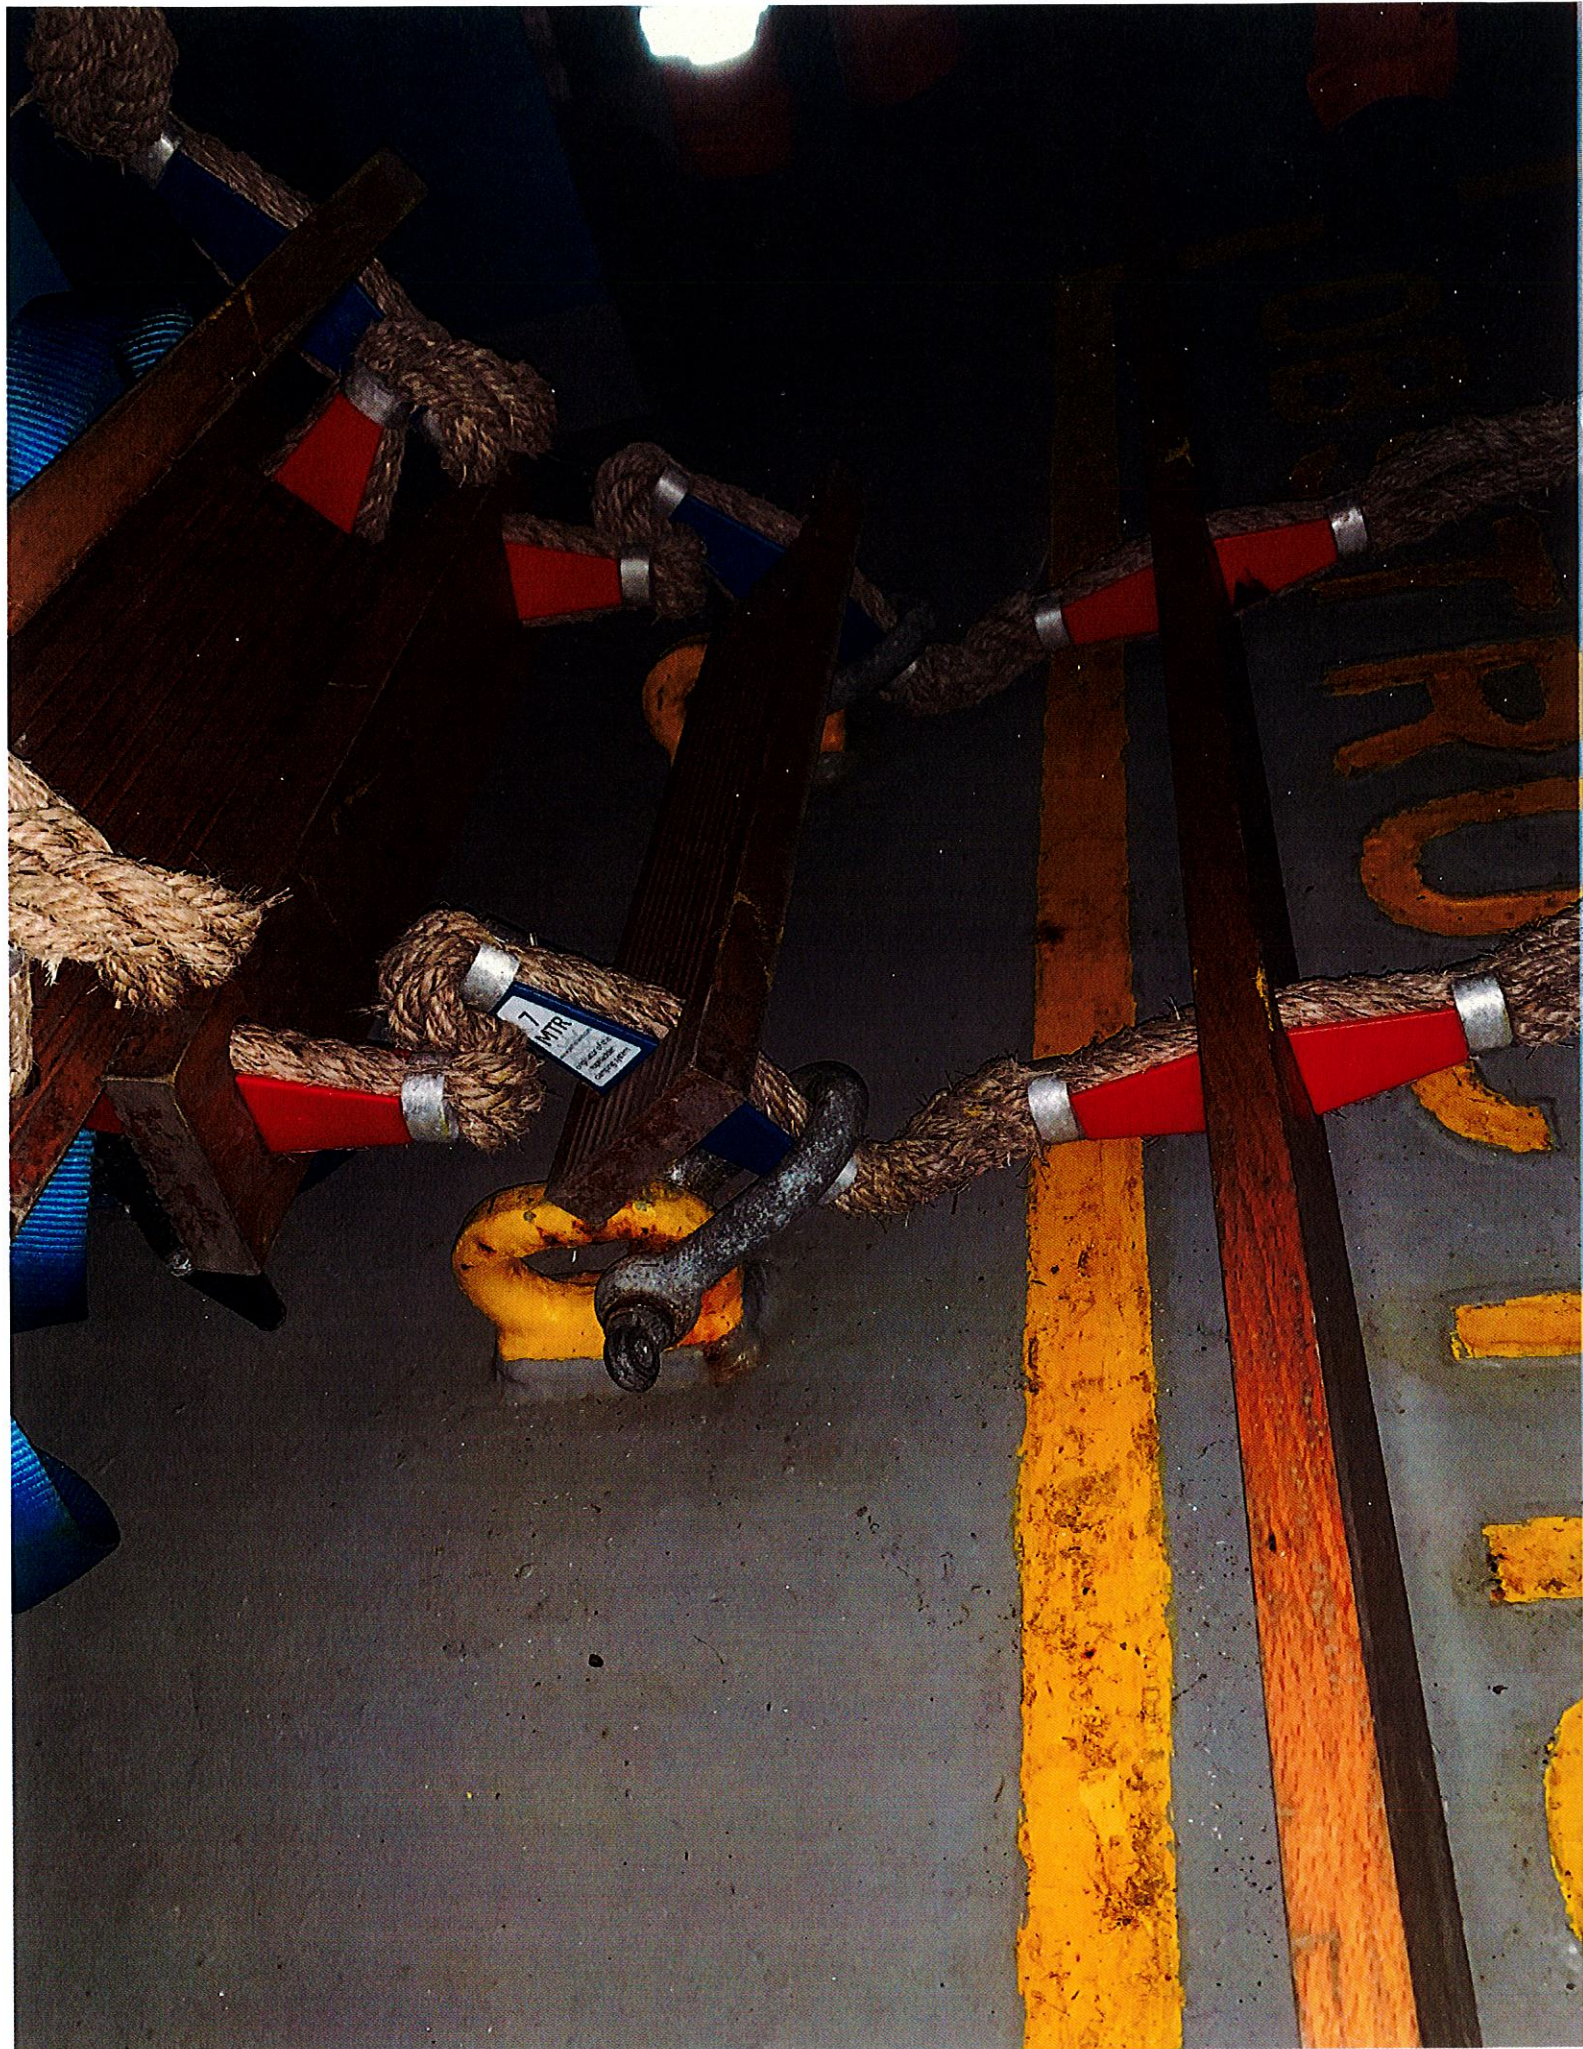
Ladder not properly secured from strong point on deck to side ropes. Shackled directly to side

Only shackles used to secure directly to side ropes. Shackles ride up to the step

All the weight of ladder is resting on the one step. Explained to captain and crew.

See picture.
