PILOT BOARDING DEFICIENCY REPORT

DATE: 2/16/2020 TIME: 0215

VESSEL: Cornelia Maersk

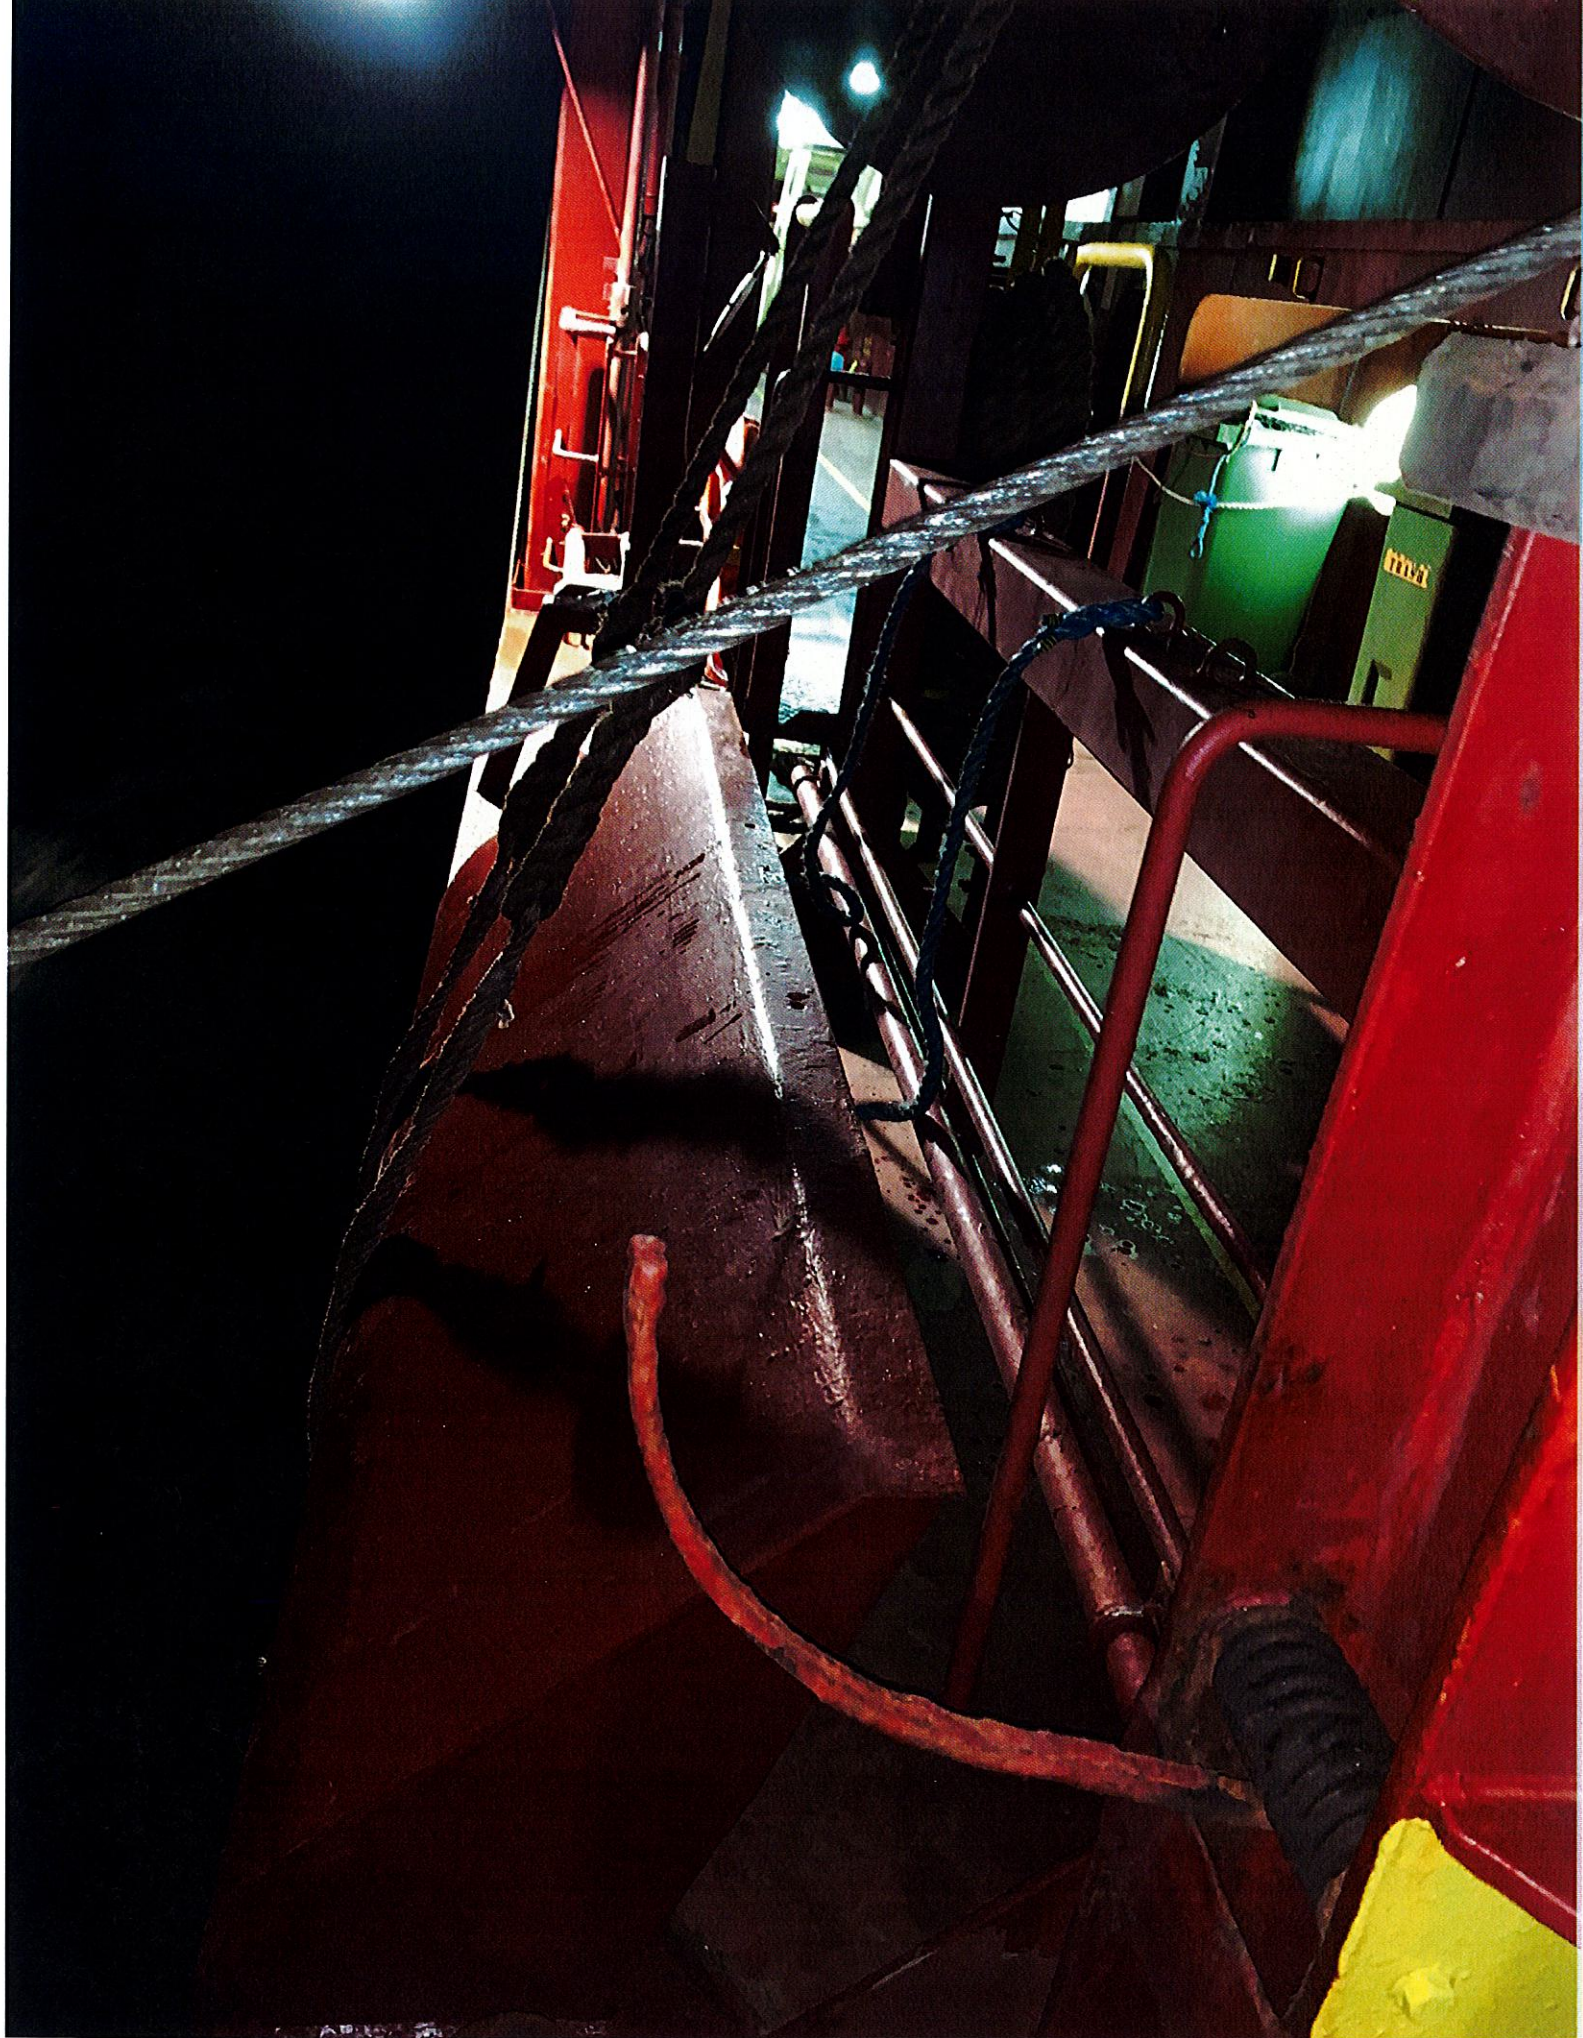
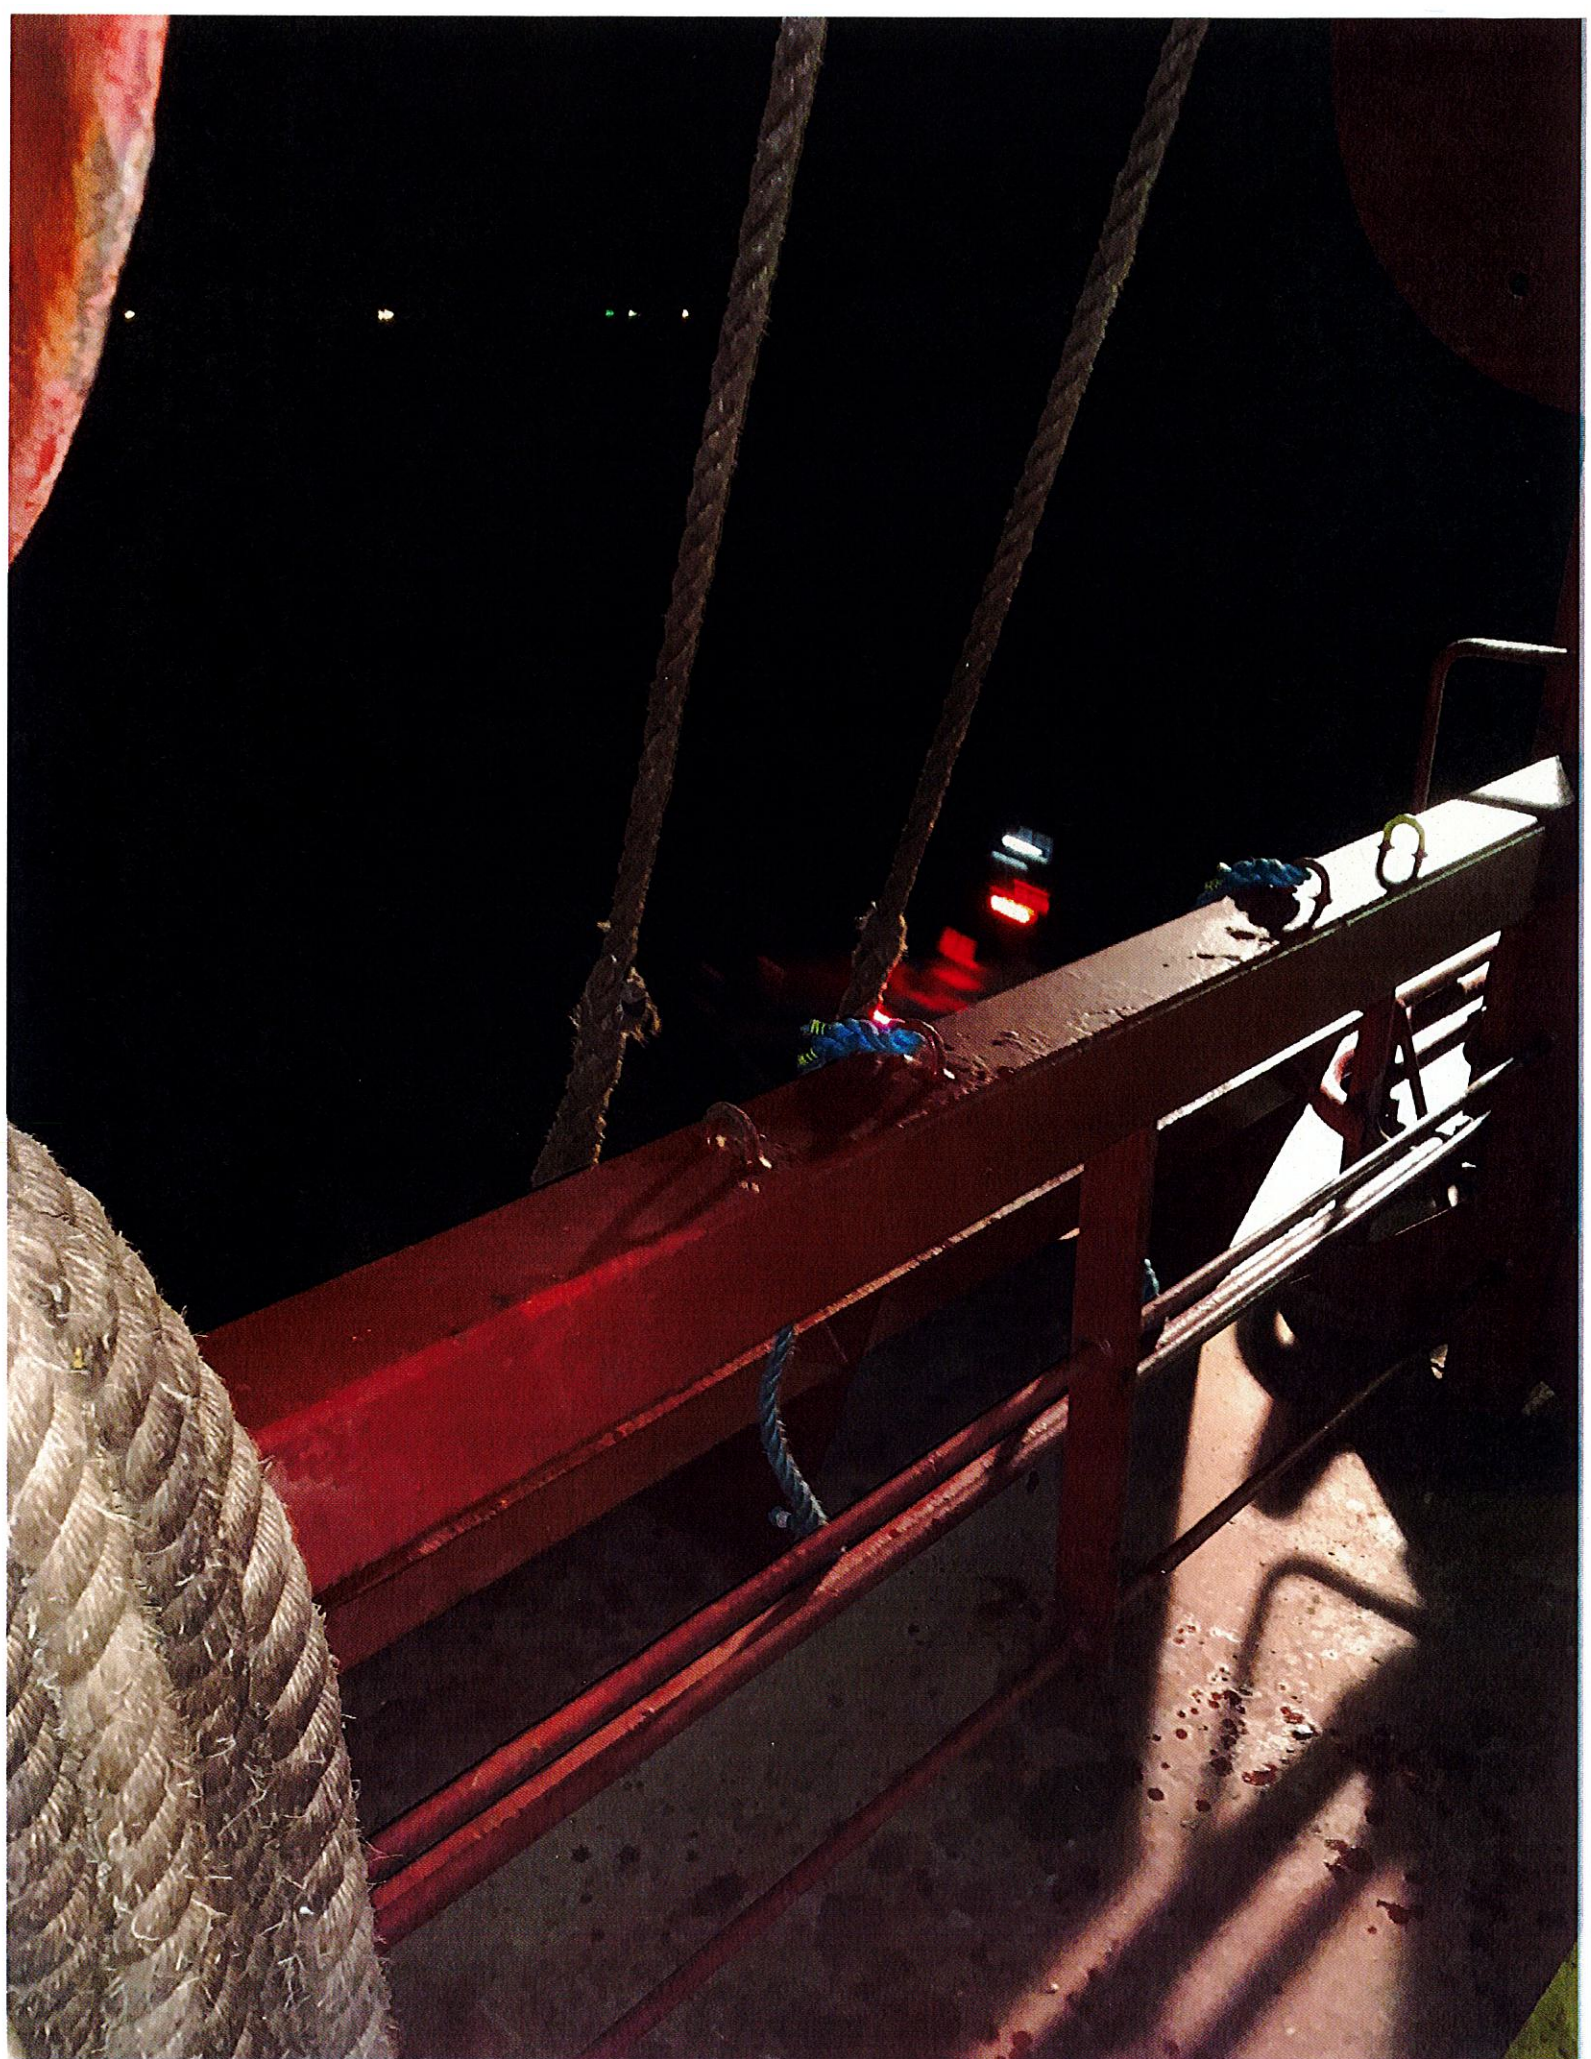
Ladder not properly secured from strong point on deck to side ropes. Not independent of ladder.

No deck Strong point available to secure ladder independent of the ladder reel. Ladder reel only method of securing.

Ladder not secured to strong point on deck. Not independently secured from ladder reel

Explained to captain and crew. See pictures.
